PROJECT 05-106

Conservation of the H.L. Hunley and its Associated Artifacts

James W. Hunter, III
Friends of the Hunley, Inc.

March 1, 2006

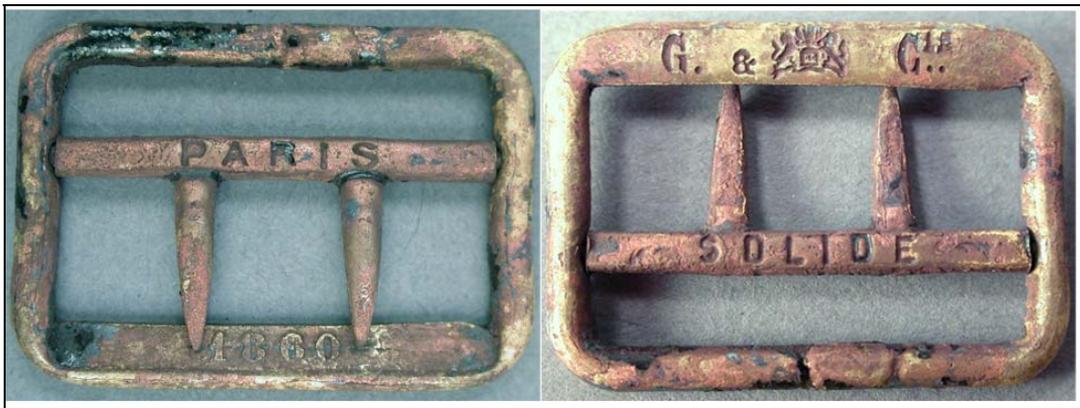
The majority of cupreous artifacts conserved during 2005 comprised personal items, including uniform and clothing buttons (HL-3200, HL-3201, HL-3232, HL-3164, HL-3329, HL-3333, HL-3337, HL-3343, HL-3341, HL-3344, HL-3346, HL-3348, HL-3350, HL-3351 and HL-3368), three buckles (HL-2073, HL-3336 and HL-3349), and a thimble (HL-1354). One of the buckles (HL-3336) belonged to Lt. Dixon and contained important diagnostic markings, including the stamped or inscribed marks "Paris," "1860" and "SOLIDE," as well as as-yet unidentified maker's mark (Figure 1). Other significant copper and copper-alloy items include pins (HL-3172 and HL-3292), wires (HL-3174, HL-3290 and HL-3299), a nut associated with the bellows-snorkel box assembly (HL-3196) and two rings or grommets (HL-1679, HL-1309), the latter of which is associated with a Union identification tag discovered among the remains of crewman Joseph Ridgaway.

Figure 1: Copper-alloy buckle HL-3336 following conservation.

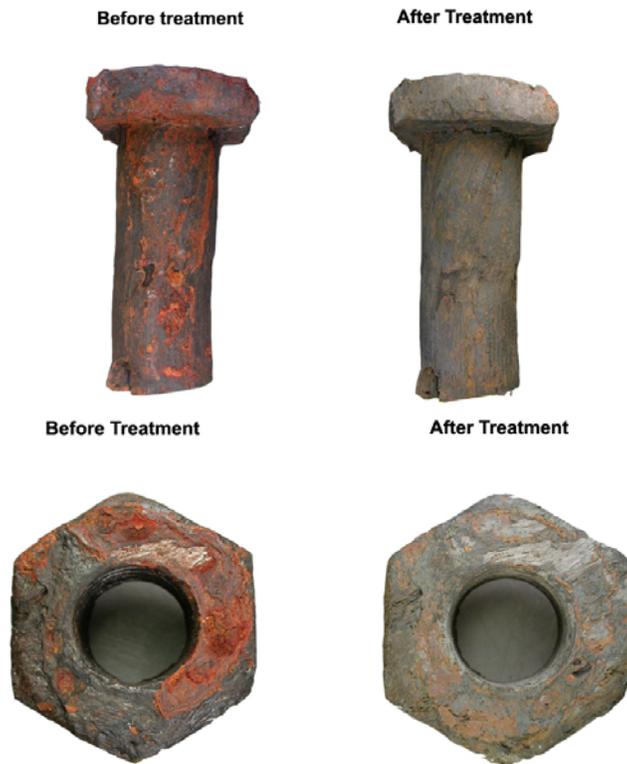
Figure 2: Spar nut (HL-502) and bolt (HL-511) before and after sub-critical treatment.

The technique is based on the use of sub-critical water solutions as the media for the removal of Cl^{-1} from cast and wrought iron. By definition, sub-critical water is water at requisite pressure and heated to a temperature between 100°C and the critical temperature of water, 374°C . In the sub-critical region, the transport properties of water as a solvent media exist between those of liquid H_2O and supercritical H_2O . The hypothesis for this investigation states the employment of sub-critical water solutions could dramatically increase Cl^{-1} removal efficiency and significantly reduce treatment times. As evidenced in Figure 2, project conservators effectively used the technique to treat the nut (HL-502) and bolt (HL-511) that once held the submarine's spar assembly to the bow. Following sub-critical treatment, each artifact's exterior surface was cleaned with a low pressure, 50-micron sodium bicarbonate micro-abrasion unit.

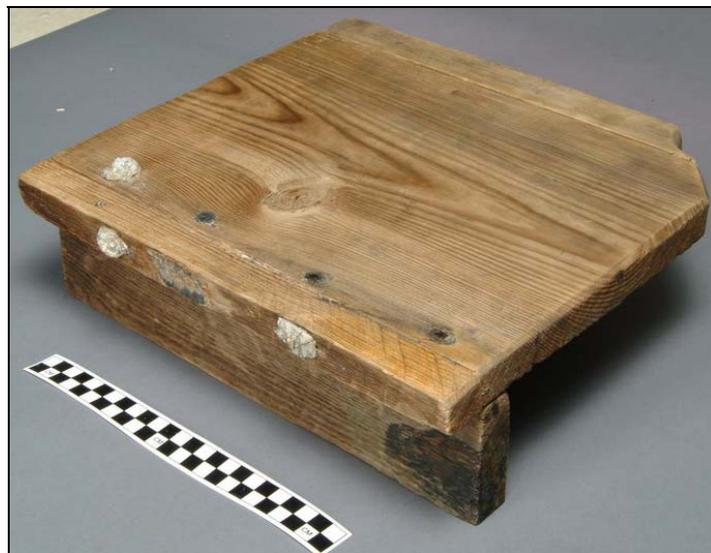
Figure 3: Lt. Dixon's seat (HL-1973) following treatment.

Lt. Dixon's three-piece wooden seat (HL-1973) was cleaned, impregnated with polyethylene glycol (PEG) and subsequently vacuum freeze-dried (Figure 3). Of the wooden matchstick assemblage, several examples exhibited carbonized ends. These were successfully cleaned and conserved, as were the numerous wooden and cork stoppers associated with the crew's individual canteens.
