GRAMP AW PETTIBONE

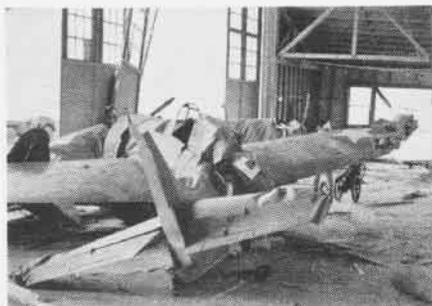
In taking off, the pilot of an F4F-4 noticed the left wing start to dip just as the wheels were leaving the ground.

He gave it more gun, got immediate increased left torque, and the Grumman veered left and smashed through a hangar, taking out a 12-inch-square wooden post and making mincemeat out of two Cubs.
