GRAMPAW PETTIBONE

Pass the Word

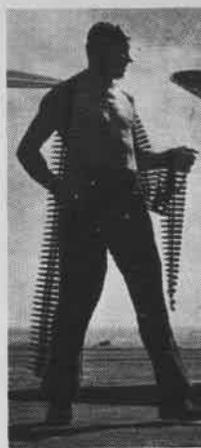
This Is Bad Practice

Carrying belted ammunition around one's neck makes a pretty picture but is bad gunnery procedure. Ammunition is supposed to be carried in standard cans, not in this manner because bent links and malalignment of cartridges easily can result by such careless handling. This picture of improper procedure appeared in NANews April 1.

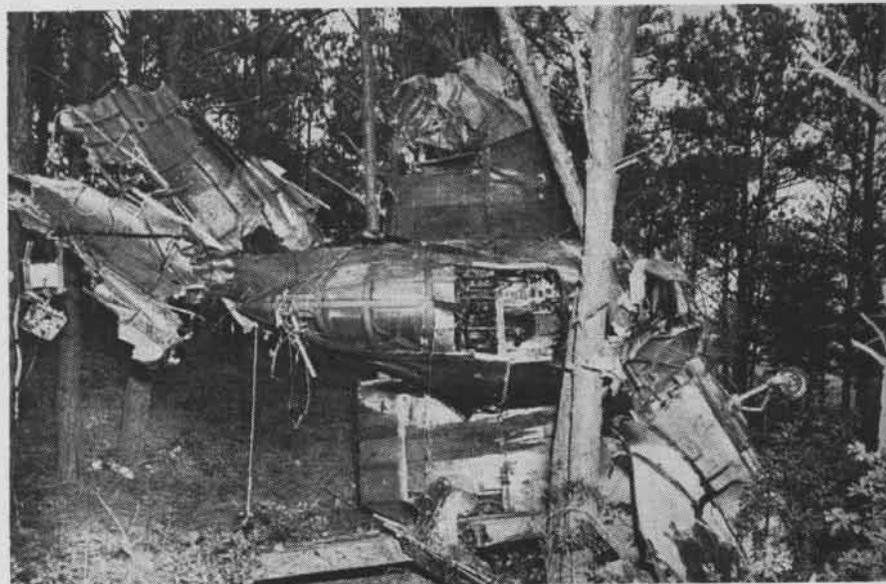
A PILOT got himself in this predicament one night when he paid more attention to eating a sandwich than to his navigation, plus being unfamiliar with the local radio range, plus failing to shift gas tanks properly. Let it be said to his credit, however, that he did have his shoulder harness secured—which is the only reason he was able to walk away from this wreck and profit by his mistakes. Any offers for this used plane?
