# GRAMPAW PETTIBONE

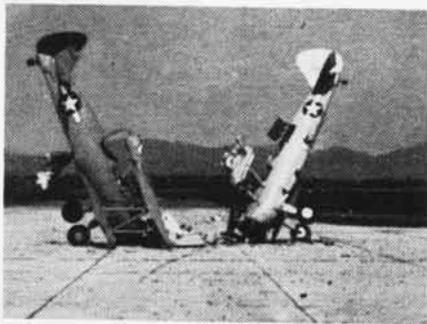
The pilots of the two N2S's pictured above landed simultaneously at an uncontrolled airport using runways 24 and 36. As can be seen from the wreckage, they arrived at the intersection in a dead heat. Both planes are recommended for strike and salvage of spare parts. Fortunately there were no injuries to personnel.

Each pilot observed the other after it was too late to avoid a collision, and each tried to turn inside the other to avoid personal injury. In so doing both aircraft collided almost head-on, bounced back a few feet, and then stopped in a nose down position.

For my money that's a down right unsafe maneuver. The blame for this accident goes to the second pilot to enter the landing circle, since he failed to observe the local traffic landing on runway 24, and didn't notice the other Navy N2S which had completed a circle of the field and was preparing to land on runway 24.
