# GRAMPAW PETTIBONE

## Wanted: An Opening

## Prematurely Gray

## In a Hurry?

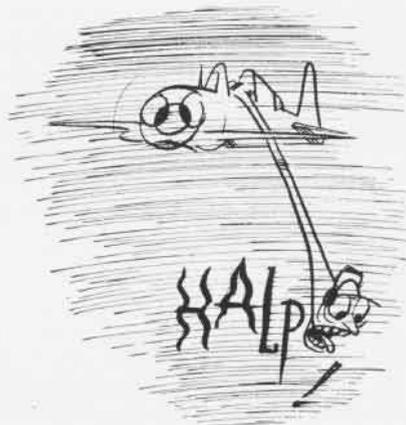
There's something downright pathetic about a pilot with nine hours of recent flight experience sitting on top of a metropolitan area at 12,000 feet with 11,600 feet of rain and soup between him and home base . . . unqualified on instruments . . .

unable to make radio contact . . . in a plane not equipped for instrument flight . . . and in all probability without a let down chart.

"On all cross country flights where weather conditions are marginal and the possibility of encountering instrument conditions exists, the aircraft and pilot must meet instrument flight requirements."

P.S. Their Operations Officer has also been directed to "deny flight clearance for a cross country flight to any Naval Aviator in an aircraft not having a clock in operation unless the pilot possesses a suitable time piece."
