GRAMPAW PETTIBONE

Jet Blast Victim

Self-Made Booby Trap

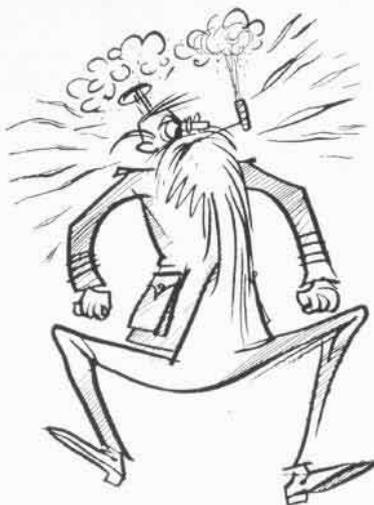
"As I had completed removing the tie-down reel from the left wing stub, I felt an excessive amount of heat and jet blast hit me. I immediately jumped behind the left wheel of my airplane.

I glanced up and realized the F2H-4 was taxiing out, and the jet blast was directed right at me. Prior to this time I did not see any signal from the taxi director nor did I see or hear the F2H-4 begin to taxi out until I felt the jet blast on my body.

"I was unable to hold onto the wheel of my airplane. I could feel my face being burned so I tried to cover my face with my hands. Immediately the blast began to blow me to the rear. As there is no catwalk or ladder in this area, I reached for the steel gutter edge of the flight deck thinking I might drop down into the gun sponson which is fifteen feet below. However, the steel edge was too hot to touch, therefore I scrambled under the tail of my airplane as I was being blown to the rear.

"I believe this accident could have been avoided if I had been given a signal from the taxi director to clear the area prior to taxiing the jet aircraft out of its spot. Further, if I had seen the jet begin to taxi, I might possibly have cleared the area safely."

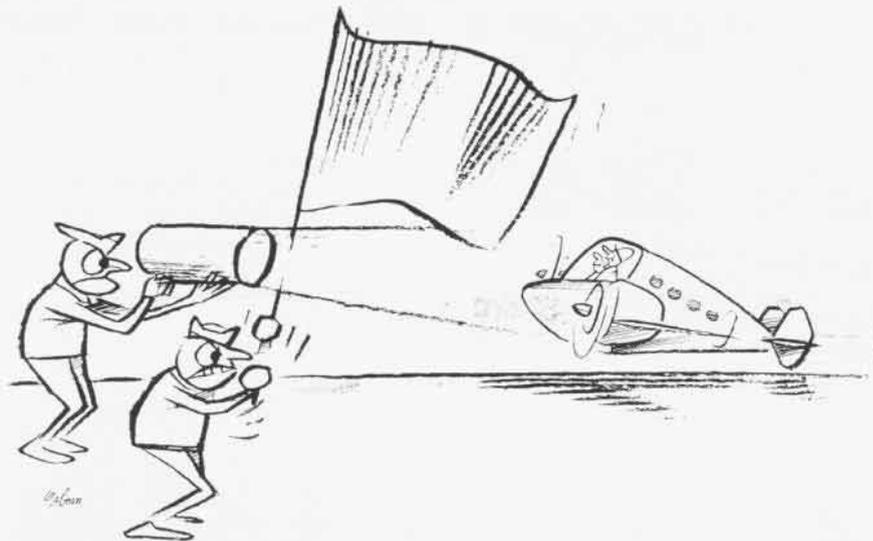
As I was about to touch down on the runway, I took off power and a landing gear warning horn was heard. Instinctively I took a wave-off! After securing from General Quarters in the cockpit, I found that my landing gear was down as I had thought, but there was still no explanation of the warning horn. To complicate matters further, the co-pilot had heard no such warning and couldn't figure why I was taking the wave-off.

plane behind me said he was very happy to see me take the wave-off, because he felt himself too close and that he had heard a horn, too. The pilot of the second plane behind me said that he was reporting over the range station to the tower and lowering his landing gear while he was transmitting. *I had heard his horn and thought it was my own!*

I thought you would like to hear of this one as it might prove embarrassing to somebody in a tight situation. Maybe you could warn other pilots that it's not good procedure to have the landing gear warning horn operating while you are transmitting on a tower frequency.

Amen to your suggestion. Now I'll stand by for some "wheels-up artist" to say, "I heard the horn, but figured it was probably from some other plane in the pattern."
