GRAMPAW PETTIBONE

Weightology

Night Lumberjack

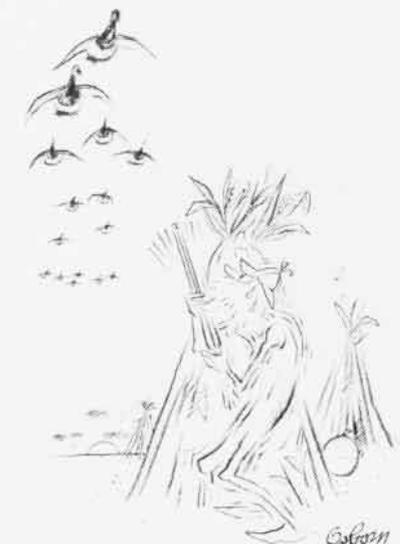
Investigation revealed that prior to his initial trap, the pilot had activated wing and auxiliary fuel dump. The pilot, knowing that the aircraft had a previous wing fuel indicator gripe, had assumed the wings were empty when

they actually contained 4,600 pounds of fuel. He was, therefore, Rogering his weight at 4,600 pounds less than his actual weight. Consequently, his catapult end speed was minus one knot the first time and plus five on the second shot.

You see, gents, so often it ain't the "big things" that do a fella in—it's all those little things that we call "up gripes." So, when it comes to looking over your previous discrepancies on the yellow sheet—be a suspicious cuss!

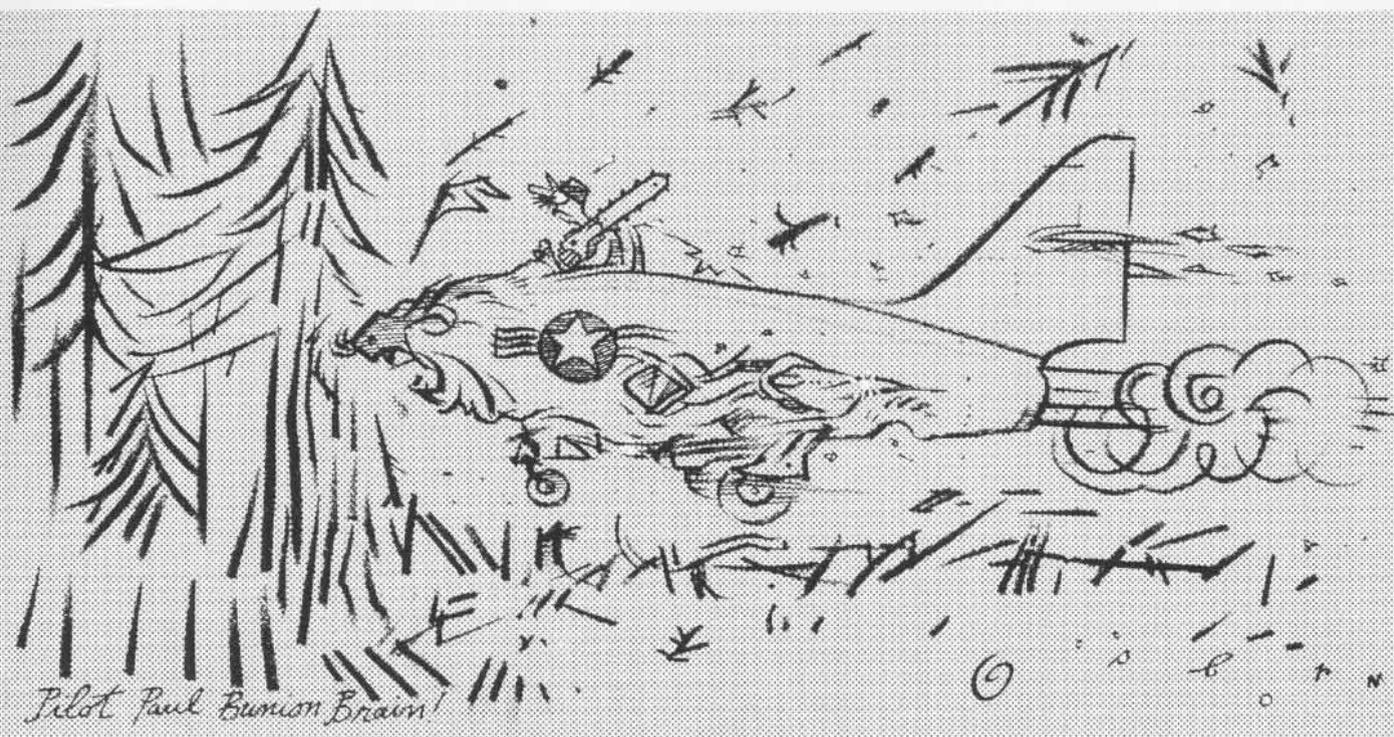
At this point, he was estimated to be below 100 feet and the additional power did not stop his sink rate. He settled into an area of small trees in a landing attitude.

As he felt the impact, he tried to eject but couldn't find the face curtain. He continued approximately 500 feet at high power through the trees until he struck a three-foot diameter metal pipe lying on the ground. It sheared all three landing gears.

The aircraft continued at high power another 330 feet through dense trees until it came to rest, heavily damaged but intact, with the engine still running. The uninjured instructor secured the engine and essential switches and then

attempted to blow the canopy. Since the emergency canopy release was not activated properly, it did not blow back. He opened it manually and exited the aircraft. The aircraft was a total loss.

My surgin' blood pressure! This pilot could'a got kilt! How many times have we seen "drivers" get pre-occupied with other traffic with the result being landing short, landing without rollers, minus the flaps, or some other forgotten item—you've gotta fly your machine! This lad said this accident could'a been prevented had we waved off—too bad his immediate analysis was not as good as his "hindsight" analysis. It's a darned good idea to keep your head out'a the cockpit—but this lad carried a good thing too far! If you want to play lumberjack, get yourself a chain saw.
