Tomcat Toppie

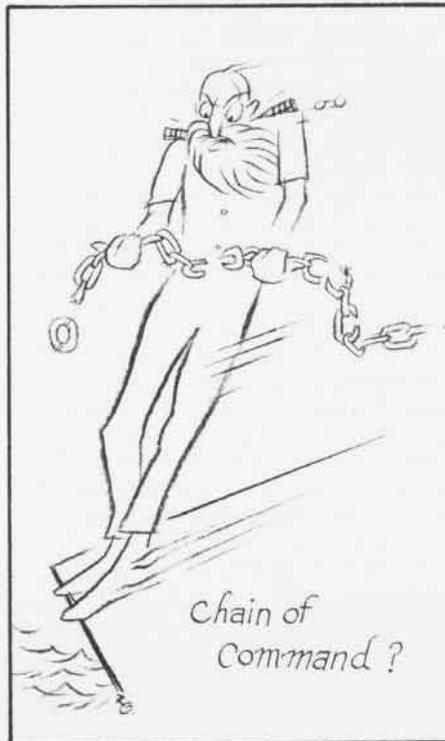
As the aircraft moved forward, the port main mount split the chock and the aft tending chain snapped. The ship then rolled starboard a second time, causing the F-14 to roll backwards again. Sensing he was *in extremis*, the pilot hurried onto the boarding ladder as the main mounts traveled over the coaming and into the safety net. As the aircraft pivoted nose up, the pilot pushed away from the airplane and landed on the elevator deck, suffering minor injuries. The RIO

The *Tomcat* achieved a 70-degree, nose-up attitude, with the drop tanks resting on the coaming. The tractor's rear wheels rose off the deck. The driver jumped to safety before the trac-

tor broke free. The aircraft paused precariously a few seconds and then fell overboard. The *Tomcat* disappeared into the sea and sank to the bottom, 9,000 feet away.

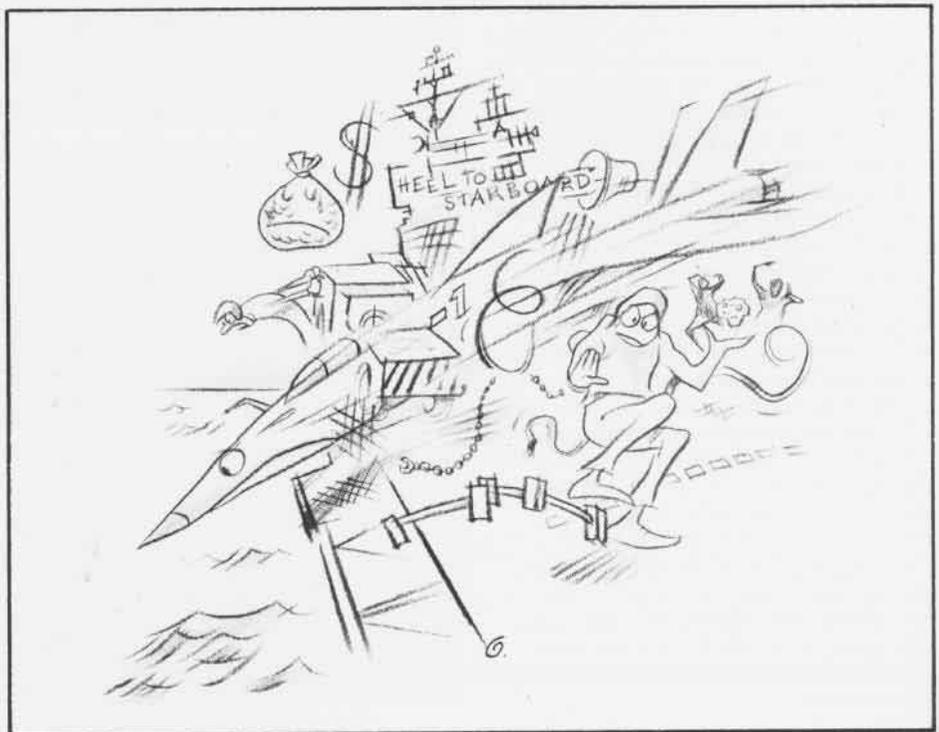
The finger of blame's got more than one target for this fiasco. In deck edge moves, the book calls for a director, a tractor driver and two chock walkers. Not only did the director double up as tractor driver, he wasn't always plainly visible to the pilot in the cockpit. The pilot didn't see the breakdown signal. He was wearing sunglasses so "eye contact" with the director was limited at best.

Lack of communication between the director and the pilot allowed removal of the tie-down chains and chocks before adequate brake accumulator

hydraulic pressure could be obtained via the hand pump. The aircraft's momentum caused by the flattop's roll to starboard was simply too great for the tractor to control without help from aircraft brakes. If the pilot had had more time to cycle the pump, this mishap might have been avoided.
