U.S. NAVAL MOBILE CONSTRUCTION BATTALION ONE

# ALFA COMPANY WATER WELL AFTER ACTION REPORT

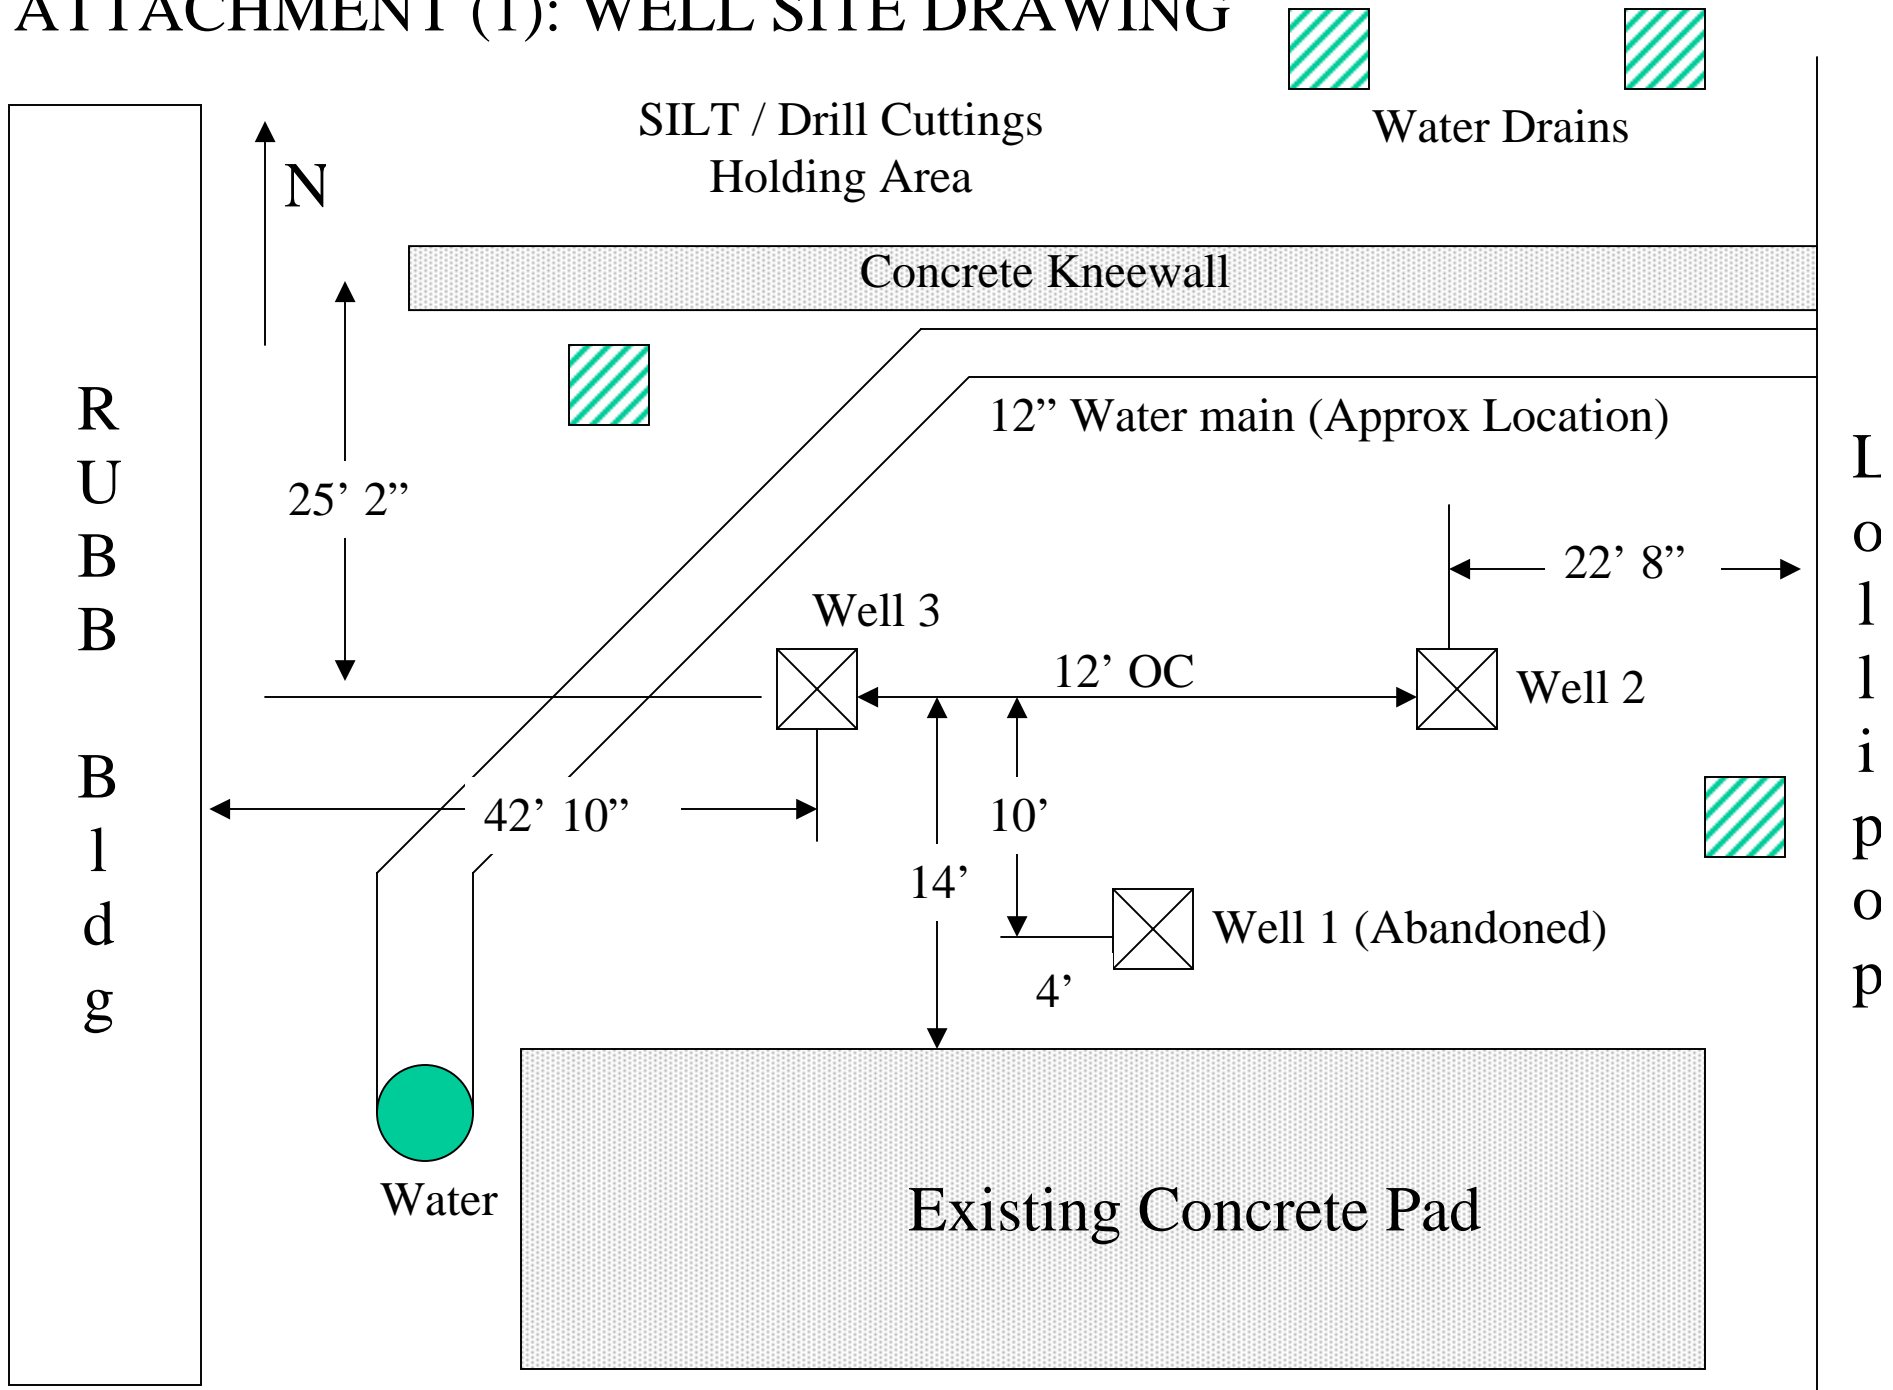
# ATTACHMENT (1): WELL SITE DRAWING

1. **General:** The primary tasking for the WWT consisted of drilling a 1,000ft well and procure materials for a 600 ft well on the Marathi Pier once site approval was obtained. On 8 February 00 drilling operations began on NSA Souda Bay using the down hole hammer technique. The well site was located by the air terminal, and in close proximity to an operational chloride plant. A rough sketch of the drill site is shown in attachment (1).

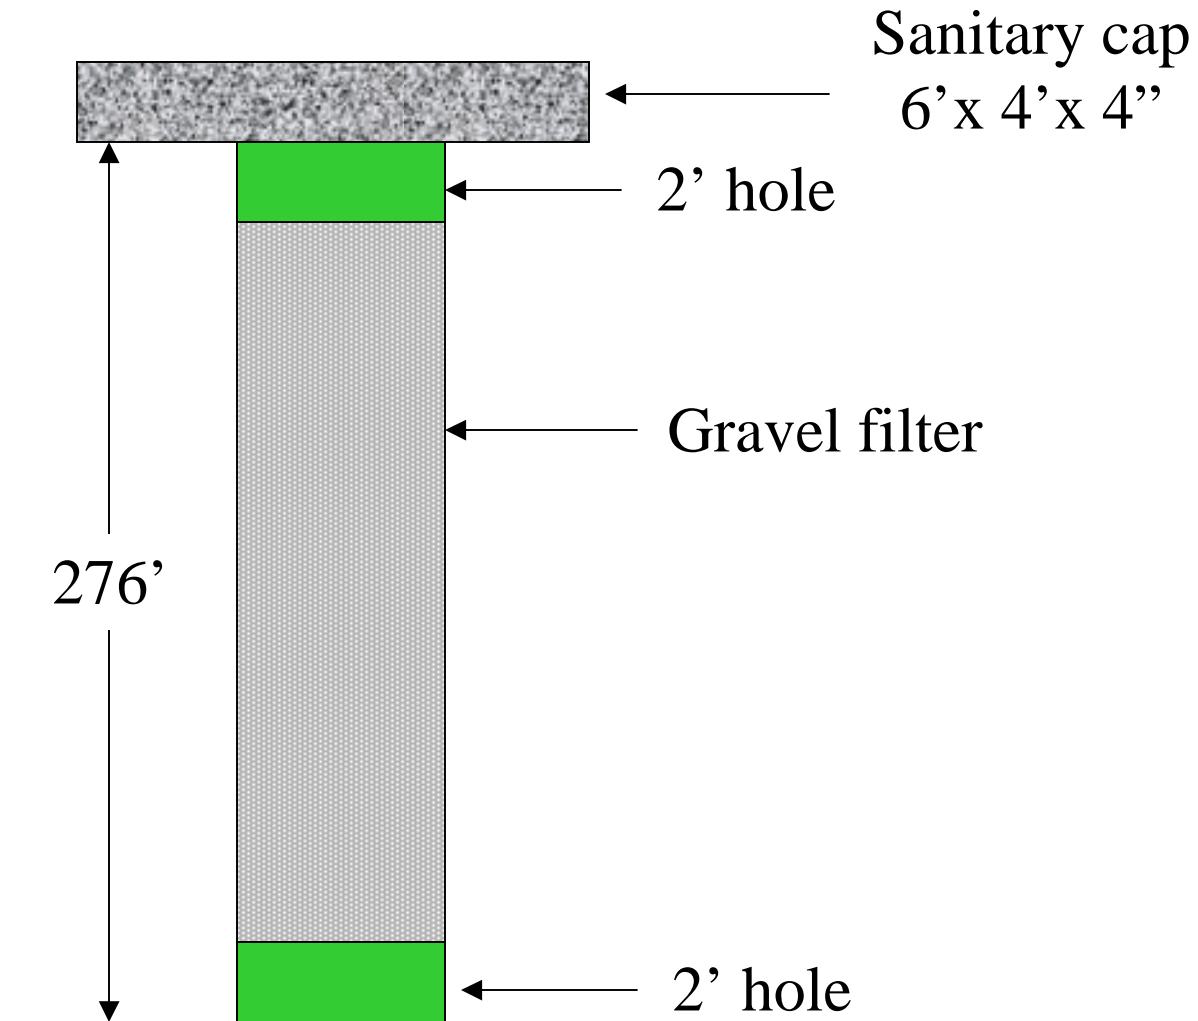
## WELL #1

On 9 February 2000, after reaching a depth of 276 ft, seven pieces of drill steel became lodged in the ground. After 12 hours of attempting to recover the steel with the well rig, the crew rented a 40-ton crane to attempt to pull the steel from the hole. The crane arrived on 10 February but was unsuccessful after three hours of pulling. After the crane departed, the crew began sending water and barafos through the center of the steel, which caused the blockage to dissolve allowing recovery of the drill steel on 11 February 00. The first well site was then abandoned with a hole plug and a 6' X 4' X 4" sanitary cap as shown in attachment (2). The crew theorized the blockage was caused by a cave-in from the backfill material that was used to construct the adjacent concrete slab.

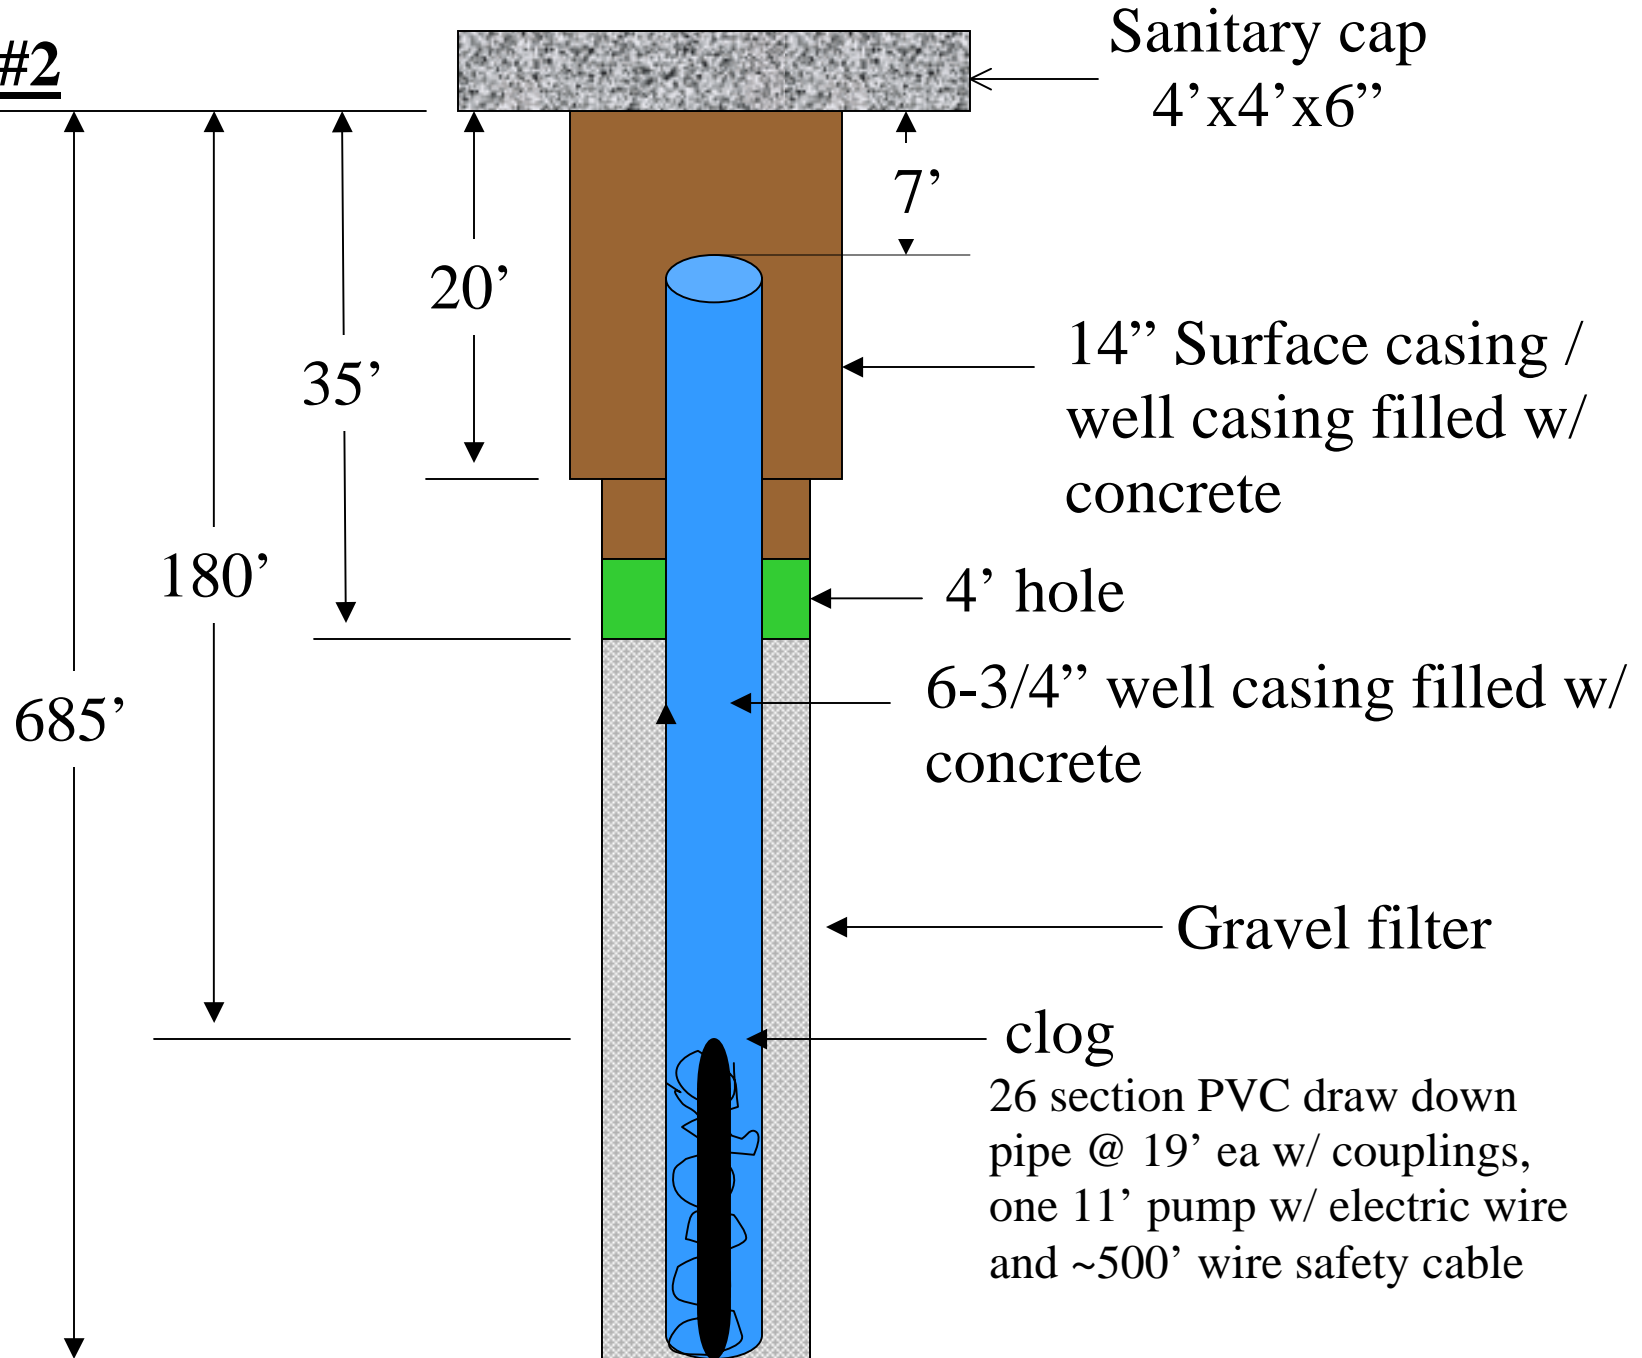
## WELL #2

On 12 February 00, the WWT started to drill for the surface casing at the second site. The actual well location was designated by Public Works to be 8 ft east and 10 ft north of the first well site. Well drilling operations were successful using foam vice the down hole hammer, until 20 February 00. After reaching 584 ft, the gear reduction box malfunctioned causing the rig to be deadlined. Since the part was not available in Automotive Repair Parts (ARP), it had to be purchased from the manufacturer, Ingersoll-Rand. The part arrived on 11 March 2000 and drilling operations began on 12 March 00. At a depth of 639 ft, a strong aquifer was uncovered and the crew continued to drill to a depth of 685 ft. After removing the drill steel, the well was cased and screened, gravel filter placed, air developing completed, and the pump/motor placed in the well with the draw down pipe. Typically, the draw down pipe is galvanized; however PVC was purchased for the specific well. During the 24 hour draw down test 57 GPM was achieved. On 18 March 00, only three hours into the draw down test, water stopped flowing from the well and the crew determined one the draw down pipe couplings had given way resulting in the draw down pipe falling 8-10 feet from the surface. The crew attempted to lift the pipe/pump combination with the attached safety cable; however the safety cable failed due to the crushing action from the rigs lifting hook and the weight being lifted. As a result, the pump fell to the bottom on the well.

For the next two weeks the WWT attempted every means possible to recover the pump and pipe. Several "fishing tools" were manufactured in the local Alfa Company shops and other fishing tools from Collateral were used to try to recover the pipe. A total of seven different attachments were created in the effort but the pump/pipe was unrecoverable. None of the attachments were able to get a solid grab on the top of the pipe. Finally, the blockage from mangled pipe was too great to penetrate or recover any

of the materials. After conferring with 2NCB and the main body, the well was abandoned.

After three failed attempts to drill, the crew attempted to break steel. The steel broke at the first coupling allowing one piece of steel to be recovered. Both sites two and three were then capped with hole plugs, concrete, and 4 ft X 4 ft X 6 inch sanitary caps as shown in attachment (2).

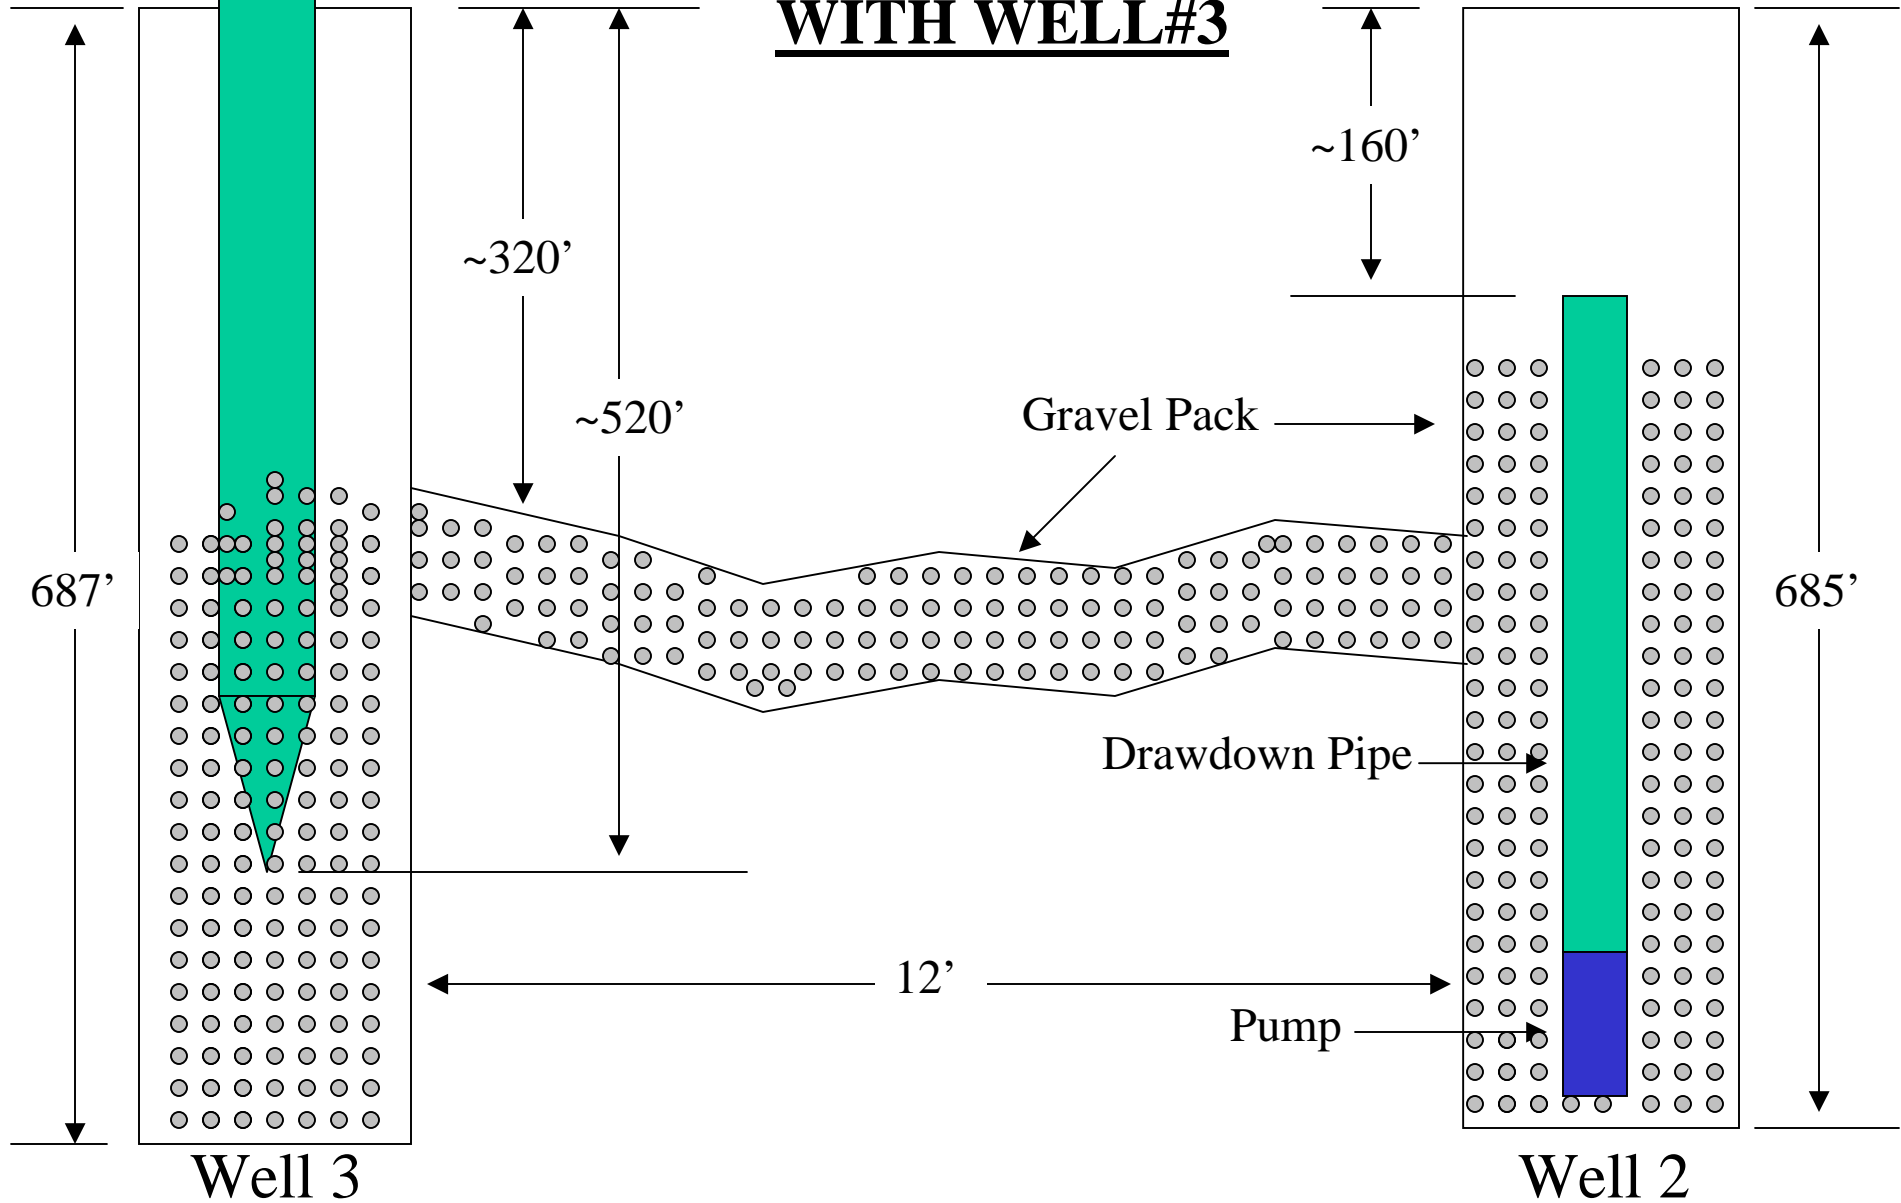
## THEORETICAL CAVE-IN PROBLEM

A new BM was developed to account for lost material. The intent was to identify all material required to drill another well at NSA Souda Bay and the well at Marathi. An additional \$28,000 was estimated to complete both wells. Once funding was obtained from CINCUSNAVEUR, a third well was started in the same vicinity of the first two wells. The new well was located 12 ft to the west of the second well, making it 10 ft north and 4 ft west of the first well (see attachment (1)). Drilling, using foam, began on 10 April 00. As each new piece of steel was added, the previous pieces were reamed out of the hole to ensure the well walls were smooth and to try to prevent any cave-ins. On 18 April 00, the crew found water and lost circulation at 687 ft. At that point, the crew started removing the drill steel. As each piece was removed, the force required to pull the steel increased. At 512 ft, the steel became lodged in the hole. The top head on the mast would not rotate and the steel could only move up and down 4-6 inches. The crew spent two days flushing the hole with water and barafos while simultaneously trying to pull the steel up and push it down. Despite flushing the hole with over 5,000 gallons of water, there was no water coming out of the hole. The water was escaping into an underground void.

Since the rig pressure was not powerful enough to move the steel, a 180-ton crane was rented to try to pull the steel. After applying about 50 tons of force to the steel over a three-hour period of time, the steel still would not move more than 6 inches. The next attempt was to have a larger civilian's water well rig attempt to pull the steel. On 22 April 00, the civilian rig arrived on site. The first piece of steel that was protruding from the ground was cut to allow the civilian's mast to line up over the hole. The civilian rig failed to pull the steel or dislodge the blockage by both pulling and drilling the same hole with a 6 inch drill bit. During the three drilling attempts, the civilian drill bit became lodged, clogged, or lost rotation, and was unable to drill past 320 ft. When air pressure was sent down the hole during drilling, the air was released through the second well excavation. Additionally, the bit became clogged with gravel filter, which resembled the gravel used on the second well. The crew theorized that the gravel filter used on the second well had also filled a continuous void underground as shown in attachment (3). This same void was encountered while drilling the third well.
