U.S. NAVAL MOBILE CONSTRUCTION BATTALION ONE

# ALFA COMPANY WATER WELL AFTER ACTION REPORT

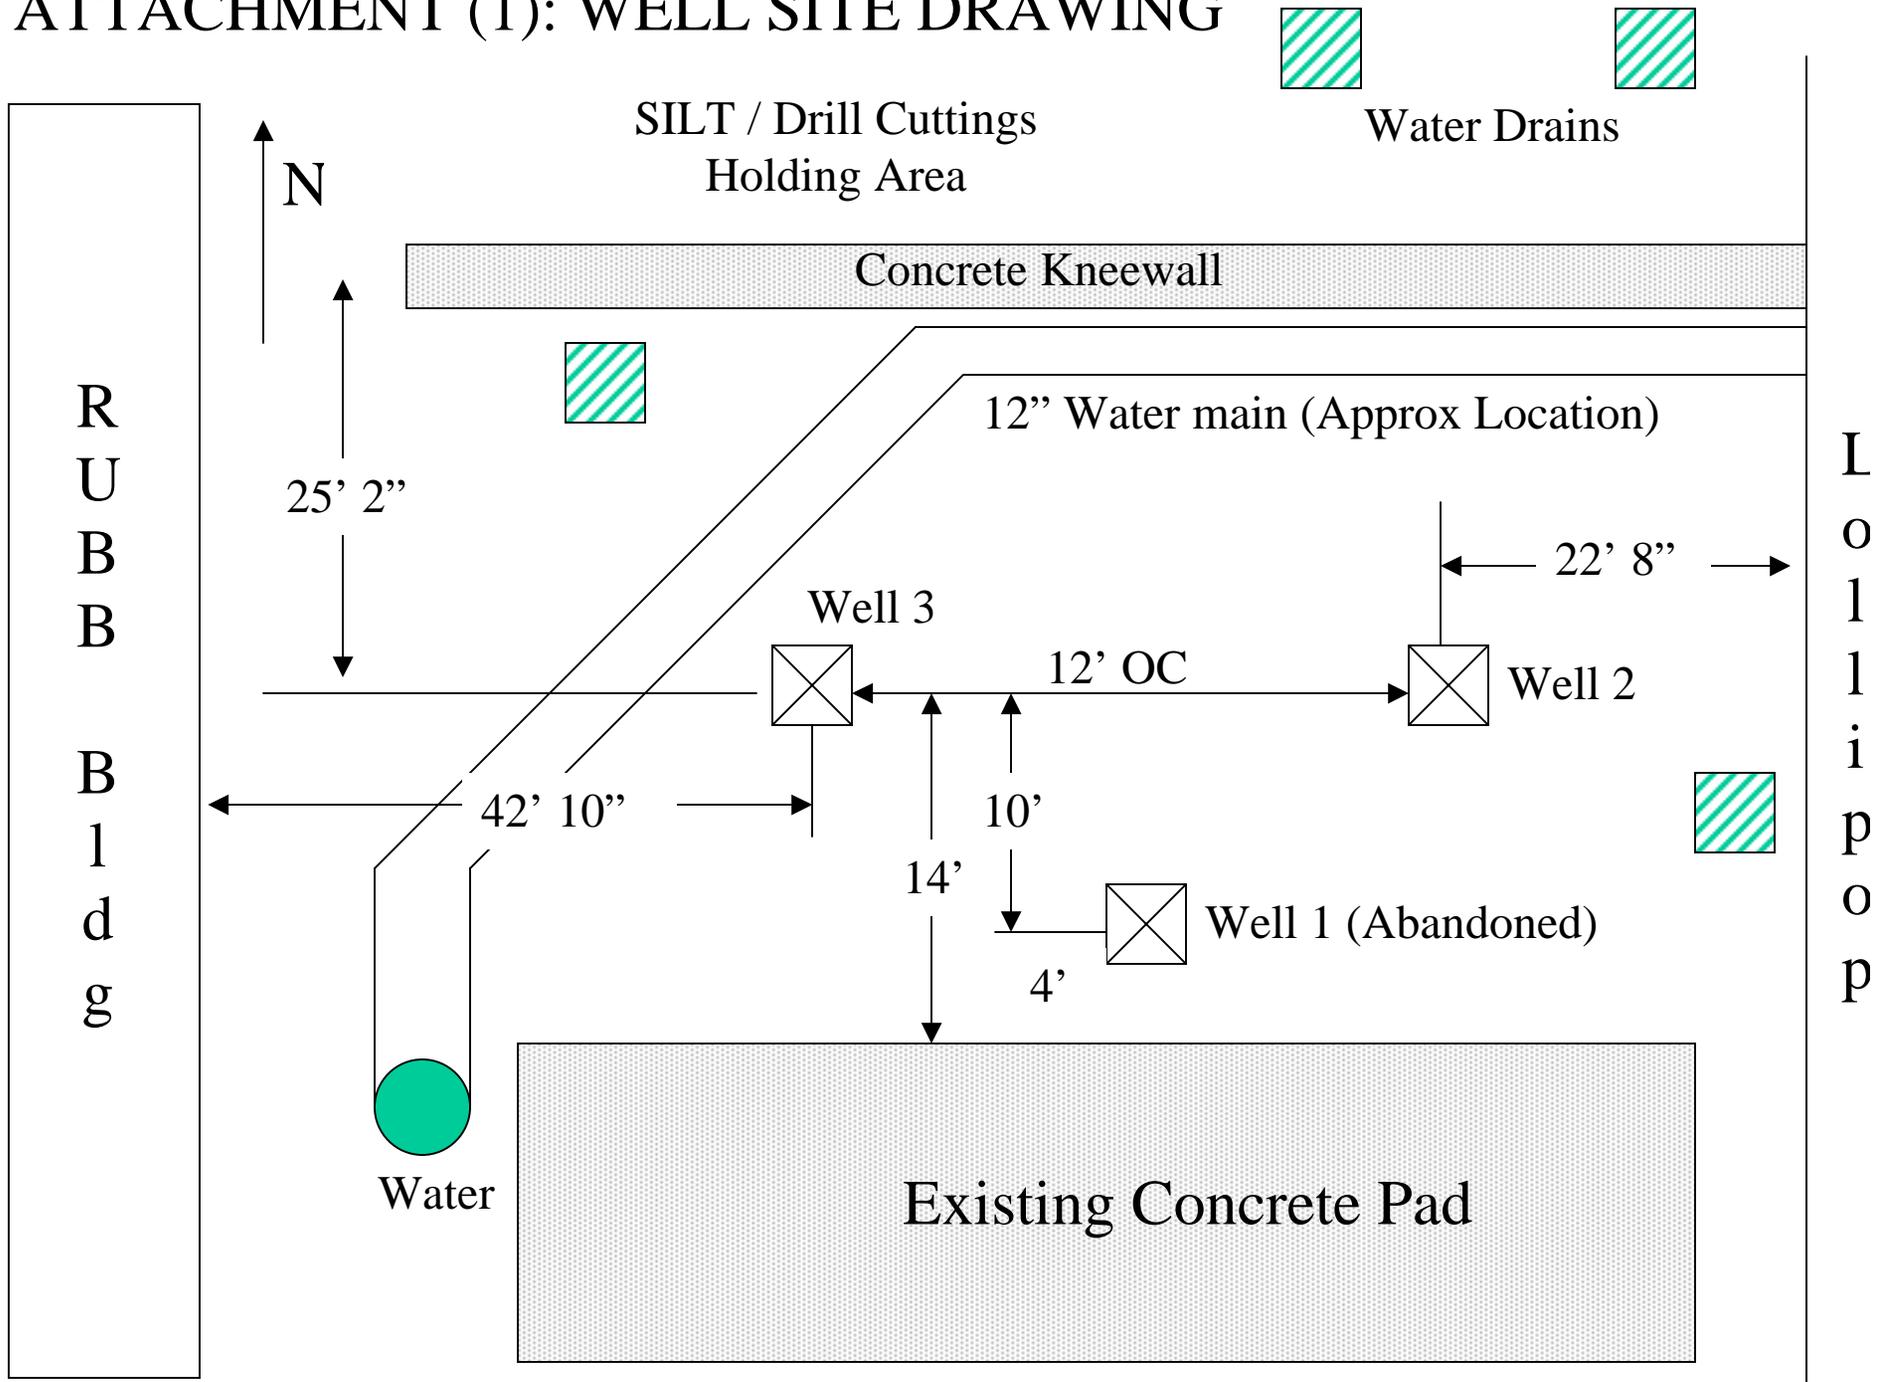
# ATTACHMENT (1): WELL SITE DRAWING

1. **General:** The primary tasking for the WWT consisted of drilling a 1,000ft well and procure materials for a 600 ft well on the Marathi Pier once site approval was obtained. On 8 February 00 drilling operations began on NSA Souda Bay using the down hole hammer technique. The well site was located by the air terminal, and in close proximity to an operational chloride plant. A rough sketch of the drill site is shown in attachment (1).

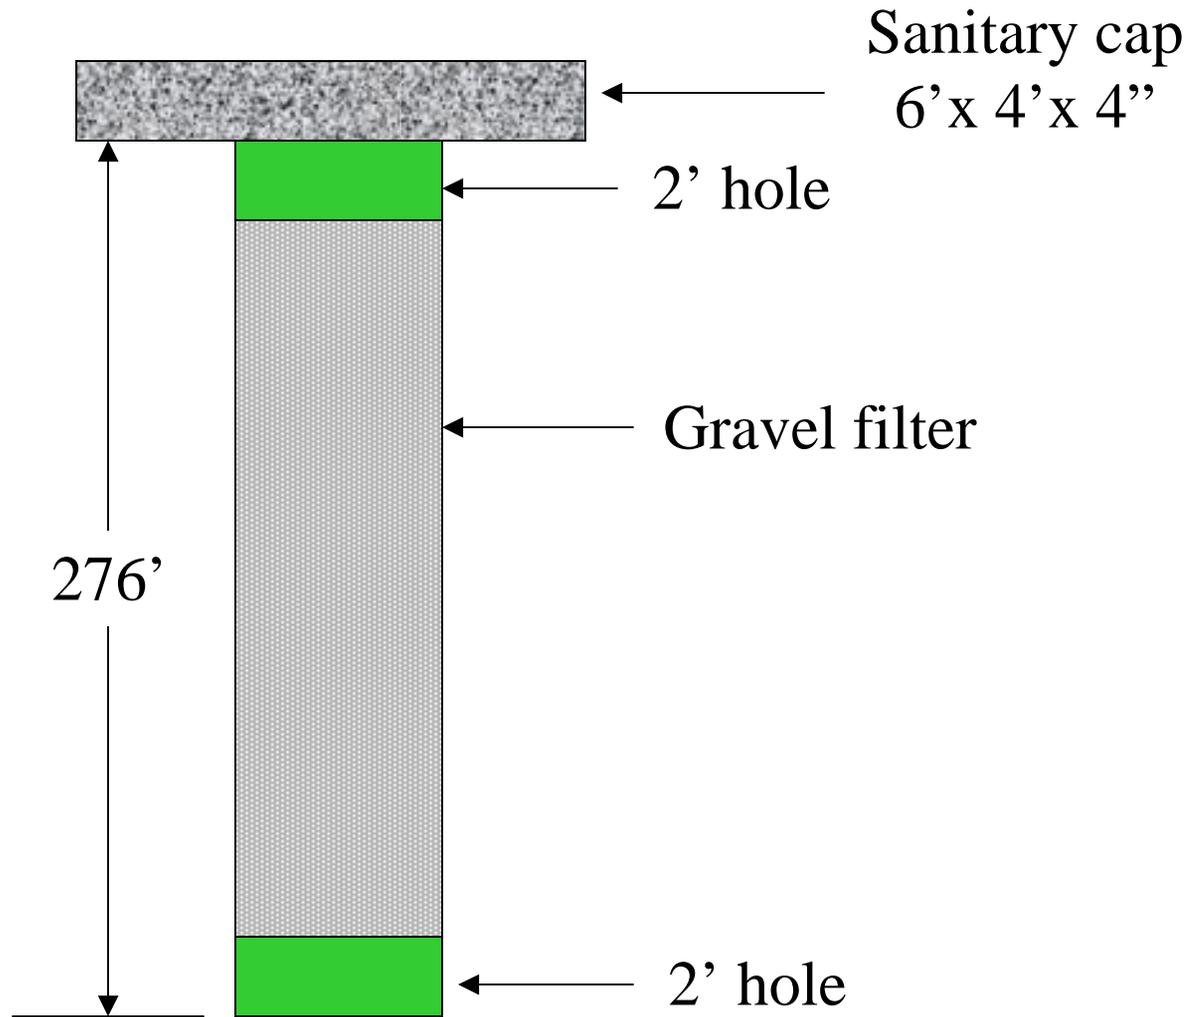
# ATTACHMENT (2): SITE SKETCH

After three failed attempts to drill, the crew attempted to break steel. The steel broke at the first coupling allowing one piece of steel to be recovered. Both sites two and three were then capped with hole plugs, concrete, and 4 ft X 4 ft X 6 inch sanitary caps as shown in attachment (2).

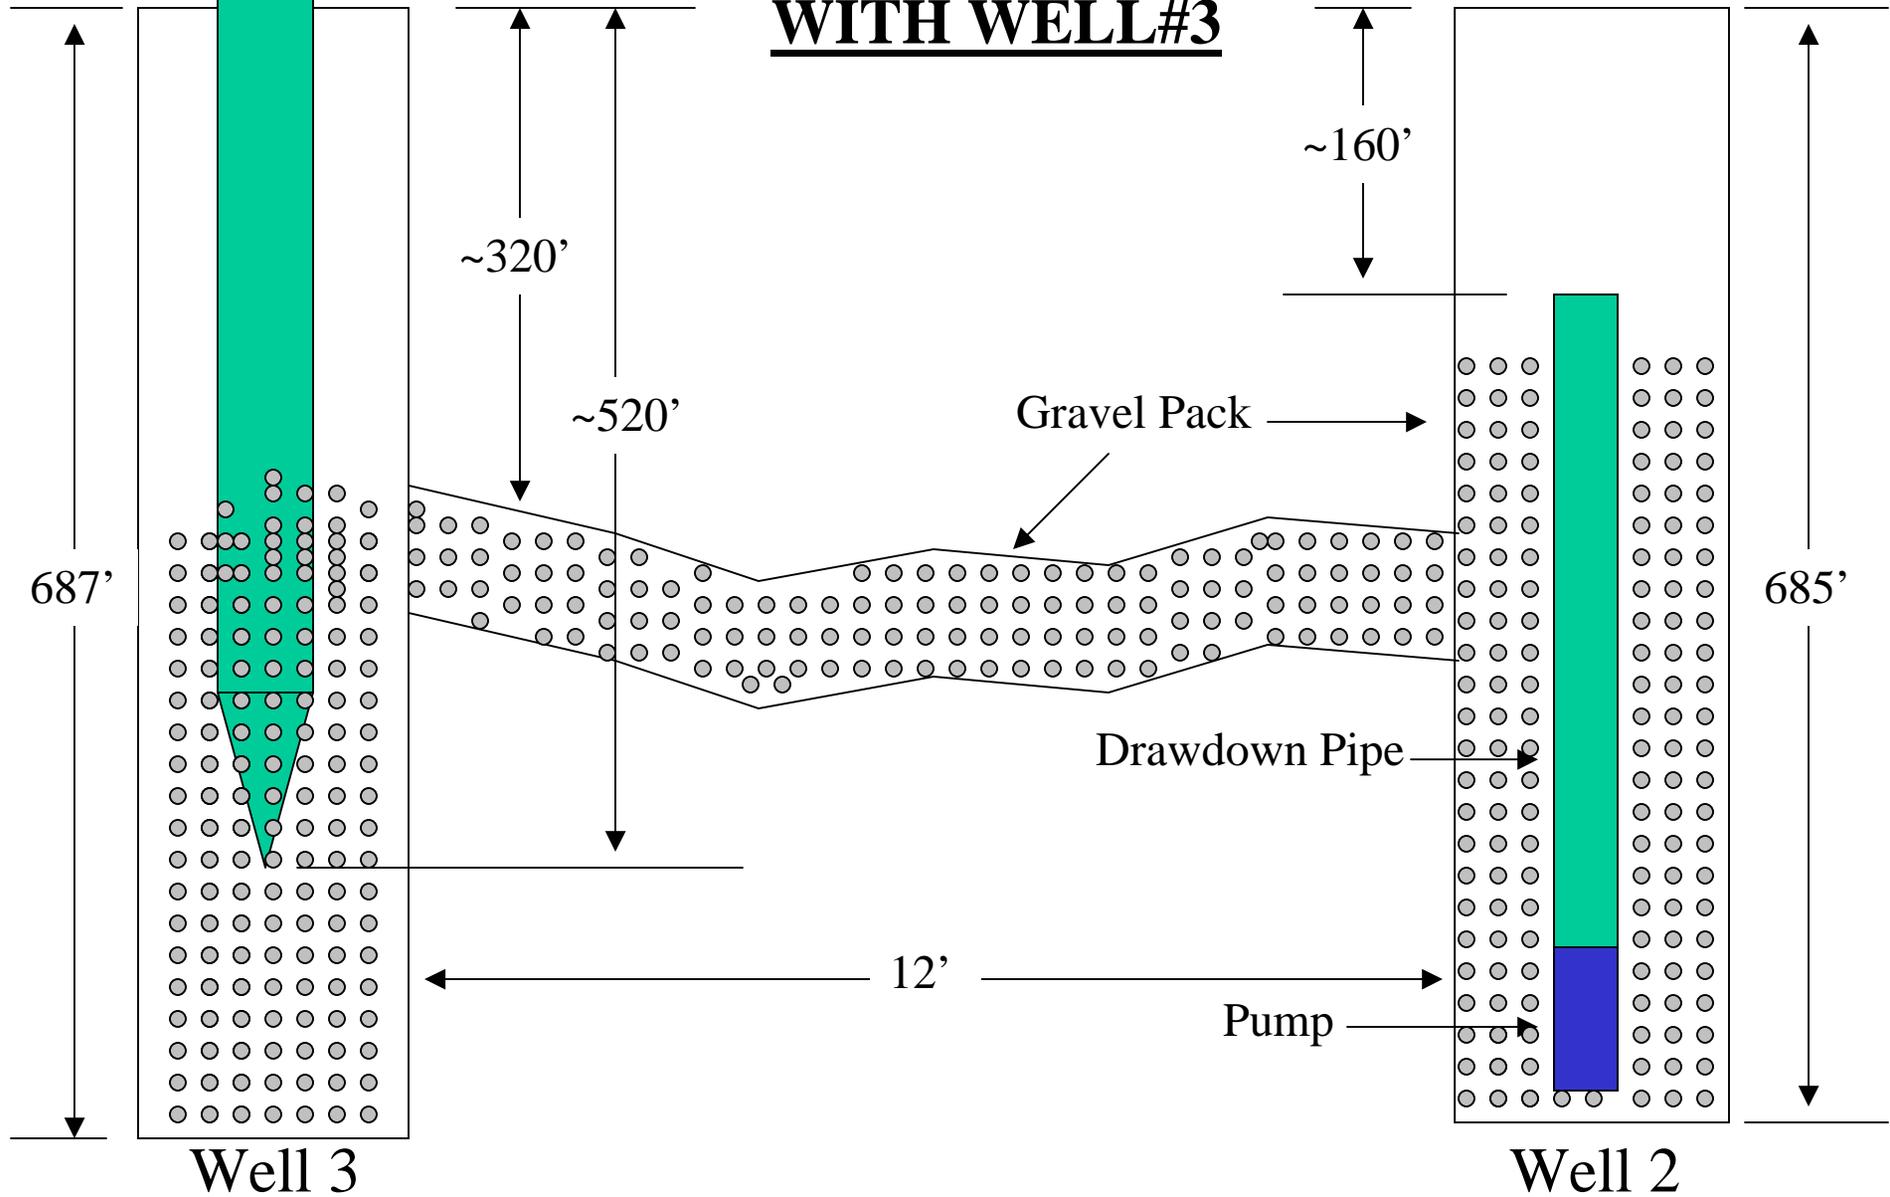
# ATTACHMENT (3): CAVE-IN SKETCH

Since the rig pressure was not powerful enough to move the steel, a 180-ton crane was rented to try to pull the steel. After applying about 50 tons of force to the steel over a three-hour period of time, the steel still would not move more than 6 inches. The next attempt was to have a larger civilian's water well rig attempt to pull the steel. On 22 April 00, the civilian rig arrived on site. The first piece of steel that was protruding from the ground was cut to allow the civilian's mast to line up over the hole. The civilian rig failed to pull the steel or dislodge the blockage by both pulling and drilling the same hole with a 6 inch drill bit. During the three drilling attempts, the civilian drill bit became lodged, clogged, or lost rotation, and was unable to drill past 320 ft. When air pressure was sent down the hole during drilling, the air was released through the second well excavation. Additionally, the bit became clogged with gravel filter, which resembled the gravel used on the second well. The crew theorized that the gravel filter used on the second well had also filled a continuous void underground as shown in attachment (3). This same void was encountered while drilling the third well.

## THEORETICAL CAVE-IN PROBLEM

### WITH WELL#3
