U.S. NAVAL MOBILE CONSTRUCTION BATTALION ONE

ALFA COMPANY WATER WELL AFTER ACTION REPORT

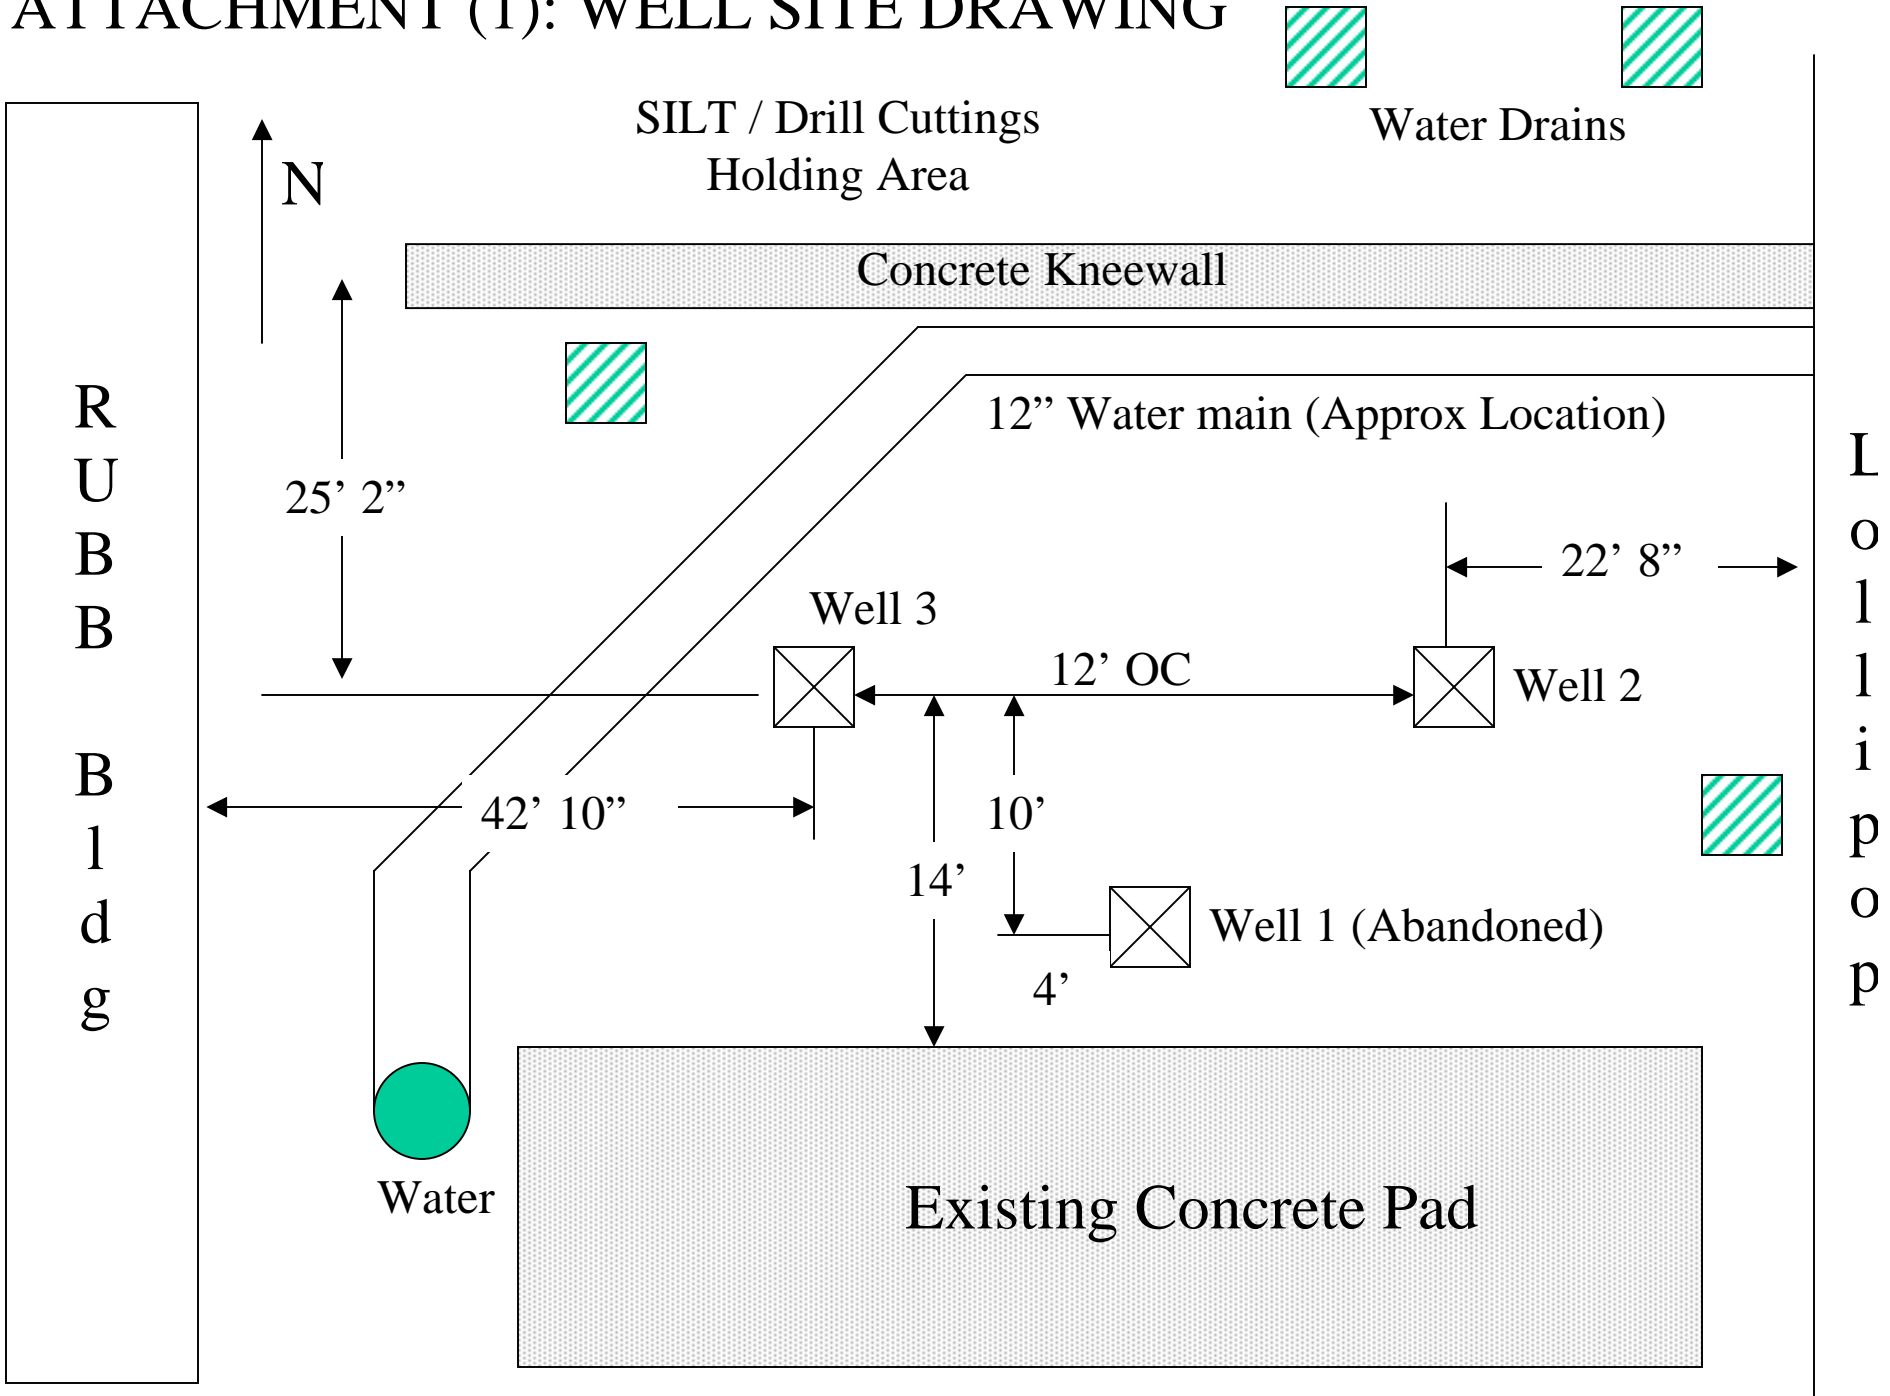
ATTACHMENT (1): WELL SITE DRAWING

1. **General:** The primary tasking for the WWT consisted of drilling a 1,000ft well and procure materials for a 600 ft well on the Marathi Pier once site approval was obtained. On 8 February 00 drilling operations began on NSA Souda Bay using the down hole hammer technique. The well site was located by the air terminal, and in close proximity to an operational chloride plant. A rough sketch of the drill site is shown in attachment (1).
