Tomcat Tangle

Hairy Harrier

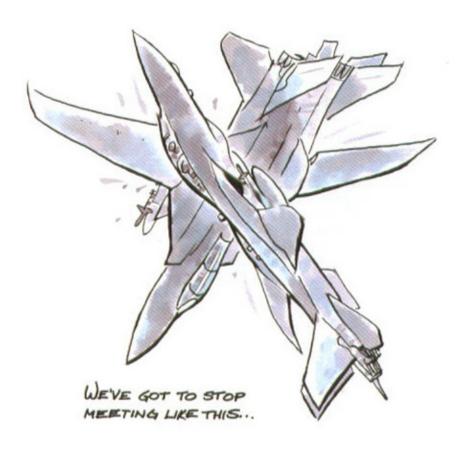
The wingman had maneuvered inside and under the leader, who executed an oblique pull over the top, aggravated by the proverse yaw. This shifted his aircraft right into the wingman's. A catastrophic collision occurred with lead inverted and 40 degrees out of the vertical. Both aircraft became uncontrollable after impact. The pilots and radar intercept officers (RIOs) in both aircraft ejected successfully, suffering first-aid injuries. The aircraft were lost at sea.

For beginners, the wingman didn't maintain safe separation

from the leader. Second, the wingman's RIO failed to caution the pilot of impending danger. On top of all that, the flight was the third of three squadron events from the carrier and ONLY THE FIRST was supposed to be a photoex. The second and third were to be performance demos of fully loaded aircraft without vertical maneuvering, air combat maneuvering or slow speed/high-angle-of-attack flight. The first event had mechanical problems and was not a factor. The second event performed the "vertical" photoex contrary to the approved schedule and overstressed the aircraft in the process. Then
