Gramps from Yesteryear

Close Shave

Suddenly!

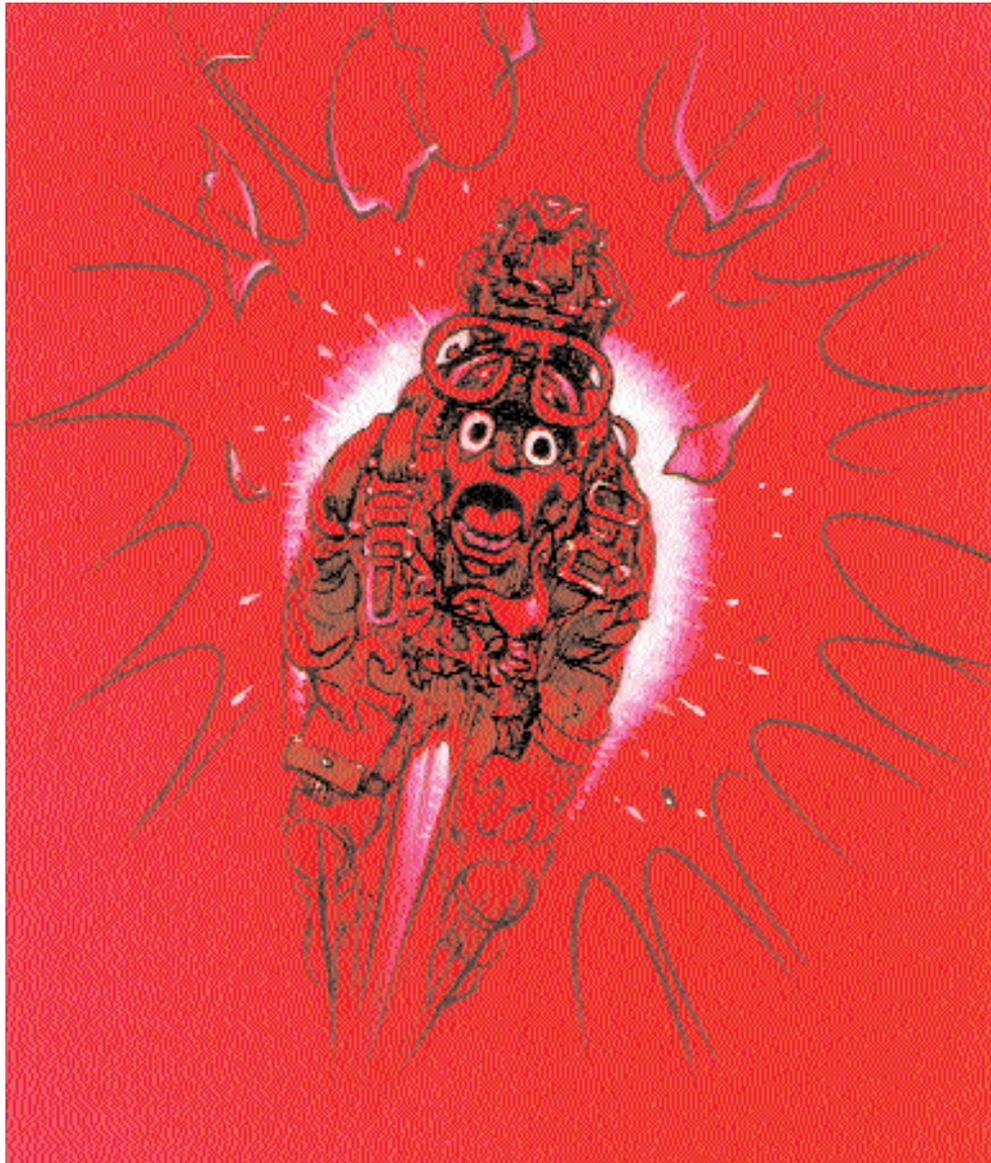
During rollout following an arrested landing, the pilot of an F-14B Tomcat experienced an uncommanded ejection through the canopy. The radar intercept officer's (RIO) seat did not fire. The pilot was rescued from the water by a search and rescue helo. Both aviators sustained first aid injuries.

During the arrested landing deceleration, the hand-held GPS became dislodged from its holder on the DDD handle and struck and displaced the pilot's ejection seat firing mechanism. Thus, the pilot's ejection seat fired

through the canopy, bypassing both the canopy jettison and the RIO's seat ejection initiation sequence.

The RIO didn't consider the GPS in its cloth holder strapped to the DDD to be loose gear. He had left the GPS in the cloth holder on previous arrested landings and did not recall ever reading or hearing that the GPS shouldn't be secured to the DDD, especially for carrier operations. The cloth holder was provided by the command with no specific instructions or restrictions on its use. Should be some now.
