GRAMPAW PETTIBONE

Salty Phrog

Fatal Distraction

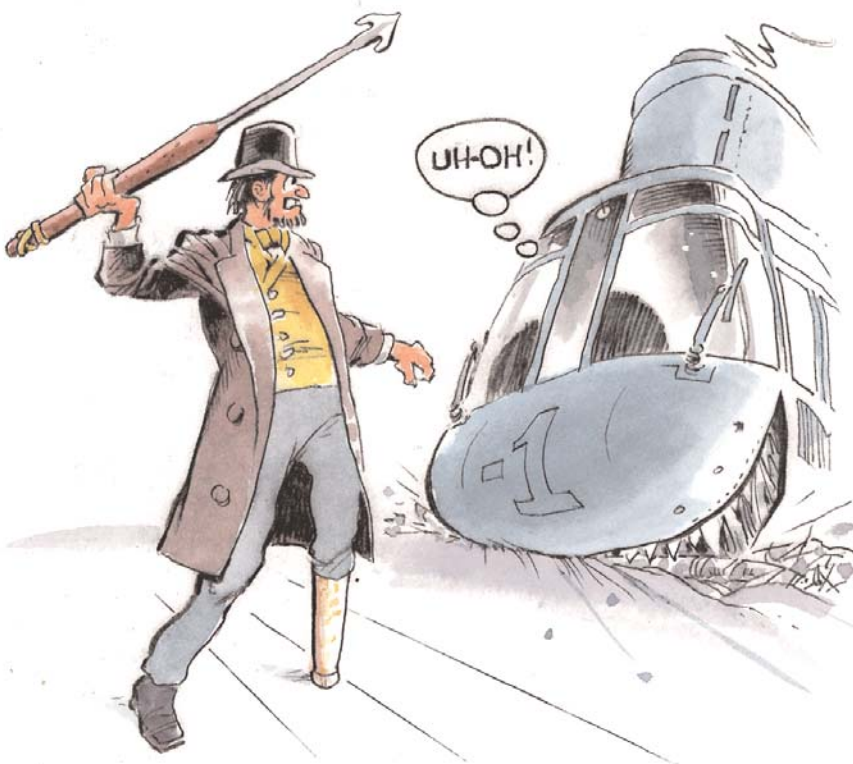
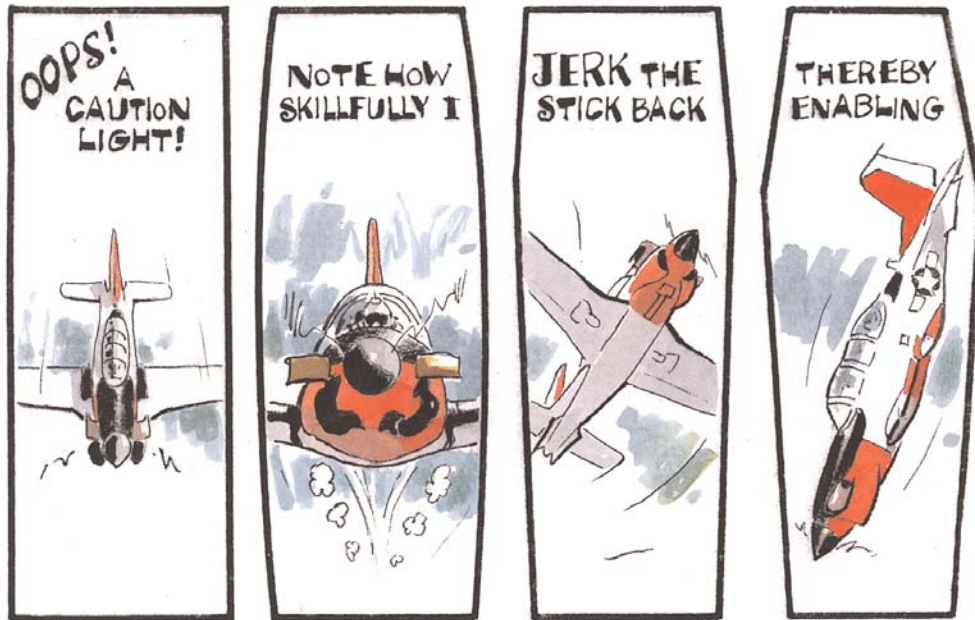
The aircraft was too far aft and the chin bubble rested against the safety net across the stern before the forward rotor blade struck the flight deck. The pilots jettisoned their doors before the H-46 rolled inverted and hit the water aft of the ship. Both pilots egressed through their respective cockpit doors. The crew chief tried unsuccessfully to push out a window, so he egressed through the side hatch. The final crewman found a window but couldn't locate the emergency pull tab, so he followed his gunner's belt back to the front of the cabin and egressed through the cockpit.

The mishap board determined that the engine had stalled due to salt encrustation. The board also assessed that flying through rain was no substitute for a thorough engine wash. The H-46 NATOPS was changed as a result of the board's findings and recommendation.

... A NON-TRADITIONAL LANDING!
