GRAMPAW PETTIBONE

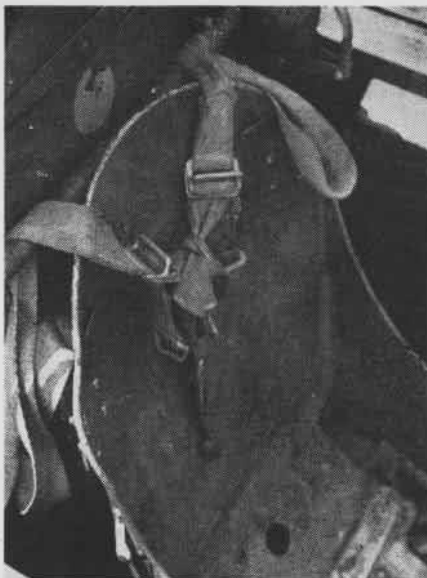
Don't Commit Suicide

The photograph above shows how an SB2A pilot brought about his own death. Note how, apparently to pre-

vent the ends of the shoulder harness adjusting straps from flapping around, they have been tied together, thus forming a loop across the pilot's chest.

In this case a forced landing was made in a river. The plane sank rapidly. The passenger had time to get out, but the unfortunate pilot had *tied himself in* and sank with the plane. His error is one pilots should not repeat.
