GRAMP AW PETTIBONE

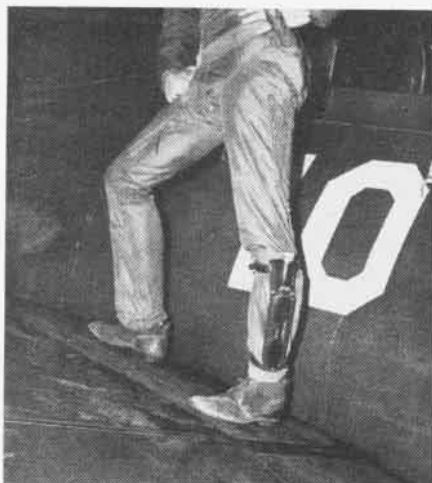
The daring young flier whose lower extremities are pictured below isn't about to take off on a flight over the jungles, despite the wicked looking weapon strapped on his left leg. Actually he's standing on the wing of an F8F-1 just after the landing gear collapsed on his return to NAS EL CENTRO, California after a night tactics flight.

The landing was normal, but shortly after touching down the right tire blew out. During the vigorous application of left rudder and brake necessary to keep the plane rolling straight, it is believed that the handle of the knife hit and released the locking plunger allowing the up-tensioned lever to fly to the "UP" position.

That's a glamorous looking getup, son, but I'm glad your squadron now has an order prohibiting the wearing of articles strapped to the lower left leg while flying in F8Fs. By the way, just about a month ago a PV pilot ran into the same difficulty when he inadvertently retracted his landing gear with a bulky article, which was stowed in the right knee pocket of his flying suit.
