# GRAMPAW PETTIBONE

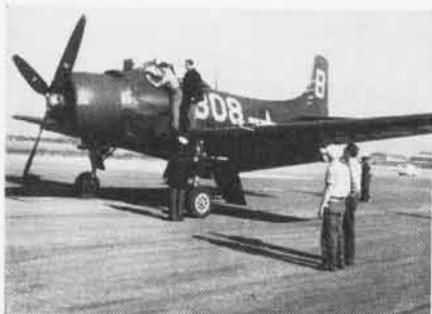
Accordingly, the pilot split his dive flaps and simulated a landing procedure at altitude to feel the plane out. Control and stall characteristics of the plane in this condition were favorable, and the pilot felt confident that he could effect a landing successfully. When his fuel supply reached the predetermined level the tower was called for a deferred emergency landing and a long straight-in approach was begun. The pilot brought the plane in at about 85 knots and made an excellent landing.

Damage was limited to approximately six inches being worn off the trailing edge of the bottom dive flap, and the plane was back in commission the next day. We feel that this technique saved many man hours of work and costly repairs to the empennage, hook, tail wheel assembly, and rudder, and so we pass it along for what it's worth to the other AD squadrons.

Incidentally, the tail wheel wouldn't extend due to a material failure in the hydraulic shut-off valve assembly.

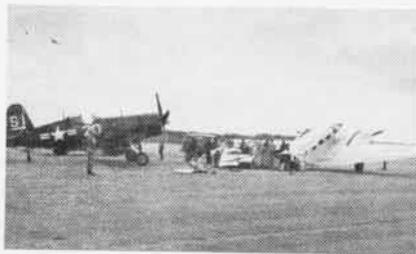
## Mince-meat Department

In the taxi accident pictured above, the tail section of the JRB has been thoroughly chewed up by the prop of the F4U. One passenger received head injuries and even the pilot of the JRB received minor injuries when the pitot tube of the F4U entered the cockpit.

The accident board found that the pilot of the F4U was negligent in failing to clear the taxiway properly before entering and in not making "S" turns while proceeding down the taxiway. Additional factors contributing to the accident were that the JRB was not parked in the usual position for warm up on the runway in use, and the tower was displaying the signal for left hand taxi rules, which was incorrect for that runway.

Alert, efficient operation on the part of tower personnel could have prevented this accident, but the primary responsibility rests with the pilot. Frequent "S" turns are a *must* in any plane where the forward visibility is restricted during taxiing.
