# GRAMPAW PETTIBONE

## High Altitude Errors

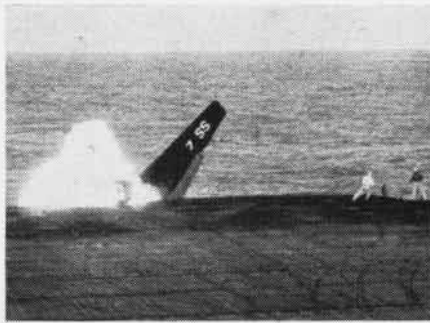
## TBM Flies into CVB Ramp

The TBM pictured above was piloted by a Lieutenant Commander with 5400 hours of flight experience. The approach appeared normal in every respect until the plane was in the "groove." About 100 feet astern of the carrier, the pilot apparently eased throttle and began to settle rapidly. He was given frantic "come-on" signals by the LSO which he did not or could not answer. The plane settled and hit the ramp on its engine in a nose high right bank. The engine broke off and the plane and engine fell to the fantail enveloped in flames.

Since the pilot did not survive this accident, we have no way of knowing whether he was having some engine difficulty or whether he simply made the critical error of easing throttle in the groove.

This picture should serve as a warning to all pilots not to ease throttle in the groove except in response to a fast signal from the LSO.
