GRAMPAW PETTIBONE

20 Knots Over Mach

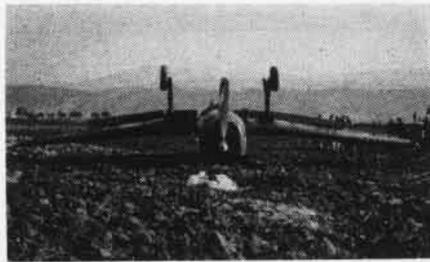
The pilot of the inverted F6F pictured here spent a very uncomfortable hour waiting for the arrival of a crane, so they could get him out.

He decided to try it with wheels extended. Although he touched down fairly close to the end of the strip, he was unable to stop and the F6F turned over on its back when it hit a ditch about 20 yards beyond the end of the runway.

priming. The accident board was of the opinion that the most probable cause of the misfiring and eventual failure was an air lock or vapor lock in the carburetor.

A good general rule to follow is: In an emergency landing, if you have any doubt about the terrain, leave the wheels up. The ground is always rougher than it looks.
