GRAMPAW PETTIBONE

Sad Selection

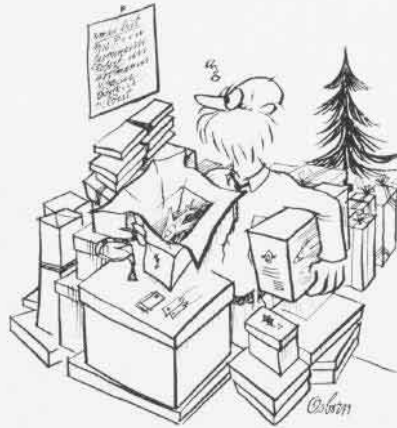
Upon landing the observer started to move the fuel selector. The pilot told him not to go through the OFF position when selecting a different tank. About this time, the pilot's attention was distracted by activities outside of the aircraft. The observer, who was accomplishing the critical task of selecting a different fuel tank for the first time, experienced difficulty in

understanding the instructions because of static in the ICS. He heard the word OFF and, although it didn't seem just right, he turned the fuel selector to the OFF position.

The pilot was concerned with other things and, after receiving an "all clear," added takeoff power and lifted. At an altitude of approximately 15 feet and a forward speed of 30 knots, the engine quit. The pilot immediately split the needles, initiated an auto rotation and landed the helo on a macadam road in an upright position. The main roto blade severed the tail pylon, causing substantial damage. The crew abandoned the aircraft uninjured.

Holy mackerel! Now doesn't a thing like this really frost you? Here is a pilot with much time in a bird—maybe too much, if experience breeds this kind of over-confidence. It's just plain difficult to see how a guy can utterly disregard that "check-off list" and trust a lad on his first flight to select the fuel. A stunt like this has no place in this business we're in, and the files are full of statistics to prove it. Failure to use the check-off list is like gambling with loaded dice—you can't win.

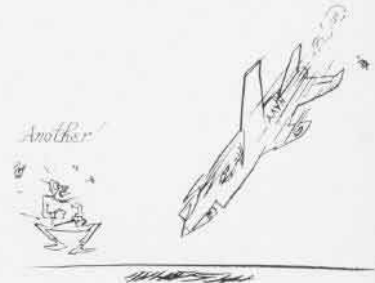
After making three traps in five approaches, the pilot assumed his refresher landings were complete. While he was being taxied onto the starboard catapult, however, information was transmitted that he was being diverted to home base. He failed to receive the transmission owing to radio failure. His TACAN had also failed, but he did not notify the ship.

At 1846 the aircraft was launched for the beach with 1800 pounds of fuel, no radio and no TACAN. After realizing his radio had failed, the pilot rocked his wings, turning down wind to indicate the failure to the ship. He received a bingo and "good-bye" from

By the time he was squared away on a westerly heading his fuel gauge read 1500 pounds. Optimum altitude for a 120-mile divert would have been 30,000 feet, but owing to a cloud layer at 3000 feet and no navigational aids, the pilot elected to remain below the clouds. He departed with old bingo information of 259°/90 NM vice 278°/124 MN, actual bingo data at time of departure.

The first lights the pilot saw were at St. Augustine. Then he saw lights from Jacksonville Beach. At this time the fuel gauge read 700 pounds, but he figured he had only 400 pounds. The pilot pulled the EEP to insure adequate control of the aircraft in case of flame-out and immediately heard a side tone on the radio. He contacted Mayport tower and informed them of his situation. Shortly thereafter the engine flamed out and the pilot ejected. All safety and survival equipment operated as advertised and a helo was overhead for rescue in approximately 30 minutes.

Great horned toadies! It sure took a bag full of unusual circumstances, varied equipment failures, decisions based on incomplete or unknown information and lack of coordination to set this one up. Divert information should be fed to pilots during carquals, but there is certainly nothing against a pilot's asking for it if he hasn't received it. This is a perfect example of how a seemingly innocent but uninterrupted chain of events can lead to the loss of extremely valuable equipment and/or personnel.

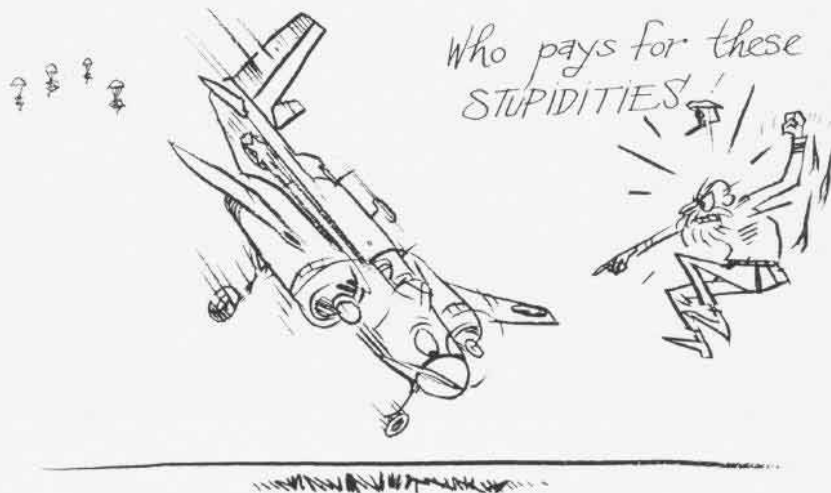
the en route stop where the pilot attempted to establish radio contact. After several unsuccessful attempts, he decided to land without radio contact. The pilot circled the field several times, then set up an approach for the lighted runway.

The approach was normal with a rather hard touchdown. Immediately after touchdown, the aircraft began to yaw and the pilot added power and again became airborne. Because of the explosive noise heard during touchdown and the pronounced yaw, the crew checked the aircraft upon regaining altitude. The pilot was amazed to discover the port main gear and part of the port engine nacelle gone. The crewmen reported a bad hydraulic leak in the aft station.

main gear and nose gear but was unsuccessful. The nose gear trailed with the wheel 90° to the aircraft. The starboard remained down and locked.

altitude of 10,000 feet. All bailouts were successful. The aircraft exploded and disintegrated on impact in an open field—a total loss.

Great heavenly days! If a fiasco like this wouldn't wilt a lily, nothin' would. An experienced pilot on a night flight at 13,000 feet without an oxygen mask is really asking for trouble. Now this lad must have had some misgivings concerning the en route stop at his home town airport. However, he elected to attempt a night landing at a strange field without radio contact which precluded getting a current altimeter setting. Now that's really askin' for it.
