GRAMPAW PETTIBONE

Close Shave

Home-Field-itis

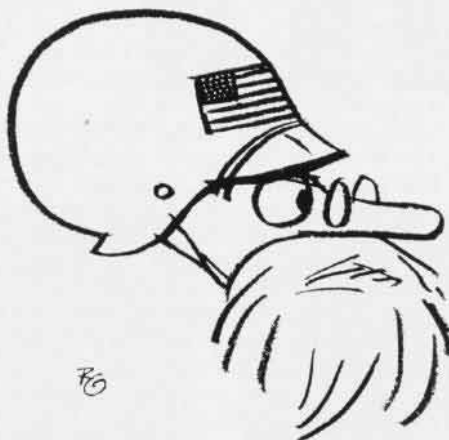
An RA-3B with a crew of four departed a Pacific island early one afternoon on a routine transPac flight to the Philippines. After take-off, the flight proceeded outbound with everything operating normally for the first 20 minutes. While climbing through 29,500 feet with the cabin pressurized at between 8,000 and 9,000 feet, the Plexiglas canopy section over the third crewman's seat suddenly failed, causing an explosive decompression.

The pilot immediately checked the cockpit altimeter and found it had risen to 19,000 feet. He quickly popped the speed brakes, ordered all crew members to check their oxygen systems and initiated a rapid descending turn. Seconds later, the navigator informed the pilot that the third crewman was hanging out of the blown canopy section.

The pilot immediately retarded the throttles and the navigator and plane captain unstrapped and began pulling the third crewman back into the aircraft. He was wearing his integrated torso harness with the oxygen hose attached to the harness but had not been strapped in the seat because he had been performing duties in the photo compartment.

This lad is downright lucky in more ways than one. Because of his duties aboard the aircraft, he wasn't strapped in and, when the explosive decompression occurred, his feet lodged under the console to keep him from being pulled out of the aircraft. His excellent physical condition without a doubt was a big plus in a speedy recovery. The pilot, navigator and plane captain demonstrated nothin' short of outstanding headwork durin' this emergency. It's a real pleasure to add these names to Gramps' Ole-Pro list. I'll fly with you guys any time.

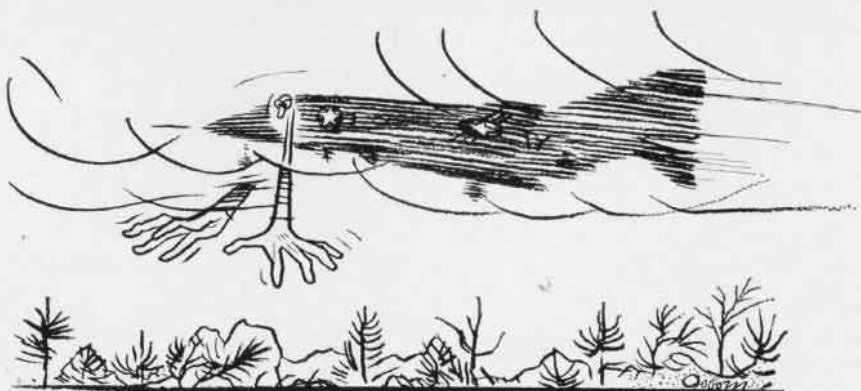
At about one mile, the final controller called the aircraft for rising slightly above glide path. At three quarters of a mile, he called again for going below glide path. At this point, the RIO, who had been watching for the runway lights, glanced at the altimeter and noted 200 feet. Glancing back out the left side of the aircraft, he saw "bare ground." He was about to tell the pilot to wave off, when he felt a surge of power followed by the crunch of the plane in the trees.

The *Phantom* proceeded into the trees at approximately 50 feet of

altitude. Feeling the machine hit the trees, the pilot braced himself with his right hand against the instrument panel. The ill-fated bird continued cutting a swath through the trees for 750 feet before settling to a stop. The forward portion of the cockpit had been carried away during impact, leaving the seat, left panel, and approximately 1½ feet of the floorboard. Although pinned between the seat and panel and slightly injured, the pilot was subsequently extricated by the RIO who had weathered the mishap without incurring any injury. Fortunately, there was no fire. The station helo arrived shortly and delivered the crew to the station.

Besides common horse sense, the lack of an acceptable alternate should have been clue enough to stow that flight plan and bone up on OpNavInst 3710.7C. There's some good reading in that manual and it was published to help prevent this sort of mishap.
