GRAMPAW PETTIBONE

The Hard Way

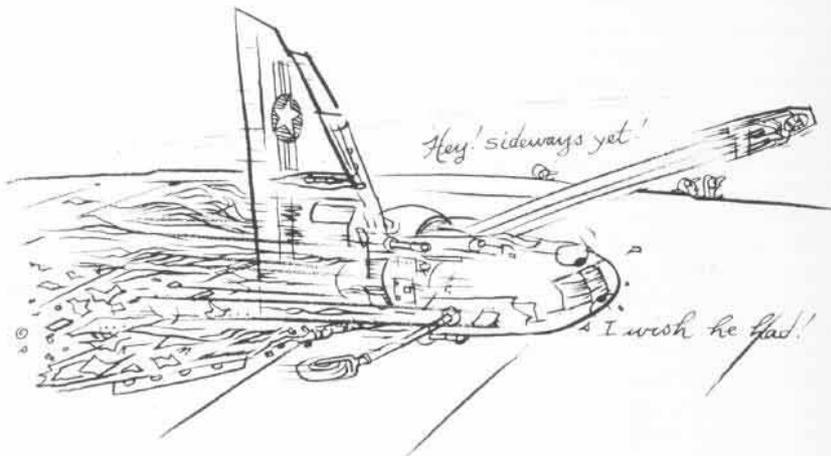
starting the descent to 600 feet at four miles. He called the meatball at 1½ miles with 2,600 pounds and came back on the power in order to start down. The ship appeared to be in a port list. Working for line-up, he dipped the starboard wing, added power to correct and subsequently went high, requiring another power reduction. Paddles heard a rapid deceleration of the engine and called for power. The driver recognized the abnormal sink rate also and added full power as well as retracting the speed brakes. Just as the engine started to respond to the added power, the aircraft struck the ramp on centerline.

Upon impact, the tailhook, landing gear and drop tanks sheared off and the plane burst into flames. The pilot pulled the secondary ejection handle as the aircraft started to cartwheel, but the seat did not fire. The canopy jettisoned, however. The aircraft, decelerated somewhat by protrusions on its bottom surface, and partially arrested by the wires, came to rest on its left side (the port wing sheared off during the cartwheel), 20 feet from the edge of the angled deck and five feet from the port catwalk. The driver pulled the harness release, literally fell out of the cockpit and got clear of the flaming wreck with minor injuries. The wreckage was subsequently jettisoned—a complete loss.

Oh, my achin' back! What a way to culminate an accumulation of "sorry about that's." There is no doubt in ole Gramp's mind that this youngster would'a been better off in bed this particular day. This mishap could've been avoided if the people involved (pilot and LSO's) hadn't accepted a sloppy performance on the glide slope. As things turned out, this young man was lucky to survive the ramp strike and doubly lucky he didn't yank that secondary handle all the way. Chances are he would'a ricocheted off the deck like a rubber ball.
