GRAMPAW PETTIBONE

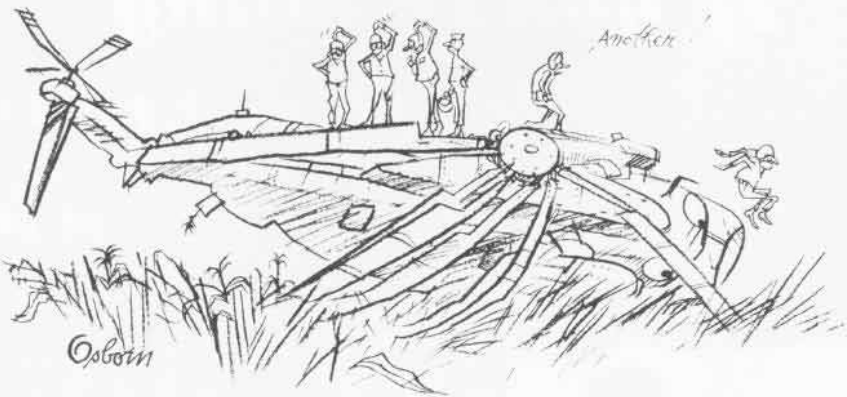
At takeoff, 1035 local time, fuel indicated only 50 pounds in each tank. About one minute later, as the big helicopter crossed the field boundary, one of the engines flamed out. The pilot started a right turn and began looking for a place to land, knowing the other engine would flame out momentarily. Rotor rpm started to decay as the other engine quit, and the aircraft descended into a cornfield. Flare was rather high, and the *Sea Stallion* landed hard, shearing the nose gear. It then rolled over on its right side and came to rest.

It's enough to make a grown man cry. This highly skilled, well respected Naval Aviator was just completing an extremely demanding and difficult mission. He then blew it all by running out of fuel on takeoff from a fully equipped air station because "in my opinion sufficient fuel remained to make it."
