# GRAMPAW PETTIBONE

## Look Ma — No Wings

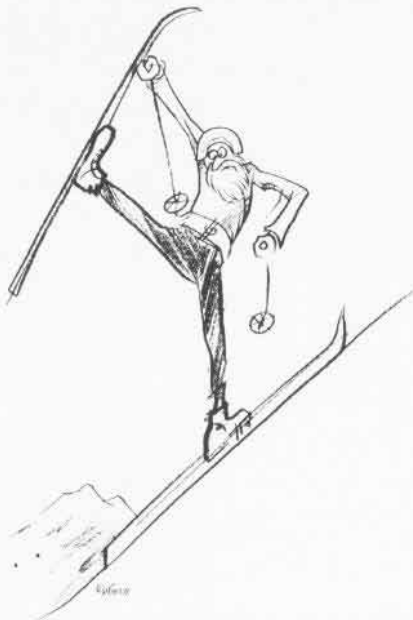
While taxiing to the pits, the lieutenant decided to put his kneboard on his right leg, partially obscuring the fuel gauge, caution and advisory panels, and he also folded the A-7's wings to facilitate hot refueling. Fueling was normal. Ltjg. Shortwings pulled out of the pits, turned on his anti-collision lights, and called for taxi clearance to the duty runway. During this time, he was thinking about making his Charlie time, the speed required to make it, and the procedures for CCA's. Shortwings "looked around the cockpit" and, seeing nothing unusual, pulled on to the duty runway for takeoff. He added takeoff power, checked his instruments and commenced his takeoff roll, progressing normally up to 145 knots. He initiated rotation with approximately 3,500 feet of runway remaining. The aircraft began a roll to the left, heading toward the left edge of the runway. The pilot, thinking he had a runaway trim, checked his gauges. They indicated normal. He applied right rudder and right stick and succeeded in touching down again on the left edge of the runway. He considered aborting; however, he noted a "couple of hundred feet of runway remaining." He also noted that he was too far to the left for a successful arrestment. Ltjg. Shortwings continued the takeoff with the idea of ejection. He was airborne again at the end of the runway and, as

was only during his ride back to the hangar that Shortwings realized he had made a takeoff with the wings folded!

he passed through 150 feet, he felt the rudder shaker and pulled the alternate ejection handle. The ejection equipment functioned as advertised. During his short descent, Shortwings saw the aircraft stall and impact approximately ½ mile from the end of the runway. He was still unaware of what caused the erratic behavior of his machine. It

**Great leapin' lizards! Checklists, checklists, checklists, checklists! Kneboard, smeboard! This lad's gonna have to shape up or ship out. If he was dead sure of his CCA procedures before the flight, he could'a concentrated his efforts on the task immediately at hand — takeoff checklist! I don't care what knee you put your kneboard on — there's no excuse for violating NATOPS! This just represents another completely needless loss of an aircraft, to say nothin' about the potential hazard to the pilot! "Lookin' around the cockpit" ain't 'nough, boy! Let this be a warning to all who do not follow checklists!**

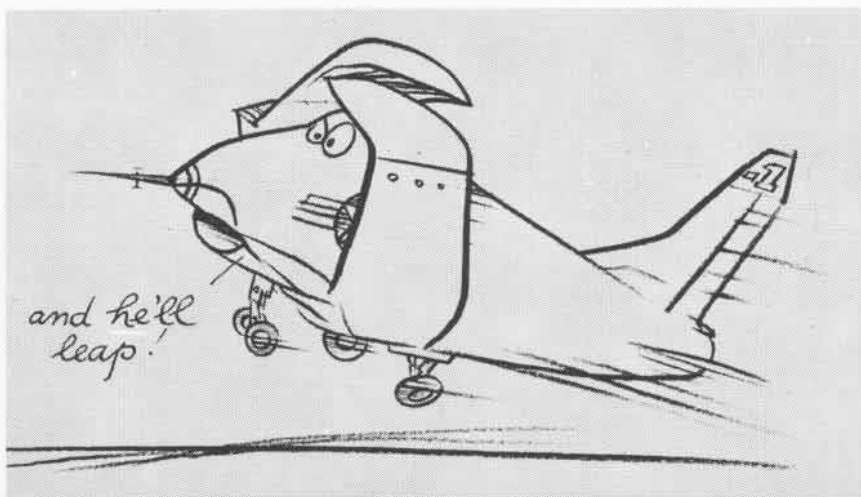
Arriving at the airfield, they made a low pass to check field conditions. The weather was estimated at 2,000 scattered, visibility seven miles plus, with a 30-degree crosswind of six knots on the runway. The runway was 2,730 feet long with an overrun of approximately 100 feet. Following a low pass, the pilot was all set up for landing and, as part of his check ride, the aircraft commander ordered a go-around. On the next approach, the pilot used 80-85 knots and full flaps. He planned to touch down in the first 100 feet of the runway. There were numerous power changes during the approach and nearly all the witnesses in the aircraft thought the aircraft was "low" during the final approach.

The *Albatross* touched down approximately 100 feet short of the runway. The starboard main landing gear failed, followed by the nose gear, as the aircraft slid 400 feet down the runway to its final resting point. After

the aircraft stopped, the uninjured crew secured the engines and left the aircraft. The HU-16D was damaged beyond economical repair.

Leapin' lizards! How could a gent with as many flying hours as this lieutenant commander allow that poor approach to continue? With a calculated landing roll of 1,300 to 1,500 feet — why shoot for a landing in the first 100 feet even though the runway is only 2,730 feet long? That's poor planning combined with complacency!

The landing was well within the capabilities of the machine. Those pilots just plain goofed. I'd down both the upgrade pilot and the check pilot. Every check pilot and instructor should

**decide now just how far they're goin' to allow the other fella to foul up before they do something. In this case, it was too far.**

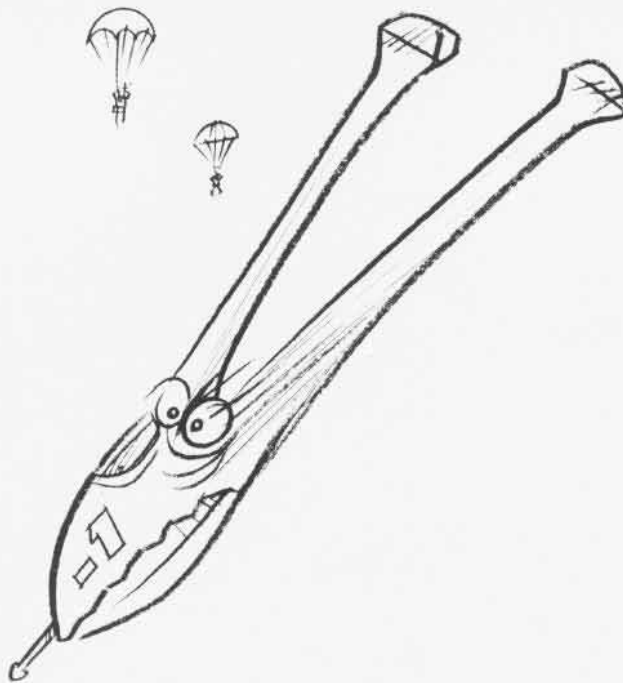
Following takeoff from the sixth touch-and-go landing, at approximately 200 feet, the engine began to unwind and run rough. The instructor pilot took control and attempted to push the throttle forward but it was already at full military power. The nose began to fall through the horizon as both pilots ejected.

advertised with both pilots landing uninjured on the runway. The aircraft impacted approximately 4,500 feet down the runway and slid to a stop, still on the runway. Both main gears and nose gear were broken off at impact. The TA-4F was a total loss.

Investigation revealed a pair of water pump pliers in the compressor section of the engine.

Egad! Alive?! Now here's one for the book! With all the preachin' we do on FOD, it still cost us this aircraft. Apparently there are still people around who are talkin' when they should be listenin'. This unit has a great FOD program—on paper! Each maintenance action must be signed off by quality assurance personnel with the FOD stamp that all tools are accounted for. Now ain't that nice—that is exactly what was done, "signed off." This accident board did a commendable job and put the blame right where it belongs—supervisory! Mr. Maintenance Officer, you better take a second look at your FOD program—looks like a paper tiger. How 'bout you other fellas? Is your FOD program really effective? Are your quality assurance personnel actually checking for missing tools, safety wire, etc.? Review your program, *now*!! Close the barn door before the horse gets out!
