grampaw pettibone

Night Caper

How Dry I Am

The Door

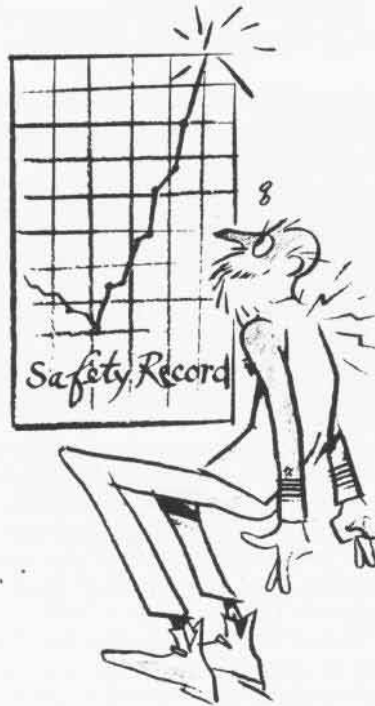
The aircraft remained slow and cleared the ramp by approximately four feet in a slight climb, in a very cocked-up wings-level attitude. After clearing the cross deck pendants, the port wing dropped sharply and the aircraft appeared to stall, the port wing striking the deck first, 70 feet past the #4 cross deck pendant. The *Crusader* at this time was 14 feet left of center line.

The aircraft then settled onto the main gear and departed the deck at about a 15-degree angle to port. The port main landing gear impacted the inboard datum light arm of the optical landing system and the aircraft settled rapidly in a slight nose-down attitude. At this time the LSO and air boss both called, "Burner, eject." The pilot selected afterburner and rotated to 20-25 degrees nose up, and ejected just prior to impact, approximately ten feet above the water in a wings-level attitude.

Holy Hannah! Makes common sense to me — if you can't see somethin' because of dim light, turn the blasted switch up. If you have a problem seein' something, you concentrate on it, and the next thing you know you have a breakdown in your scan. Then anything can happen — as it did here!

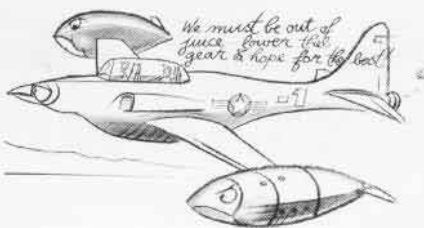
The aircraft hit tail first, then very hard on the main mounts and nose gear. At touchdown, the canopy was jettisoned. The pilot called for throttle, fuel and battery off. The aircraft rolled to a stop on the dry bed and the crew exited normally. No fire occurred.

Great balls of fire! Another case of having the fuel, but not where the pilot thought it was. Apparently, earlier in the flight, neither the tip tank or leading edge tank switches were on to provide pressurization of the tanks and normal fuel flow.

The fuel gauge reading of 195 gallons was due to an attempted air start during which all the tank selector switches were open. Still, not enough fuel was transferred to assist in obtaining a relight.

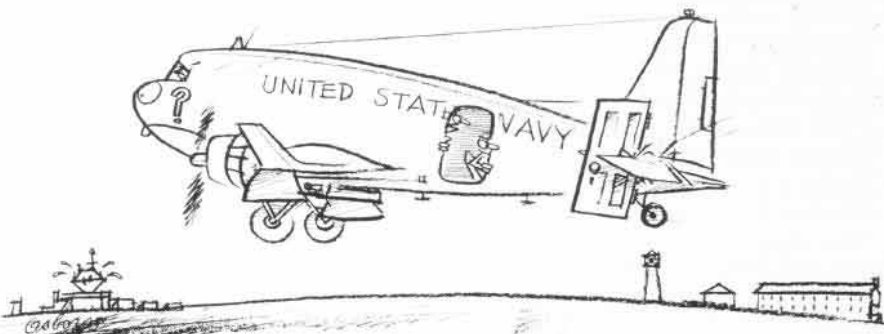
Departure on the second leg was normal. Although filed for 6,000 feet, the flight was cleared to 8,000. Weather conditions in the climb and at altitude were intermittent IFR with light to moderate turbulence in clouds. A lower altitude was requested to avoid turbulence and adverse headwinds. Approach control approved descent to 6,000 feet. Power was reduced and the nose was lowered to begin descent. At 6,500 feet, airspeed 160 to 170 knots, the cargo door came off the aircraft and struck the port horizontal stabilizer. The nose dropped abruptly and was not leveled until the aircraft bottomed out at 2,000 feet.

The pilot-in-command decided against a slow flight check at altitude. The landing and rollout were normal in all respects. The door remained lodged until it was forcibly removed from the horizontal stabilizer after the accident investigation.

Jumpin' Juniper! When you think that one of our machines has been around long enough to finally have all the "bugs" worked out—bang, it happens. Who would have guessed that with all the modifications on this aircraft, the doors are still coming off!
