grampaw pettibone

Pro Sans Luck

Basically Basic

Basic Ignorance

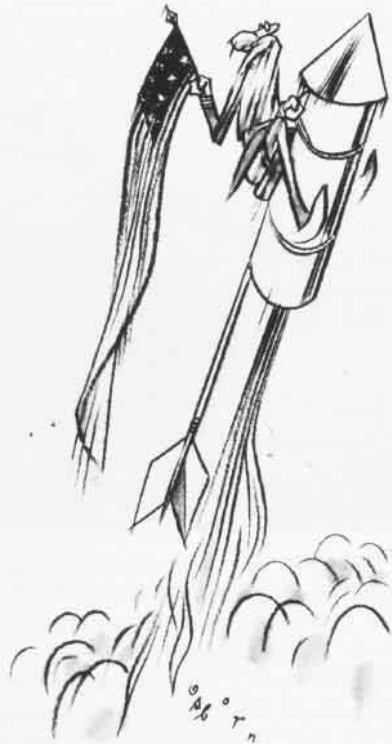
While cruising at 7,000 feet, the port engine of the SP-2E commenced backfiring. The pilot reduced power and the engine smoothed out. The engine analyzer, however, indicated that number one and two cylinders were not firing on the left magneto. The PPC increased manifold pressure and the engine began backfiring again. A small amount of oil was seen coming from the inboard cowl flap and the PPC immediately secured the engine. The shutdown was normal in all respects, and further inspection gave no evidence of fire. With the situation temporarily squared away, the PPC elected to continue on to his destination which was the nearest military field. The control center was informed and a descent to 6,000 feet was approved.

About five minutes later, smoke was observed coming from the port engine. An emergency was declared and the pilot was given a vector to a nearby civilian airport. The crew was directed to make preparations for bailing out as the fire increased in intensity. The center was informed it would be necessary to land immediately or the crew would be forced to bail out.

The center vectored the *Neptune* to a small private airport directly below and a single engine landing was attempted on a 3,300-foot runway. The PPC brought the P-2 to a complete stop 500 feet off the end of the runway with no apparent damage incurred on landing; all hands exited without injury. The airport fire jeep arrived within two minutes, but did not have sufficient equipment to extinguish the fire. Before the city fire trucks could reach the scene, the

aircraft was completely engulfed in flames.

Too bad! The operation was a success but the patient died. This is an outstanding testimonial to back up my insistence on using military fields as much as possible. This plane crew was well organized and handled the emergency in a professional manner, but was unfortunate enough not to be close to a military field which could have fought the fire and saved the plane. (The culprit causing this mishap was failure of the exhaust valve on the number two cylinder.)

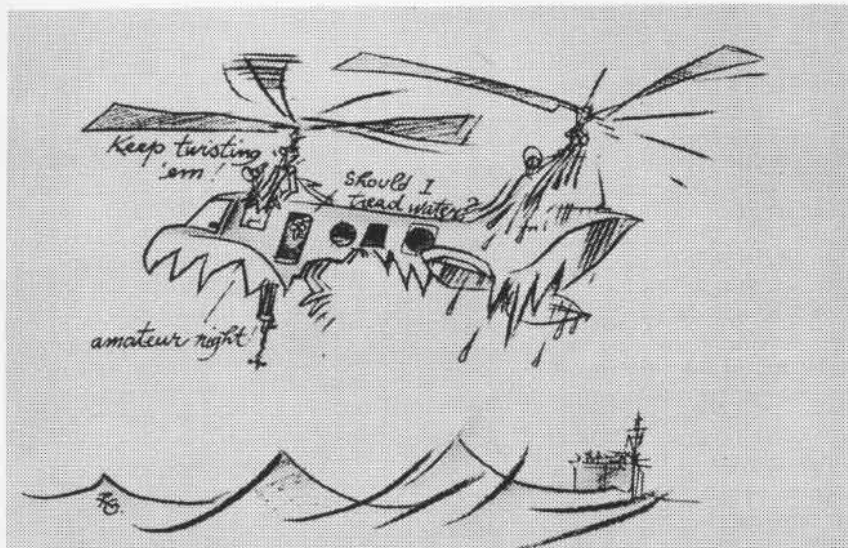
A CH-46D was airborne for a day/night practice vertrep mission and touch and go's. During the early portion of the flight all had gone well. About half an hour after darkness the pilot was making an approach to the ship from port to starboard. As the aircraft reached an in-close position, the deck was noted fouled and a wave-off initiated. The weather was beginning to deteriorate rapidly and on the wave-off, without warning, the helo encountered heavy rain.

As the CH-46D passed the stern of the ship, the pilot told the copilot to activate the right side windshield wiper. This accomplished, the pilot asked the copilot to activate the left side wiper. The copilot couldn't reach the left side wiper control, so an aircrew member was called forward to assist. At this point the helo was on the starboard side of the ship at 300 feet AGL and 60 knots.

Visibility dropped to below one mile. It was pitch black with no horizon. The pilot could not determine if his wipers were functioning, so, after setting the aircraft in a 10-degree angle-of-bank starboard turn at 300 feet AGL and 60 knots, he gave control of the aircraft to the copilot. The pilot told the copilot to maintain the aircraft at 300 feet and continue turning to setup for another approach. The exchange of aircraft control was a positive and understood change.

The copilot flew and monitored the flight instruments, only breaking his scan with a glance to see how the pilot was coming with the wiper controls. As he broke his scan, the aircraft began a subtle descent. The copilot noted the radar altimeter pass through

25 feet AGL and initiated a positive climb simultaneous with water impact. Ascending through 100 feet the pilot took control of the aircraft, checked the controls, and completed a successful landing back aboard the ship. Fortunately, no one was hurt. The aircraft sustained damage to the fuselage skin, nose gear support structure, antennas, pitot system, and was missing the nose landing gear.

Holy splashdown! It amazes me what some guys get away with. This was as demanding an instrument environment as you can find (IFR, night, overwater, low altitude, no horizon). The situation called for good basic instruments, crew coordination, and maximum attention to flying the aircraft. Gramps says, "Oh Boo!" to passing aircraft control IFR in a turn. Basic air work, basic instruments, basic headwork, and basic discipline were handled in a basically casual fashion and the outcome was basically predictable.

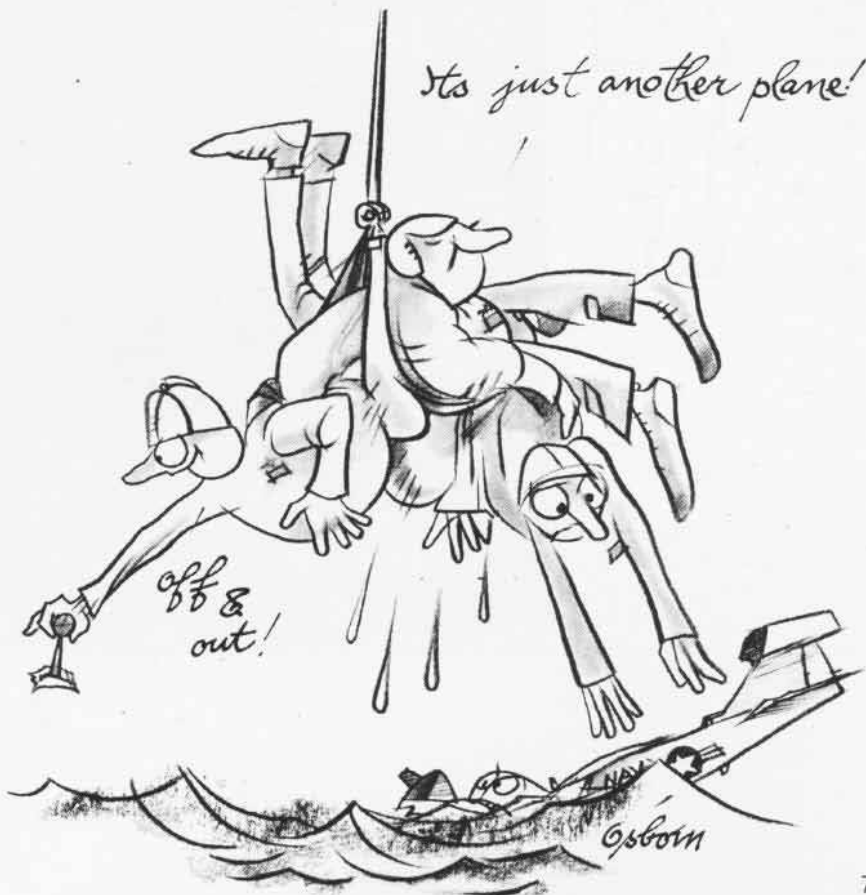
idle position to the "off." Realizing he had inadvertently shut the engines down, he initiated an immediate air start.

Attempts to restart the engines were unsuccessful and the pilot initiated command ejection at 700 feet and 220 knots. Ejection, parachute descent and water entry for all three crew members were as advertised. The search and rescue effort went well

except that the new D ring (W/GATE P/N SA-82071-1, aircrew systems change 361) was not compatible with the swimmer rescue harness snap link (P/N MS 22018-1). A horse collar was used for the pickup of all three crew members.

Holy retarded throttle jockey! Guess who didn't learn in the replacement training squadron that you don't bring the throttle below 75 percent rpm in the break. Nothing surprises your Ole Gramps anymore. This proves to me there is always a need to review basics.

As for the rescue problem between the swimmers and the downed crewmen: What a neat time to find out compatibility problems exist between equipments. Why didn't the SAR Det know what the air wing flyers were using and vice versa? Incredible!!

An EA-6B launched on a routine hop from USS Aircraft Carrier. The flight was uneventful until entry into the break for landing. The pilot (using cold mike) entered a 60-degree angle-of-bank turn four miles ahead of the ship. The speed brakes were opened and the power reduced to idle. The pilot felt the throttles go beyond the
