# grampaw pettibone

## Double Trouble

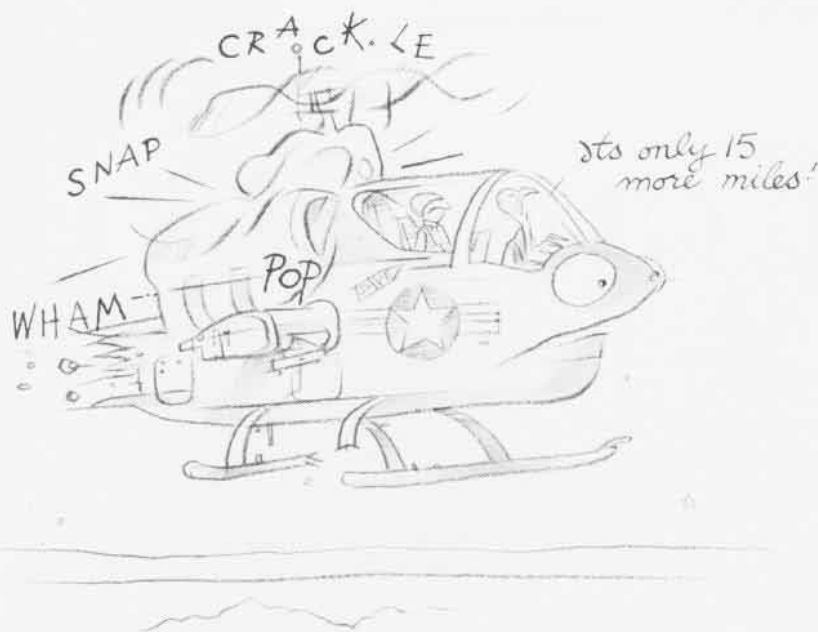
caution panel illuminated, indicating a transmission chip detection. He decided to land in an open field located 12-15 miles short of his final destination. The pilot stayed in the aircraft, keeping the rotors turning, while the crewman made a visual inspection of the exterior. No panels were opened. Finding nothing amiss the pilot decided to continue on his way — with the transmission chip light illuminated.

Upon arrival at destination, maintenance personnel checked the aircraft and found that four of the five chip detectors contained large amounts of ferrous metal. The internal oil filter looked as if someone had struck a mother lode. The transmission, containing inordinate amounts of ferrous metal throughout, was removed and replaced.
