grampaw pettibone

Some Birds Don't Fly

AHAA

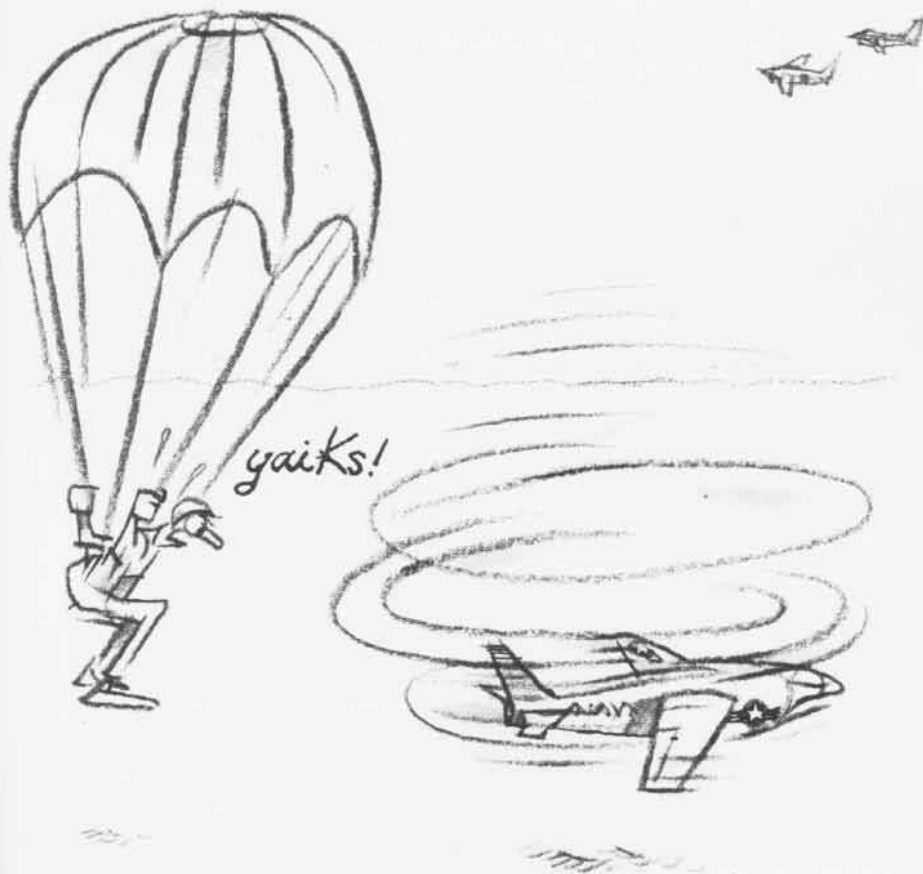
The A-7 immediately entered a rapid right spin. No post-departure pitch or roll oscillations were noted. After two turns, the pilot applied full right aileron, full left rudder and stick slightly forward of neutral. AOA remained pegged at 30 units, airspeed remained at zero.

The flight leader confirmed a right spin. Controls were left in, through five turns, with no effect. The wingman ejected, passing 6,500 feet. The aircraft was observed to continue the flat spin until water impact. The pilot, suffering from extreme cold, was rescued approximately 25 minutes later.

The aircraft mishap board concluded the most probable cause of the aircraft entering the spin following departure was failure of the AFCS roll augmentation cut-out to function properly. No maintenance-related factors were assigned. But this aircraft had had nine AFCS gripes in the past 26 days with nine additional AOA gripes. Three other squadron pilots had previously experienced sudden or unexpected departures in this machine. What I want to know is where was all this hot info being kept before the mishap. Sounds like someone took "hands and feet off the controls" in the maintenance department, and QA spun in, too. DCM training is a vital part of aircrew readiness, gang, and it's an all hands effort, as always! And that's the truth! Nuff said.
