GRAMPAW PETTIBONE

Exercise "Dawn Patrol"

Flaming Phantom on Deck

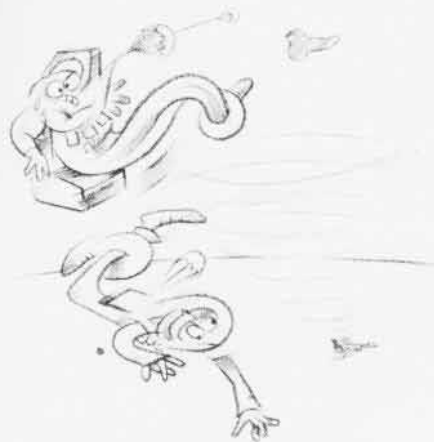
The cause of this accident is tagged plainly and simply as pilot error. This experienced aviator is known to be aggressive and flies his aircraft to the edge of its limits. Old Gramps supports this philosophy wholeheartedly. But dang-it-all you gotta know what those limits are and be able to effect recovery should they be exceeded. If you can't, then don't!! Although highly experienced, this was the first time this pilot had flown the F-14 into such a high altitude, high gross weight, and low airspeed regime. He misjudged the situation badly, lost control of his aircraft, and nearly lost his and his RIO's life.

Gents, it's more than well-documented that the F-14 exhibits a flat-

spin tendency following departure/engine stalls, and recovery from one is like pulling a scrapping cat out of a wire basket. No more demonstration or ad hoc flight test data is desired or required, please!

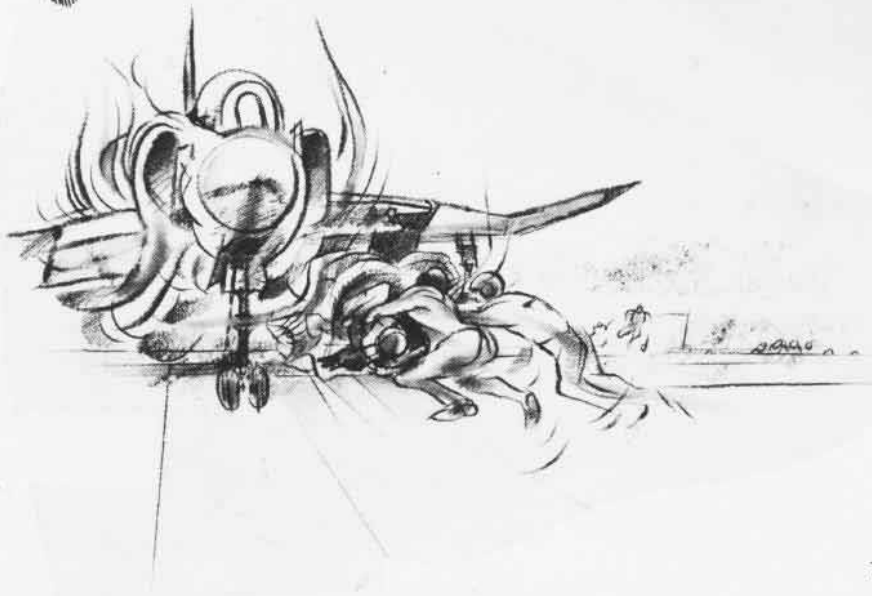
In close, the aircraft drifted right, then rolled back to the left. The aircraft struck the ramp in a left-wing-down, nose-high attitude and exploded into flames. The radar intercept officer (RIO) initiated dual ejection and the crewless aircraft continued up the deck and engaged the number one arresting cable, stopping in mid-deck after 155 feet of rollout.

The pilot was ejected to the left, landing in the water off the ship's port side, and was rescued within 20 minutes. The RIO was ejected forward. His chute drifted over and onto the flight deck. With 40 knots of wind across the deck, the RIO was dragged by his chute into the burning F-4. He came to rest under the wing and belly of the burning aircraft with his shroud lines entangled in the left wing pylon. He was pulled to safety.

Holy roastin' RIO! To escape a ramp strike and then become shroud-bound in flames on the flight deck is asking too much. The cause of this accident was pilot error. Had it not been for the quick reaction of the *Forrestal* flight deck crew, and the gallant efforts of V-2 division officers, Lieutenant Commander Denny Bergo and Lieutenant Dave Hastings, this RIO, who was severely injured, may not have survived.
