GRAMPAW PETTIBONE

Sundown Kid in Flaps-up Fiasco

Misguided Tomcat

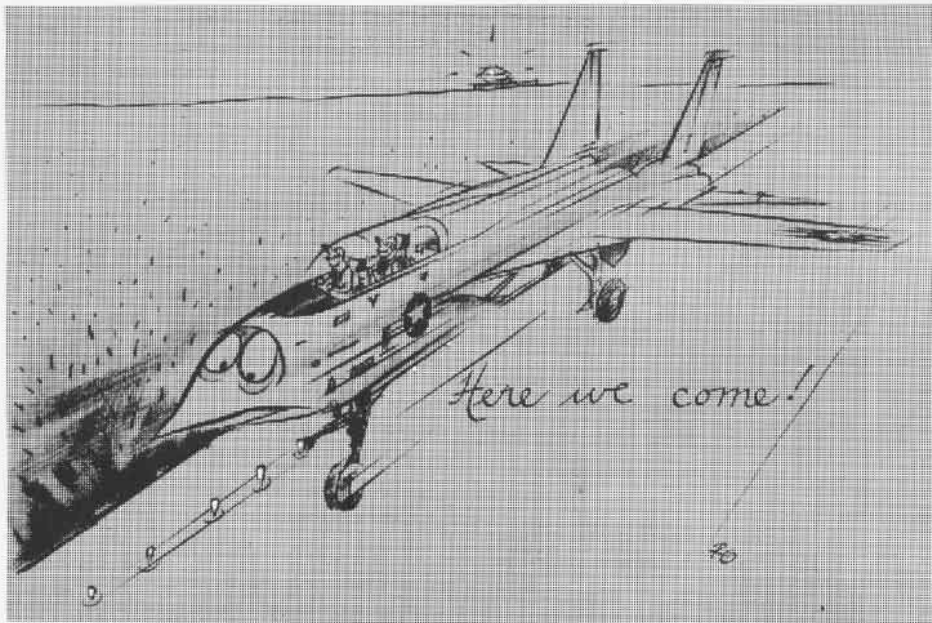
marks show that the blown tire resulted from the starboard nose gear striking a 6-inch white runway-edge light and the starboard main wheel impacting the wheels-up/wave-off lights located nine feet right of the runway's starboard edge at 1,200 feet down the runway. The aircraft continued another 600 feet on runway heading when the starboard main landing gear strut impacted the runway arresting gear sheave assembly which extends 18 inches above the runway surface. This collision tore the main landing gear from the aircraft, causing considerable damage to the starboard engine and fuselage as it separated from the aircraft. The crew interpreted this to be compressor stalls and engine failure.

The pilot became preoccupied with ensuring that his aircraft was in the proper configuration for takeoff and failed to pay adequate attention to proper aircraft positioning for takeoff. The RIO, one of the most senior in the FRS, became so preoccupied with taking proper interval, monitoring the LSO/FCLP frequency, becoming angry that the tower had let an S-3 and EA-6B into their pattern, and double-checking aircraft takeoff configuration that he failed to visually check runway lineup. Use of the taxi light would have prevented this mishap.
