GRAMPAW PETTIBONE

A Knight on the Beach

"Know When to Go"

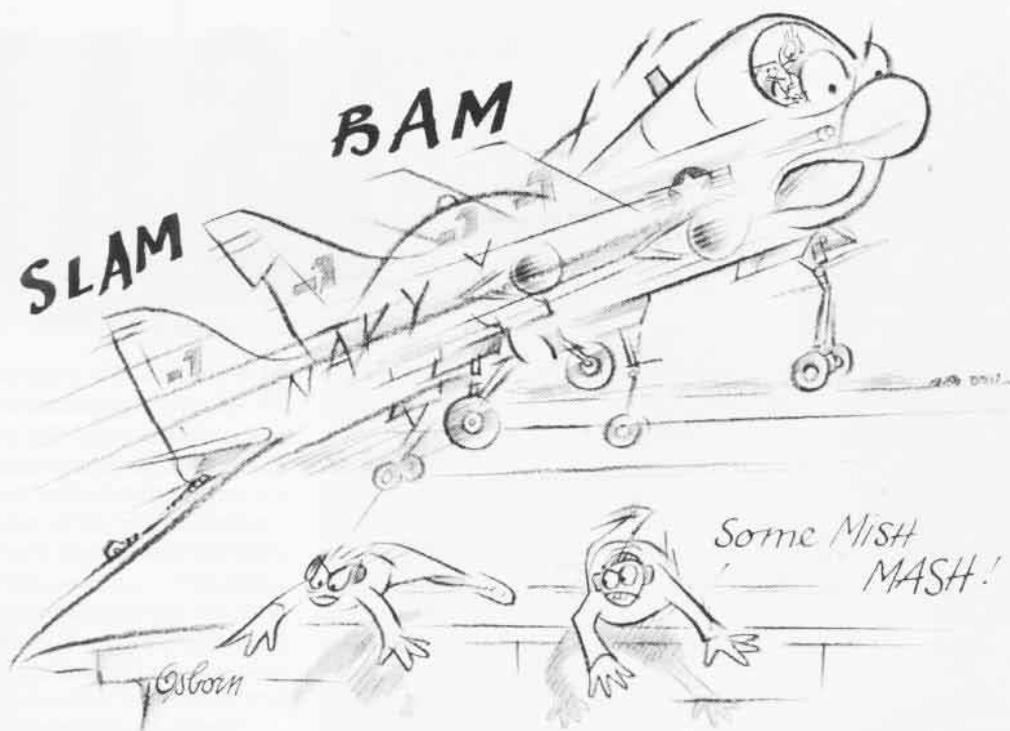
sent to the overhead tanking pattern and then radar vectored to his next approach. At two and one-half miles, the LSO, still seeing no approach lights, requested the pilot to switch to the "day" lights position. Approach lights were illuminated and the approach continued. At one mile from the carrier, the aircraft was observed to be "high" (above the glideslope). The LSO instructed the pilot to "start working it down nice and easy." The aircraft continued to parallel the glideslope, still holding high. At 20 seconds (approximately .75 mile) from touchdown, the LSO gave a second "You're high" call. With this, the pilot increased his rate of descent. "Catch it in the middle with power," called the LSO as it appeared the aircraft might now pass through and go below the glideslope. The pilot responded with power and the aircraft went back above the glideslope. At 10 seconds from touchdown (approximately .25 mile), a third "You're high" call was given. At six seconds, the LSO called, "Keep it coming down." Just inside the wave-off point, prior to touchdown, the pilot lowered the aircraft's nose attitude and reduced power. Observing this, the LSO commanded,

"A little power . . . Power, power, power, wave it off, wave it off, waveofffff!" The pilot, responding with power and nose-up attitude, was unable to arrest the excessive sink rate, and the aircraft collided with the ramp! The main landing gear slammed down four feet forward of the ramp line with the tail hook impacting seven and one-half feet short of the landing area. The hook bounced and struck the ramp area once more as the aircraft continued forward in an extremely nose-high attitude. The hook skipped the first three arresting cables but engaged the #4 arresting wire. After 178 feet of rollout, the hook point separated from the shaft, leaving the aircraft to trundle up the deck. The aircraft left the angle in a very cocked-up climbing attitude. Two seconds later, the pilot ejected. He landed back on the flight deck, striking the raised wing of an A-7, was dragged aft by his chute, and was rescued immediately by the flight deck crew.
