GRAMPAW PETTIBONE

Confusion

Rollout Roulette

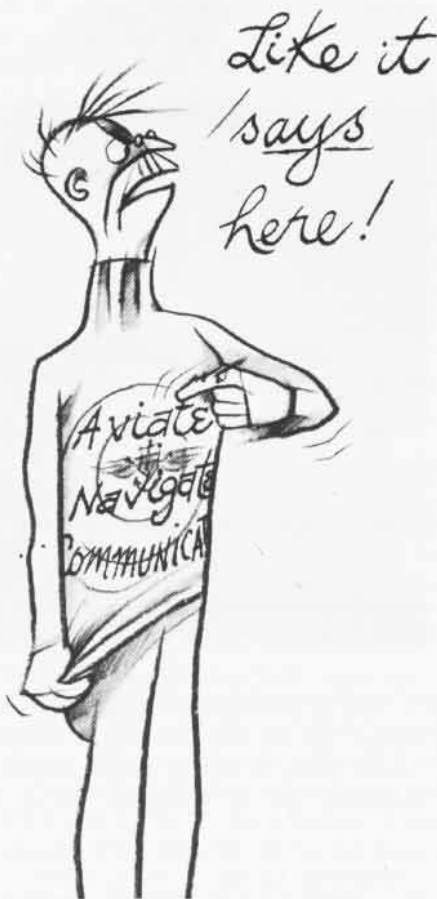
Ditching was inevitable. As the pilot attempted to flare and level the wings, the left wing, port engine still windmilling, hit the water and the plane cartwheeled, coming to rest in three to five feet of water, inverted.

All eight aviators aboard were injured but survived. No one had worn a parachute harness, only one had on a Mae West, neither pilot had used a hard hat, and three out of five passengers did not have shoulder harness fastened. One passenger who was strapped in, released his safety belt on

Gosh, dang it, this whole deal really hurts my soarin' blood pressure! Dropping the landing gear on the pilot while he had his hands full with a burning engine at low altitude purty near cost us eight birdmen. It's just too doggone bad there weren't more seats up front to take care of everyone trying to get into the act.

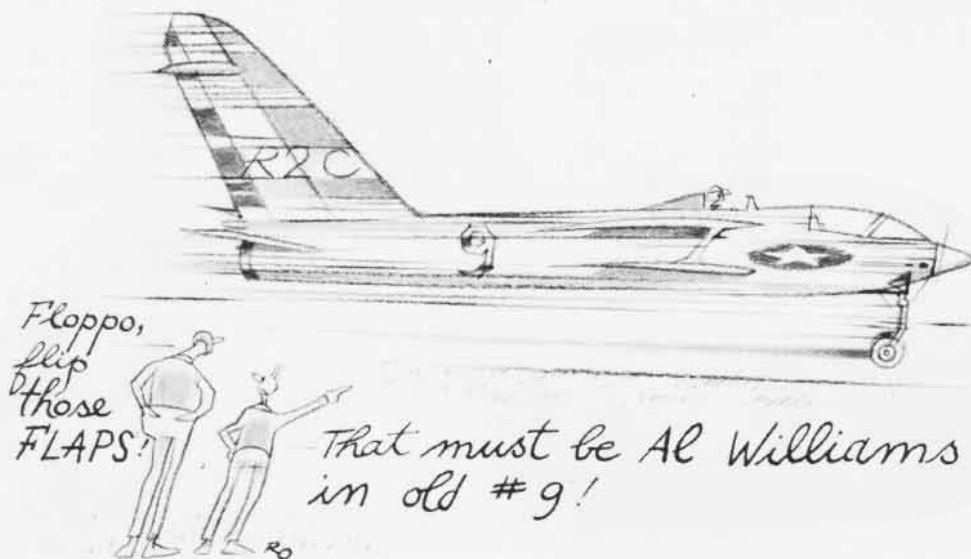
The aircraft departed the runway pointing 90 degrees to the runway heading, but sliding with a forward velocity vector. The port landing gear

dug into the dirt and was torn from the aircraft. The port wing tip contacted the ground and shed pieces of wing panels as it plowed its way to a final resting place 180 feet from the runway.

Of serious concern was the pilot's failure to note his airspeed until he commenced braking. He remembered putting the gear down but did not remember lowering the flaps. Four things should have alerted him to his flaps-up condition during the approach. He neither cross-checked airspeed with the AOA, nor saw the flashing wheels/flaps warning light or flap gauge. His transition to optimum angle of attack was quicker than

The pilot's decision to stay on deck would have been okay had the antiskid or nose gear steering functioned as expected. After the tires blew, full rudder throw and more directional control would have been available by lowering the flaps. Finally, his luck was all but exhausted when the tailhook lowered and caused the apparent malfunctioning nose gear centering device to swerve the aircraft off the runway.
