GRAMPAW PETTIBONE

Slip Sliding Away

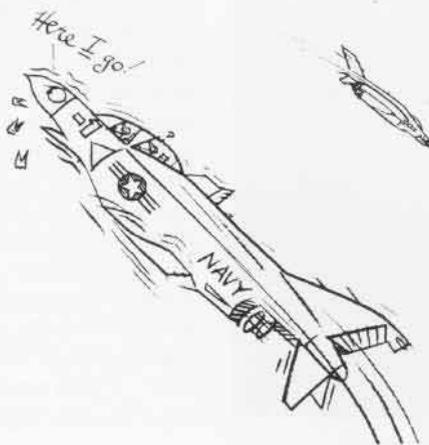
ter reversals, the F-4 under attack turned left at a high angle of attack with full left rudder. To increase his turn rate, the pilot used some opposite aileron, at which time the F-4 departed to the right and entered a right spin.

At spin entry, the altitude was approximately 10,000 feet, airspeed fluctuating between 0 and 80 knots and angle of attack pegged at 30 units. The pilot immediately neutralized the controls and put the stick forward to unload. He then deployed the drag chute, which had no noticeable effect on the aircraft. Full forward stick, right aileron and neutral rudders were then employed.

Jumpin' Jehoshaphat! With pilots like this one on our side, we don't need enemies! Where the heck did this pilot get his aerodynamics trainin'? Maybe he slept through the lectures. The cause of the accident was simple: a pilot-induced spin by the use of cross controls at high angles of attack — in violation of a warning in NATOPS!
