PROJECT NUMBER (05-170)

Long-Term Management Strategies for USS ARIZONA, A Submerged Cultural Resource in Pearl Harbor

NATIONAL PARK SERVICE
SUBMERGED RESOURCES CENTER

SEPTEMBER 2008
THIS REPORT IS APPROVED FOR PUBLIC RELEASE

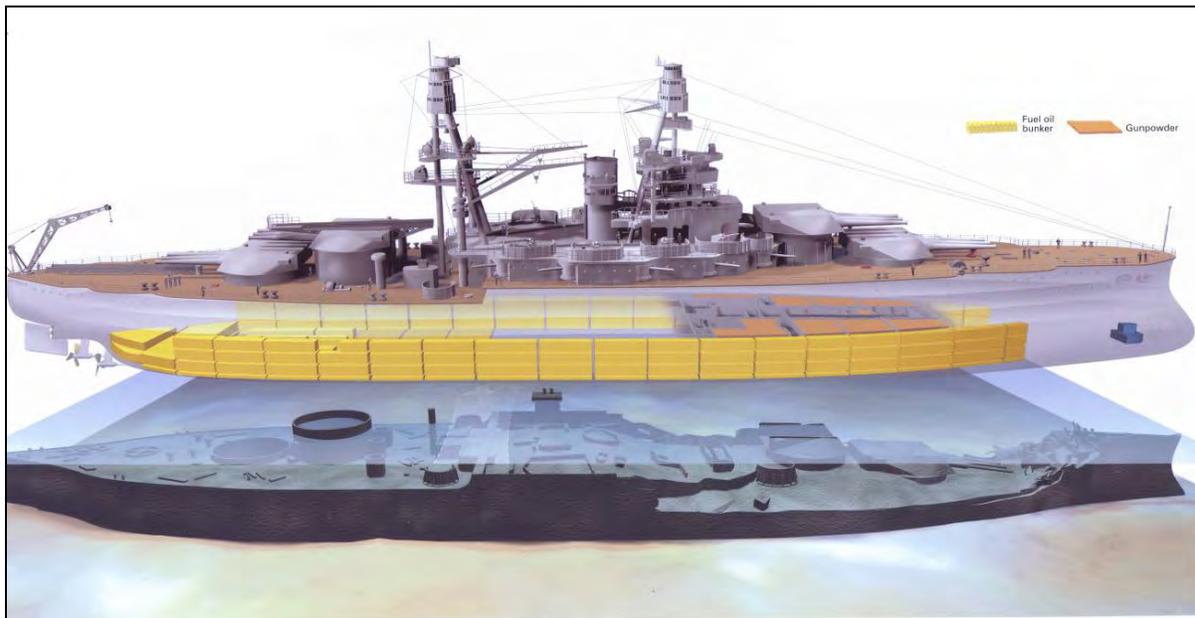
Figure 3.3. Graphic of Arizona showing oil bunker and forward magazine locations in relation to hull damage mapped by SRC in the 1980s (Graphic by National Geographic Society).

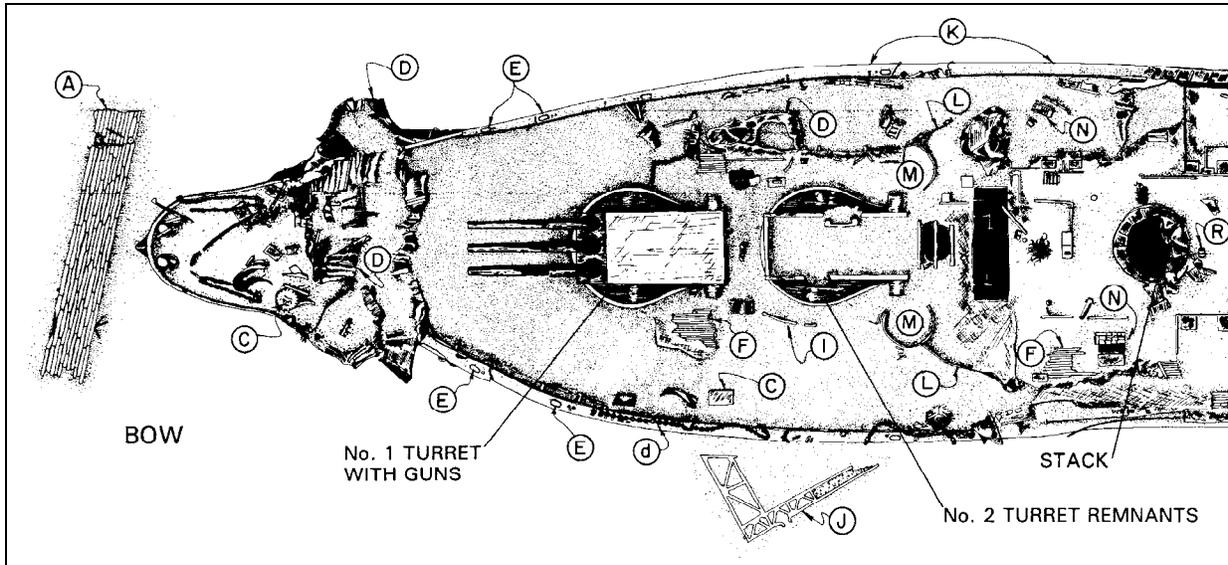
Figure 3.8. Planimetric view of *Arizona* bow damage (Drawing by NPS-SRC).

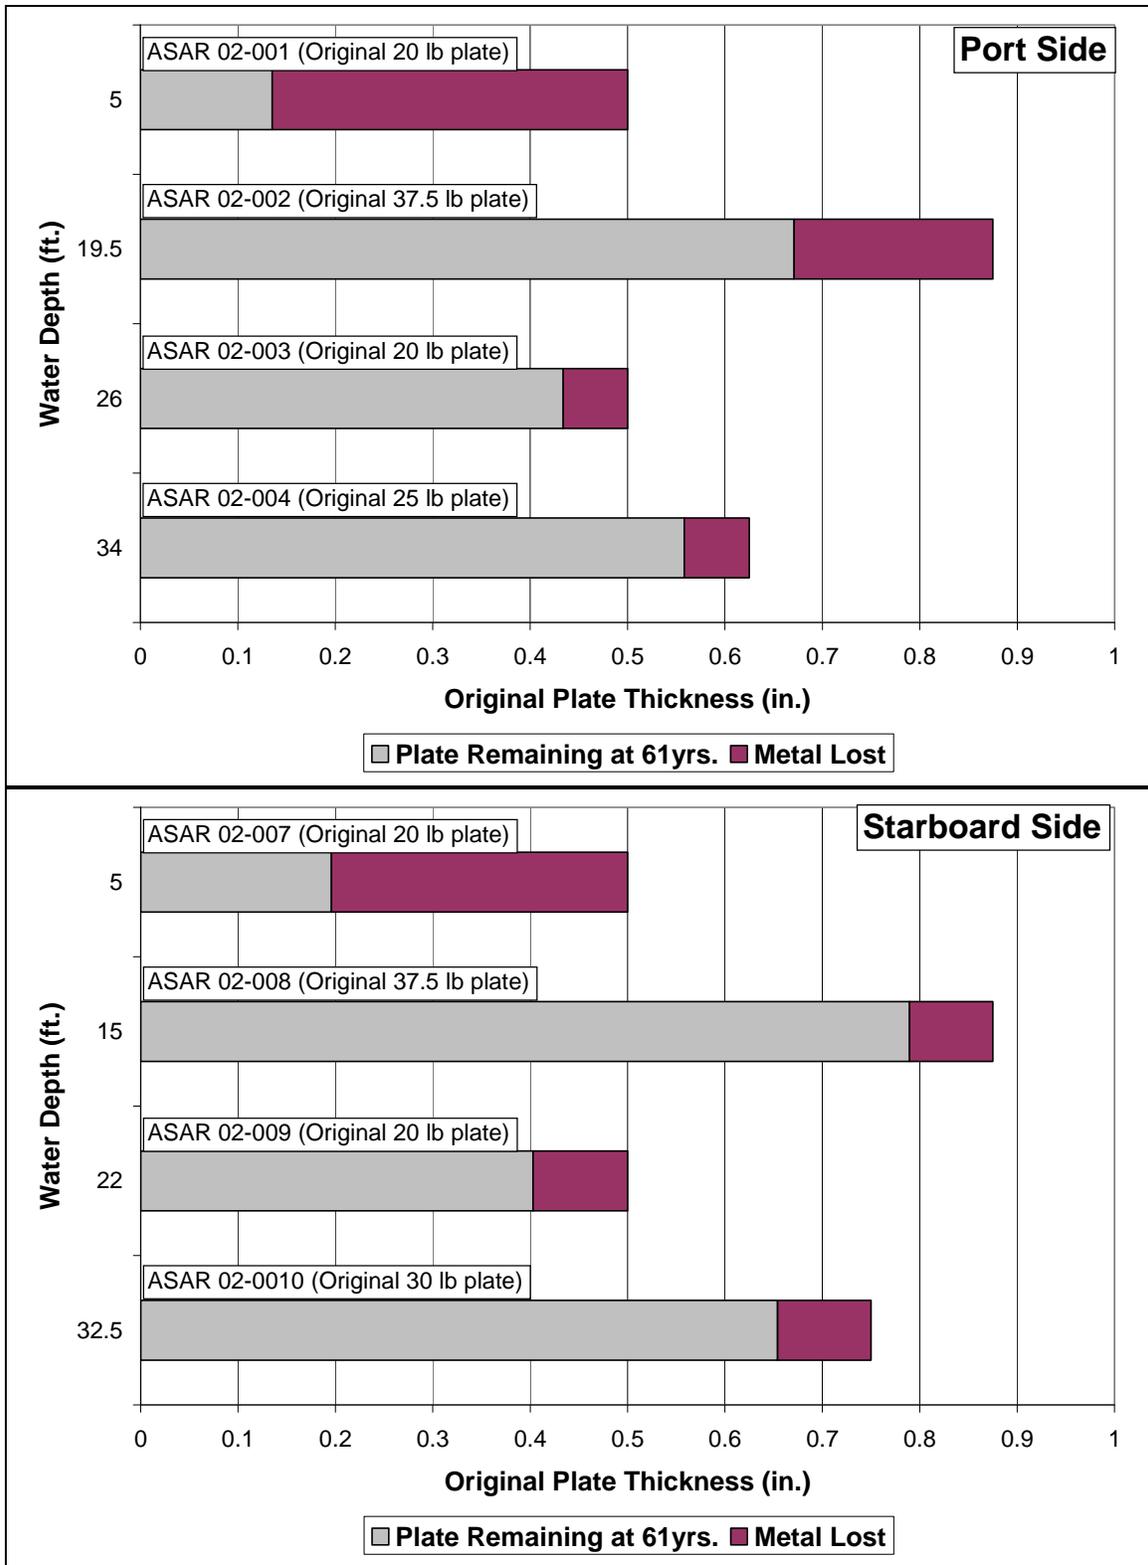
Figure 5.70. Metal loss as a function of original plate thickness and water depth

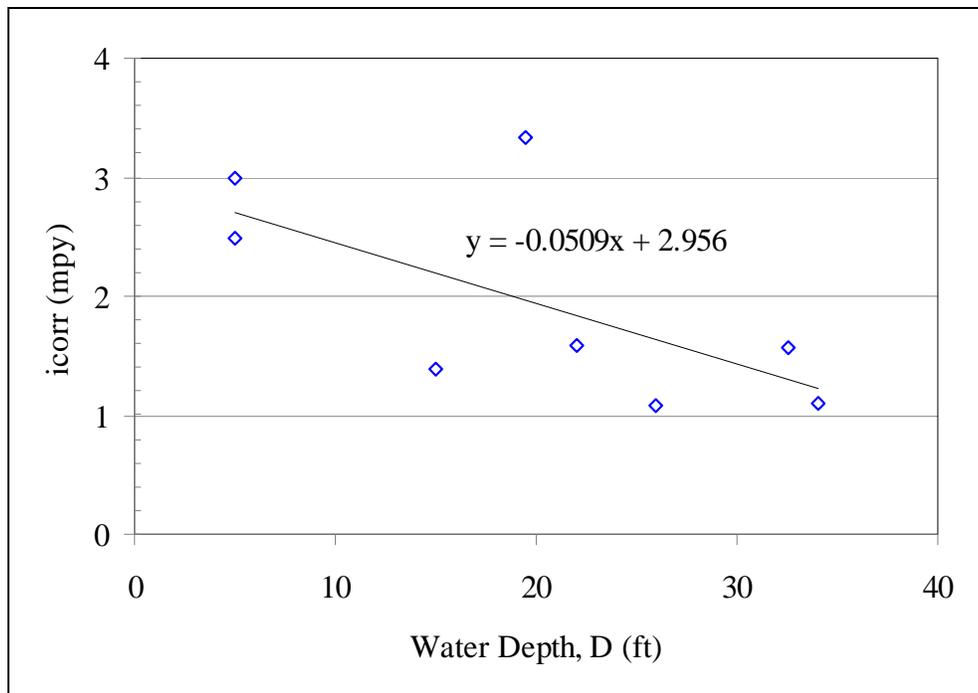
Figure 5.71. Corrosion rate (i_{corr}) of hull samples as a function of water depth.

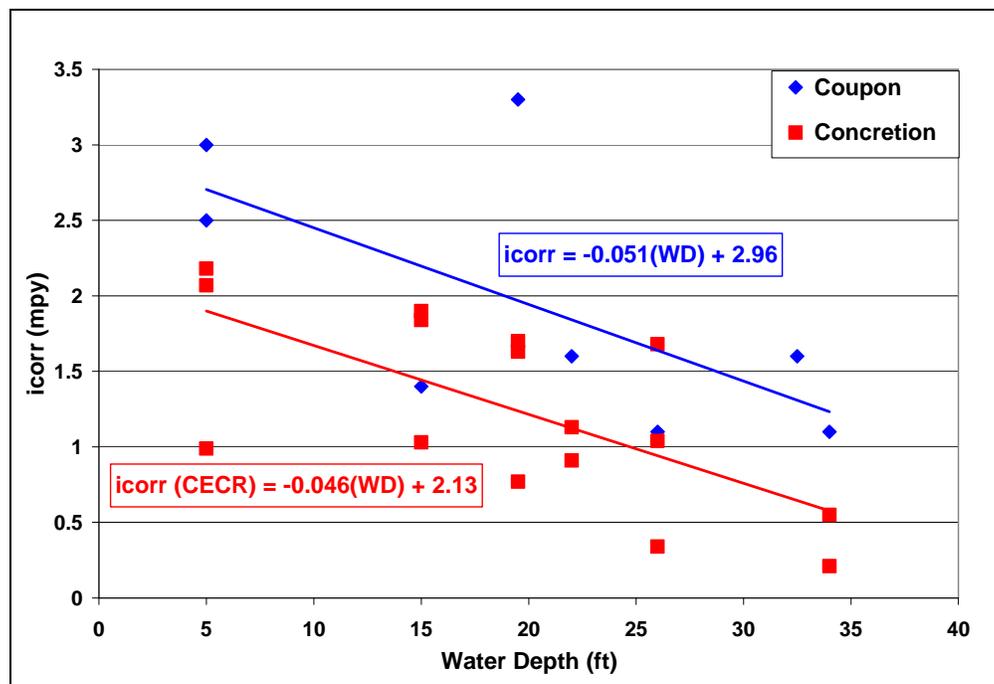
Figure 5.76. Comparison of the corrosion rate on Arizona compiled from both coupon data and concretion iron content measurements as a function of water depth.

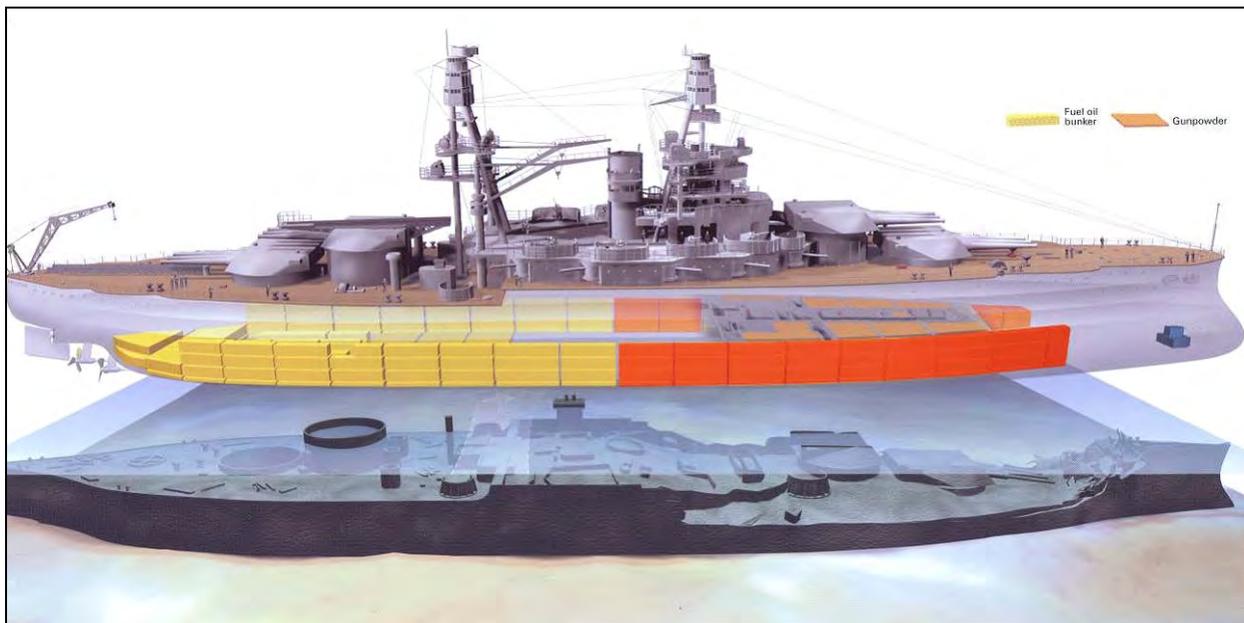
Figure 9.1. Graphic of oil bunker locations relative to hull damage. The yellow bunkers in the aft section (left) are presumed intact. This graphic depicts 50% of the hull remaining, rather than the more accurate 40% (Graphic by National Geographic Society).

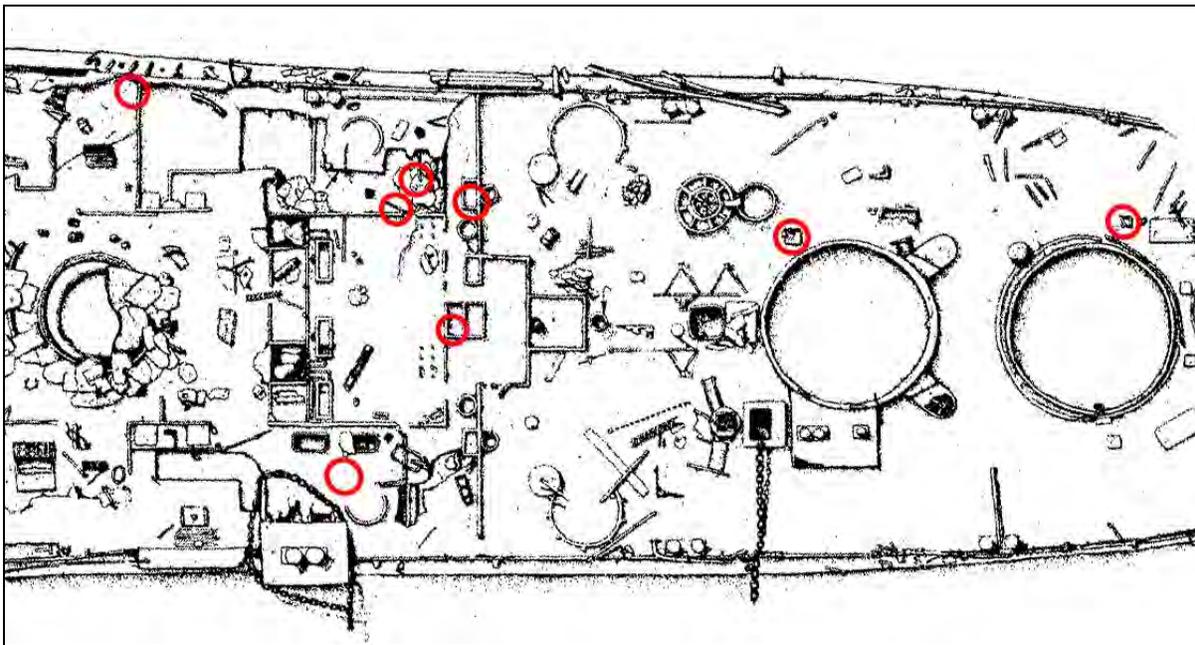
Figure 9.23. Oil release points measured on *Arizona's* hull, June 2006 (bow is to left) (Graphic by NPS-SRC).

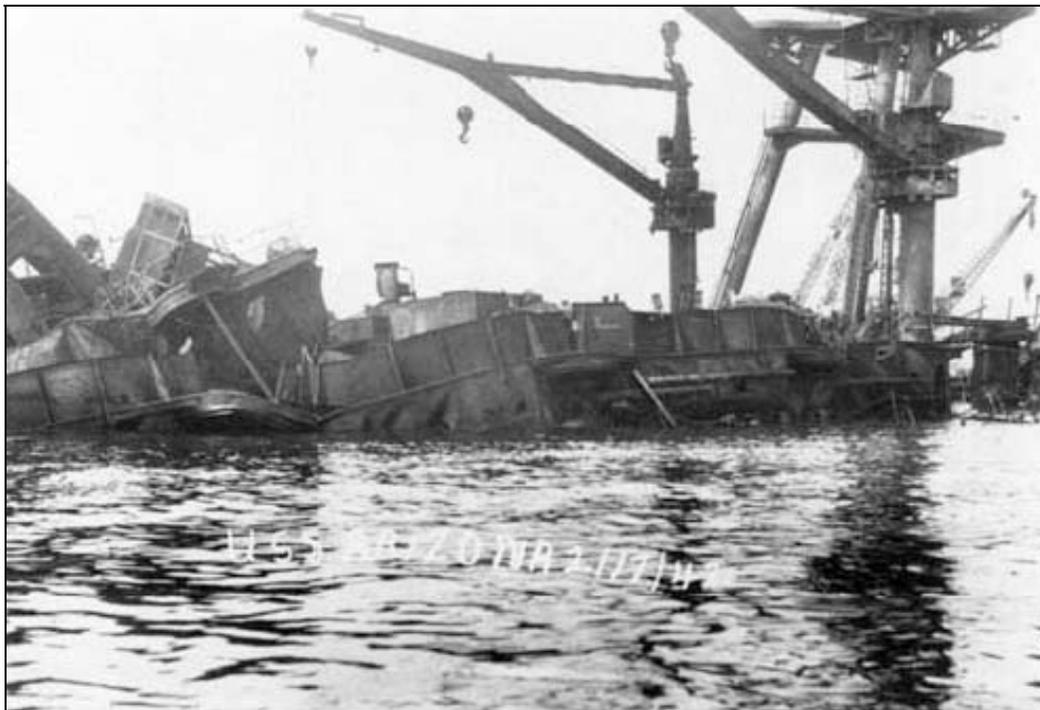
Figure 10.4. A photograph of USS *Arizona*'s damaged exposed deck (USS Arizona Memorial Photo Archive).
