GRAMPAW PETTIBONE

Crosswind Caper

'Clean' Landing

Narrow Escape

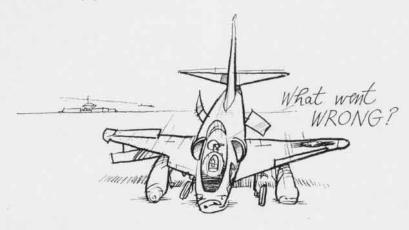
The pilot stated that after completing the landing check list he continued the approach at an airspeed of 100-110 knots with an apparently normal touchdown. He further stated that, just after contact with the runway, the nose of the aircraft seemed extremely heavy and almost immediately the propeller blades made contact with the runway. He hauled back on the stick in an effort to raise the nose but got no response. When the pilot applied pressure, the brakes felt as though they were locked. With the prop damaged, he realized it was useless to attempt a takeoff so he shut off the gas.

The aircraft continued nearly 2,500 feet up the runway in a fairly straight line before coming to rest on the right side of the runway. Fire broke out immediately and the pilot and passenger quickly abandoned the aircraft uniniured.

The pilot says he remembers lowering the gear. I don't doubt that he did, but he probably forgot that he pulled it up when he took the waveoff. The belly tank started scraping the runway 639 feet from the approach end and the prop started bitin' into the runway 100 feet later. There's really not too much evidence that this lad did anything except make a real good landing in a CLEAN condition.

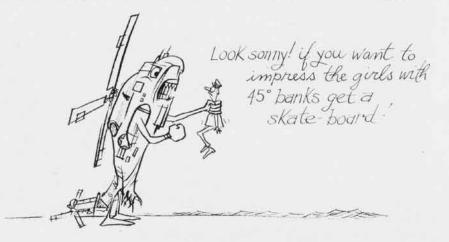
Realizing that an excessive sink rate had been established, the pilot attempted to flare the aircraft by pulling the nose up and adding full power. He was unable to stop the descent and the aircraft hit the water in a level attitude with very little forward motion. Immediately after hitting the water, the helo again became airborne and the pilot was able to keep it in a hover.

The crew chief quickly informed the pilot that it looked like the tail wheel strut sheared on impact with the water. The pilot then moved over to a small sand bar in the river and hovered while the crew chief got out and inspected the aircraft for further damage. He confirmed the previous report of the missing tail wheel. He also found that the aft fuselage and pylon area were buckled and damaged. In addition, all of the external equipment aft of the auxiliary tanks was wiped off on impact with the water.

The holo sustained overhaul damage as a result of the impact, but, to be honest, it did pretty well to hang together at all. Every airframe has a design limit. When you exceed that limit with this kind of treatment, somethin' is sure to come unglued.
