GRAMPAW PETTIBONE

Low-Level Lunacy

Flame Out to Flame Up

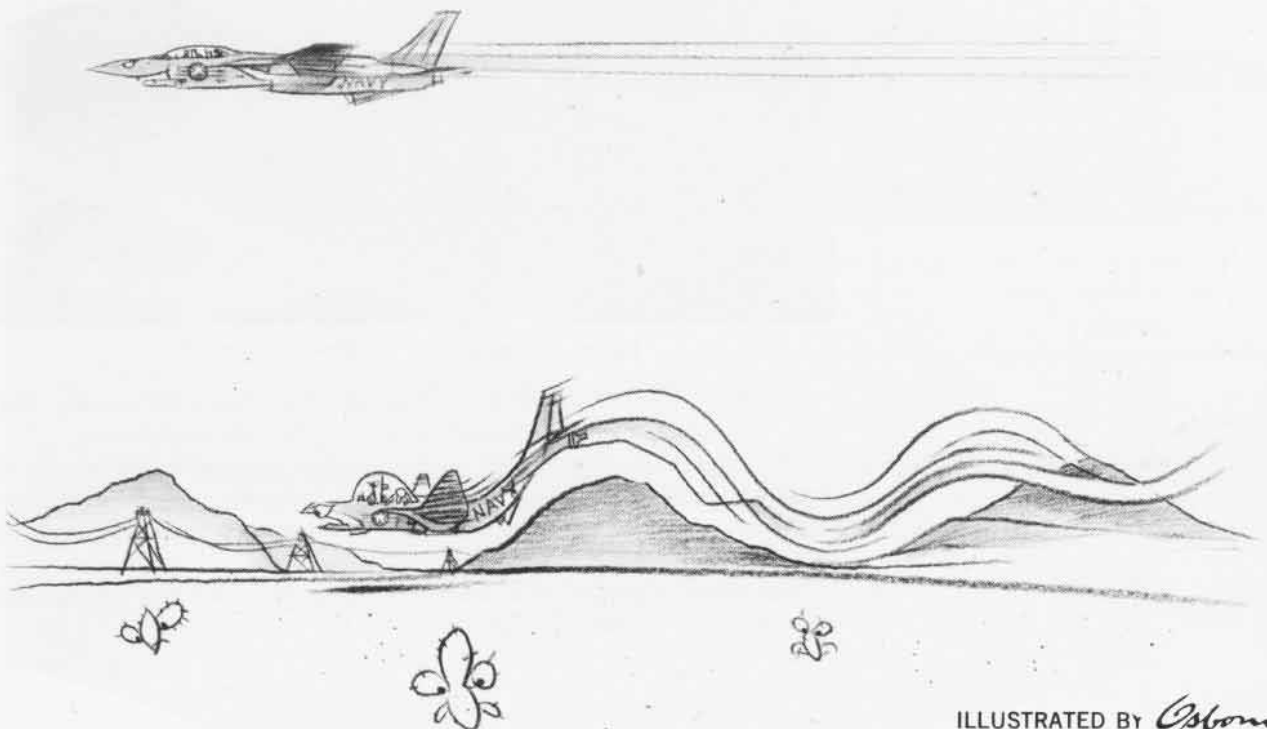
The pilot began an immediate climb, leveled at 8,000 feet and decelerated to 250 knots. During the climb, his RIO saw a large hole in the starboard slat. Additionally, he noted that the outer portion of the starboard horizontal stabilizer was bent up at a 90-degree angle. The other *Tomcat* was informed of the problem, rendezvoused and observed the damage.

Holy low-level lunacy! This accident was the result of extremely bad judgment, airmanship and violation of Nap-tops. The loud thump was caused when the aircraft's right wing struck an oblique metal brace on top of a 45-foot-power-line pole. Damage involved the starboard LAU/7 launcher, leading edge wing slat and the horizontal stabilizer. Pure dumb luck prevented this crew from becoming permanently ingrained in the sands of this low-level route. Professionalism on the part of the pilot and RIO (senior member of the crew) was needed on this escapade. Nuff said!

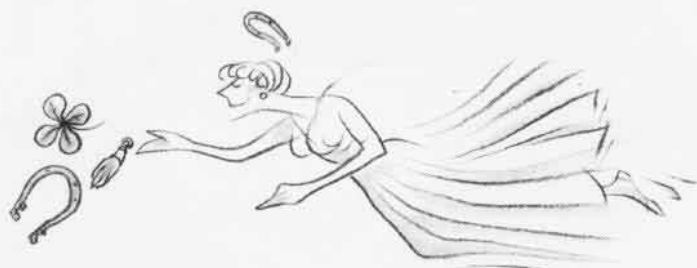
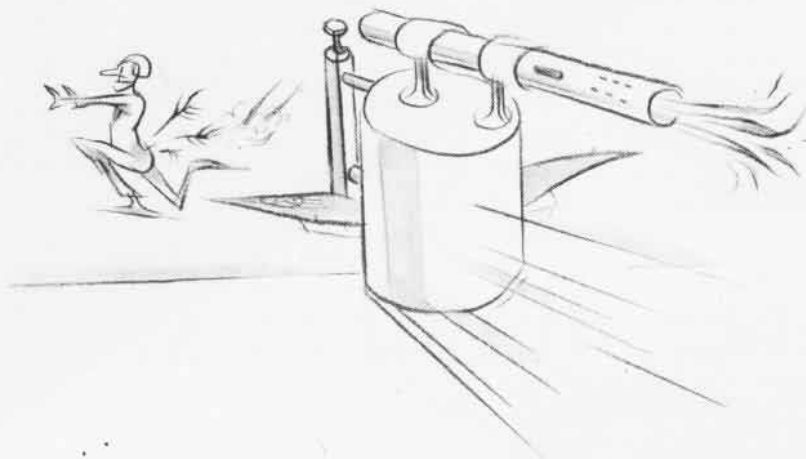
Great balls of fire! This is one way to warm up a chilly November afternoon. The cause of this young man's misfortune was a misplaced lock washer lodged between the fuel control body and the elbow to the flow meter. The washer prevented the elbow from seating properly and eventually caused the rubber seal to work free, allowing a sizeable fuel leak to develop. Upon landing, the hot sparks from the grinding wheel assembly ignited the fuel pouring from the port aft fuselage section.

Power loss continued throughout the approach and, at touchdown, the engine stopped. The port main tire blew and wheel rotation stopped, grinding away approximately four inches of wheel diameter. The wingman, circling overhead, informed the pilot that he had a fire in the aft section of the aircraft. The pilot in trouble then secured the engine fuel master switch and dropped his hook for an arrested landing.

The hook-shank retaining point separated from the aircraft as the *Crusader* continued down the runway. The pilot commenced aerodynamic braking and noted the aircraft veering to the left due to drag from the blown tire and locked wheel. The aircraft slowed and came to a stop 5,200 feet down the runway, just after departing the left edge of the surface. The pilot opened the canopy, unstrapped and jumped out of the flaming aircraft. Crash crews arrived within two minutes and promptly extinguished the fire which was located primarily along the port fuselage from the wing flap to the tail.
