Arizona Adventure

Fatal Vision

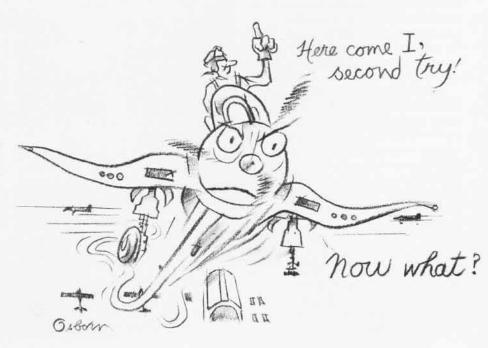
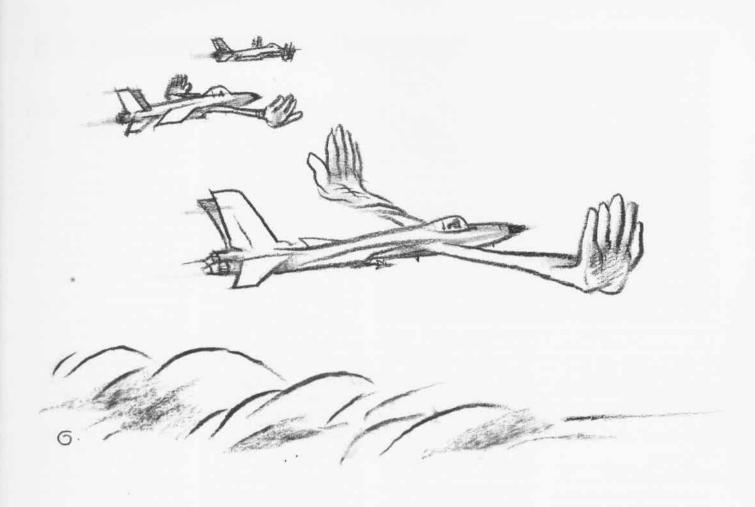
After a few more seconds, number three collided with the section leader, nose section to tail section. There was heavy damage to number three's nose section and to the aft underside and nozzle area of the section leader. Altitude was about 22,000 feet at impact. The pilot of number three was subjected to direct exhaust blast from the section leader's engine and sustained fatal injuries when cockpit integrity

We don't know why the pilot descended through the section leader's altitude. Maybe he misunderstood the geographic position call. Whatever, 'pears he got a couple of thousand feet above and maybe even ahead of the other Hornet in the turn and couldn't see him. He made some adjustments, came down at a good clip, then slammed into the section leader's tail – with tragic results.

The decision to descend, without seeing the other aircraft, was critical. Remember that...and keep your distance...PLEASE!
