Fire in the Hole

Night Line

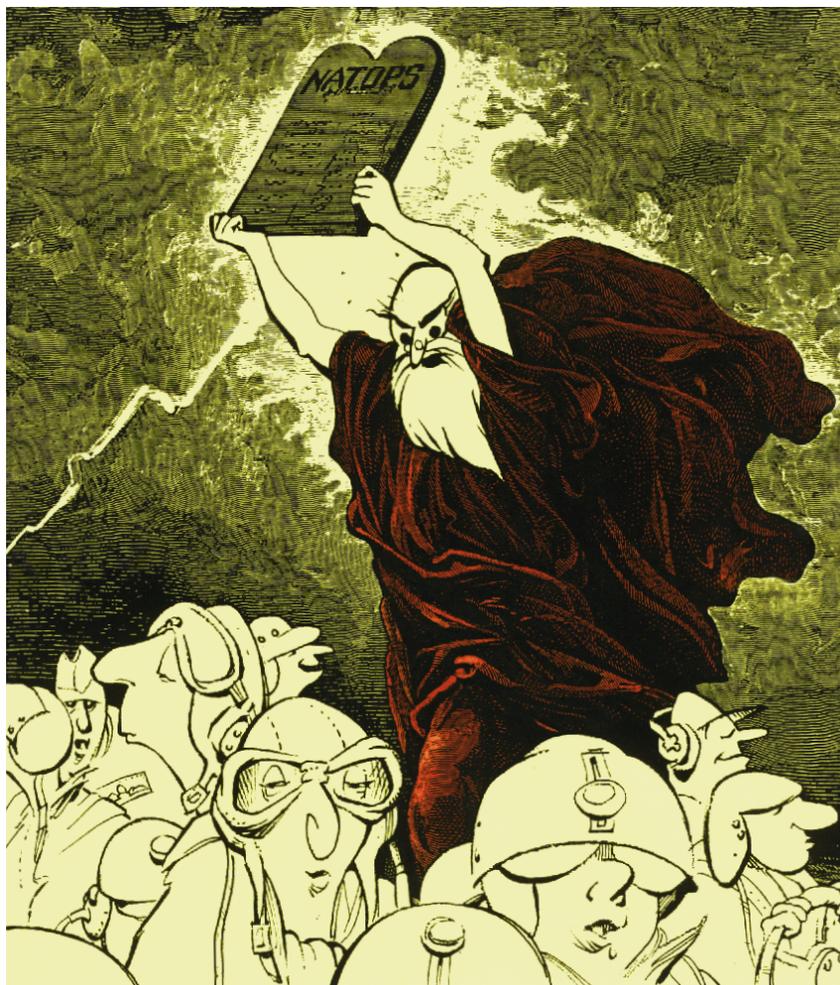
A division of four F/A-18Cs was en route to the air-to-ground working area when the second section leader's left engine fire light came on. The pilot informed the division leader, who saw a thin stream of smoke emanating from the *Hornet* but didn't advise the pilot. The pilot in trouble informed the leader he did not need assistance and that he and his wingman would return to base in section. As the F/A-18s turned toward home, the wingman saw trickles of smoke coming from the *Hornet*. The smoke increased and then flames streamed momentarily from the bottom of the aircraft near the auxiliary power unit. The pilot secured the left throttle and pushed the fire light in accordance with Naval Air Training and Operating Procedures Standardization (NATOPS). The light stayed on, confirming that a fire did exist. The pilot continued to look for other indications of the fire and noted the exhaust gas temperature spiked (at maximum) on his instruments. This occurred about one minute after the fire began. At this point the pilot activated the left engine fire extin-

Post-flight examination revealed that the airframe-mounted accessory drive aft power transmission shaft

had failed. The fire started as a result of the flailing of the broken shaft which ruptured a fuel line, causing severe fire and heat damage to the engine compartment.

knows how much damage could have been prevented with prompt actuation of the fire extinguisher? NATOPS sez: if fire indications exist after pushing the left or right fire light and the light continues, activate the fire extinguisher.

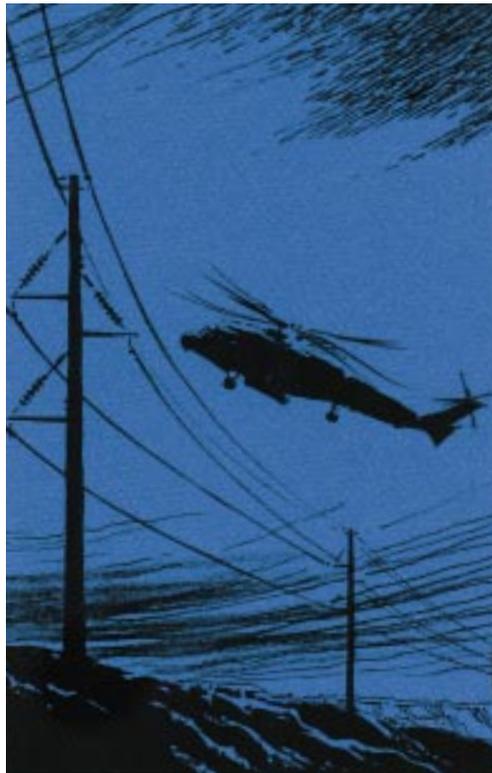
"Where?" asked the copilot, immediately after which the *Seahawk* struck two aluminum static wires strung 15 feet above three 230,000-volt power lines. The mis-

The mishap helo experienced a pronounced deceleration accompanied by the sound of wire scraping along the fuselage. Two main rotor blades contacted the wires. The tail rotor blade tip cap was torn off at the point of wire impact. When the wires broke, deceleration stopped. The aircraft continued in a descent, yawing to the right. It hit the ground 5 degrees nose down, 10 degrees right wing down, at 30 knots. The helicopter swung around, coming to a halt 180 degrees from the flight path, resting

The lower helo erred in flyin' too low in the area of a charted hazard. Everybody knew where the power lines were and that they stood 80 feet AGL. The mishap crew believed that 150 AGL would be a safe altitude to avoid all power lines along the flight route. Right on—except for those areas in which the lines pass over a valley or a wash. Even so, the mishap pilot elected to fly below the presumed safe altitude. Impact with the wires occurred at 115 AGL over the wash.

The *Seahawk* fleet readiness squadron trains all pilots to use a 1:50,000-scale chart for insertion and extraction of SEALs, because it provides more precise terrain navigation information. The chart was on board, all right, but not used.
