## Spinning Sea Dragon

## Canyon Catastrophe

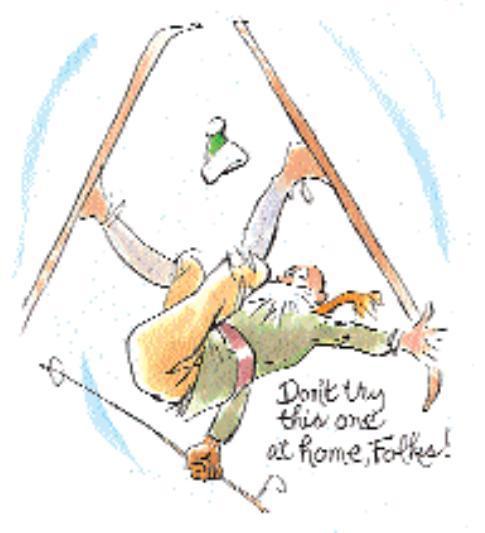
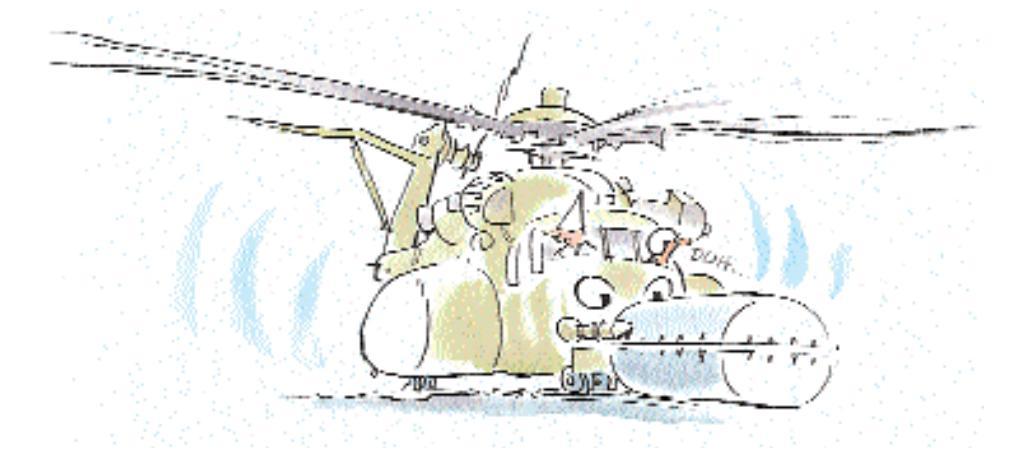
Landing without incident at the destination, the pilot taxied onto a parking apron, set the parking brake, then transferred control to the copilot. The pilot may have left other-than-neutral control inputs on the helo when he made the transfer. Additionally, chocks were not placed on the main landing gear.

The leak in the right brake caused the brake pads to disengage, but the left main landing gear brake remained pressurized. The parking brake slipped off again and the left brake released slowly due to a pressure restrictor on the hydraulic line. The aircraft began to move because the flight controls were not neutralized. The asymmetrical distribution of braking allowed the helo to pivot on the left main landing gear until pressure was completely gone from the left brake. Then, the left main landing gear started rolling backward, in effect accelerating the turn.

The copilot did not apply the brakes right away because he assumed the command pilot would handle them as he had earlier in the day. When the copilot did apply brakes, the right brake pedal laid down flat because of the leak. The copilot then applied left yaw pedal, which helped little.

nesses heard a sound which was attributed to a change in the pitch of the tail rotor. The helo accelerated rapidly after 90 degrees of turn. After 270 degrees the engine can, still attached to the helo's cargo winch cable, slid out of the fuselage and was dragged across the concrete. It hit a tow tractor and fatally struck the helo's aircrewman, who had been ejected at nearly the same time as the engine can. The aircraft continued to spin, and the cargo winch cable snapped after 1.2 turns. The pilot took control of the helo but could not slow the turn with the right pedal. He concentrated on keeping the aircraft level and in position on the parking apron. He added left pedal, believing that would prevent the helo from rolling over and from hitting other obstacles on the

apron. The helo's refueling probe struck the engine can at 1.5 turns and again in the fourth turn. The helo completed a little over five turns and came to a stop when all of the engines were shut down.

The aircrewman failed to pass on the brake discrepancy to the pilot in command.

The pilot applied a combination of flight control inputs prior to setting the brake which allowed the helo to move on the ground. The copilot failed to reset the parking brake after it released. The copilot inadvertently aggravated the left turn by applying left pedal. The pilot failed to react to the emergency in a timely fashion. Aircrew coordination took a holiday. A Naval Air Training and Operating Procedures Standardization brief, including emergency procedures, was not conducted. And why wasn t the helo chocked?

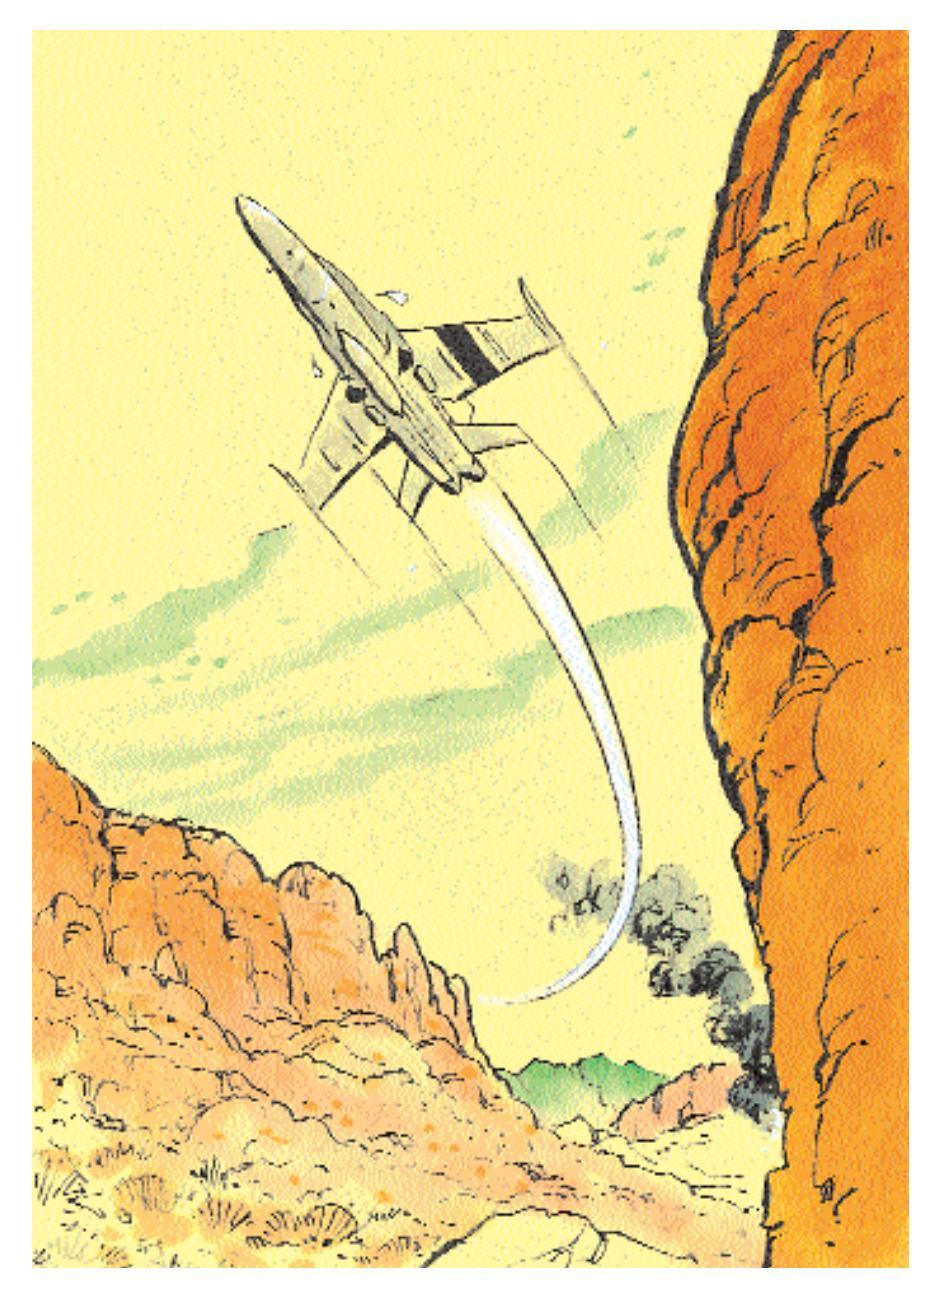
The mission commander lost sight of the leader as the flight commenced the route. Approxi- mately one minute later, the mission commander observed a bright flash ahead and low on the canyon s left wall. The flash then changed to what was perceived as a fireball followed by thick black smoke. The *Hornet* had crashed. The pilot was killed, the aircraft destroyed.

Investigators determined that the F/A-18 struck the canyon wall about 75 feet from the edge of a sloping ridge line in a high-G, high-angle-of-attack, right banked turn. There was no evidence of engine or systems failure, nor any sign of an ejection attempt.

Shouldn ta happened, but it did, so learn from it. The lead pilot s *Hornet* was in a hard right-hand turn within the confines of the canyon walls, and he either didn t see the ridge line approaching or did not realize his flight path was below it. Its also possible that he became aware of the ridge line too late to avoid it.

Would it have helped if the flight had practiced low-level maneuvers over less hazardous terrain before descending into the canyon environment? Maybe. The investigators did conclude that the lead pilot had insufficient low-level flight experience for operating in a canyon area. Plus, he hadn t had enough rest before the mission. He was an extremely motivated aviator but considered by some to be overconfident. Not a good combination for pilots flying high-performance aircraft fast and close to Mother Earth.
