An Archaeological Survey and Site
Investigation of 18PR226, a War of
1812 Shipwreck (Suspected USS
Scorpion) in the Patuxent River,
Maryland

Field Investigations 2010

Prepared by:
Department of the Navy
Naval History and Heritage Command
Underwater Archaeology Branch
805 Kidder Breese Street SE
Washington, D.C. 20374-5060

January 2012

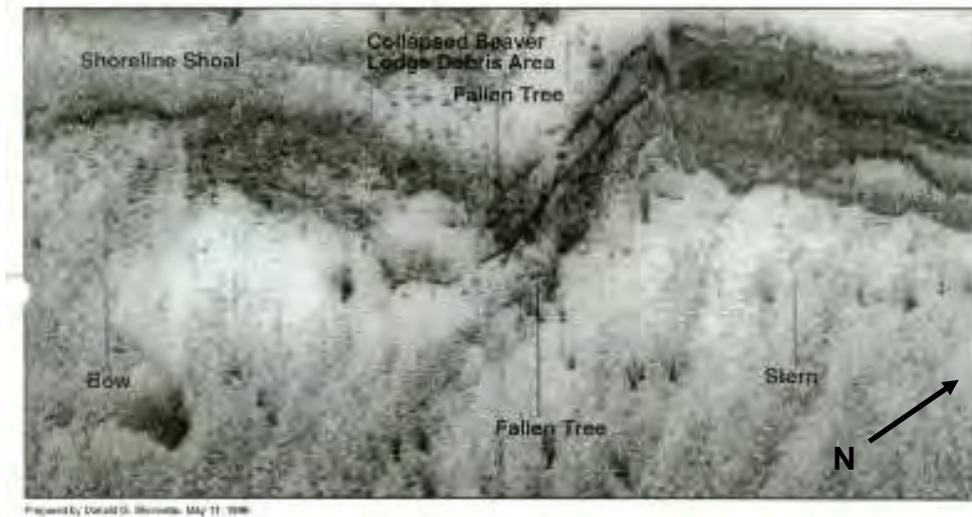
FIGURE 18. Side-scan sonar image of the *Scorpion* site produced during the April 1996 remote-sensing survey. It has since been determined that the bow is to the north and the stern to the south. (Shomette 1996b:28)

side-scan to pick up (Figure 18). The fact that it did not register on the magnetometer was problematic, as the site was originally discovered using that method. In St. Leonard's Creek, the survey team located the remains of one vessel, with a possible second nearby, but could not determine at the time if they were connected to Barney's flotilla.

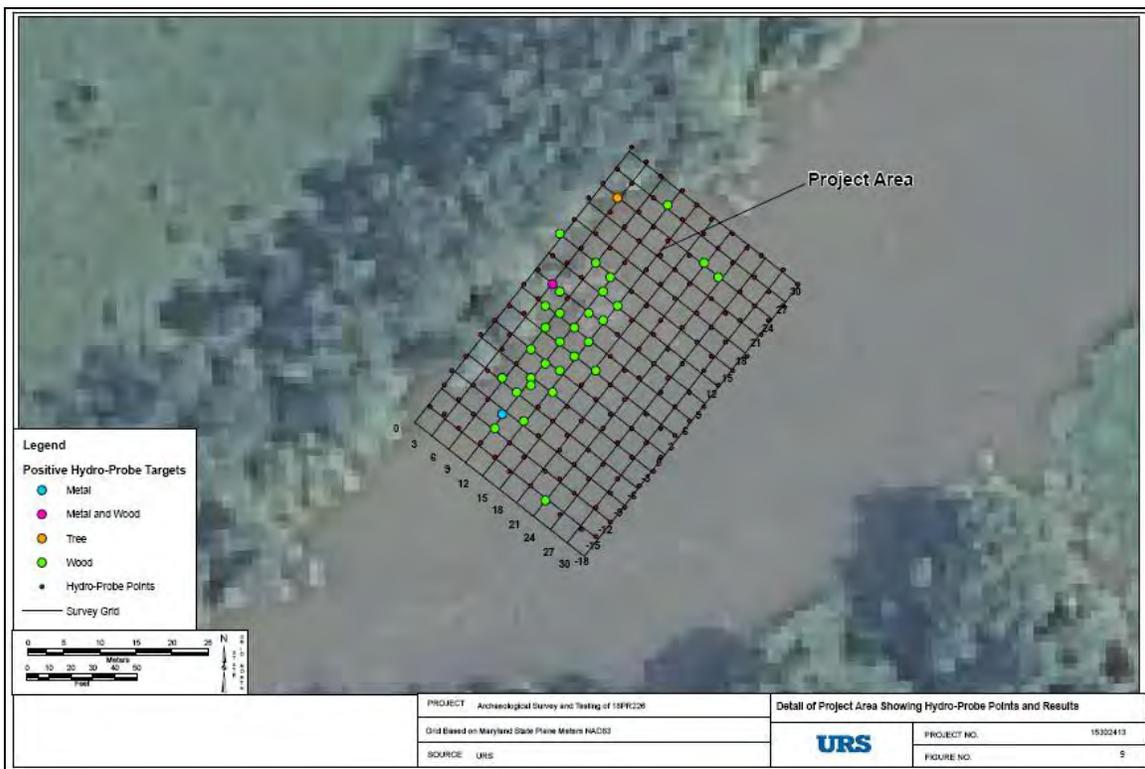
FIGURE 32. Detail of project area showing hydro-probe points and results (Pelletier et al. 2011:17).

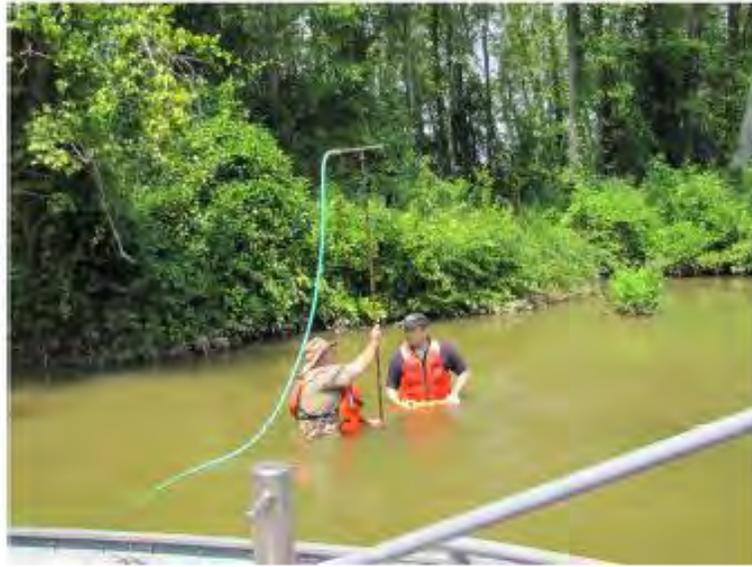
FIGURE 33. Hydro-probe operations (Pelletier et al. 2011:Fig.19).

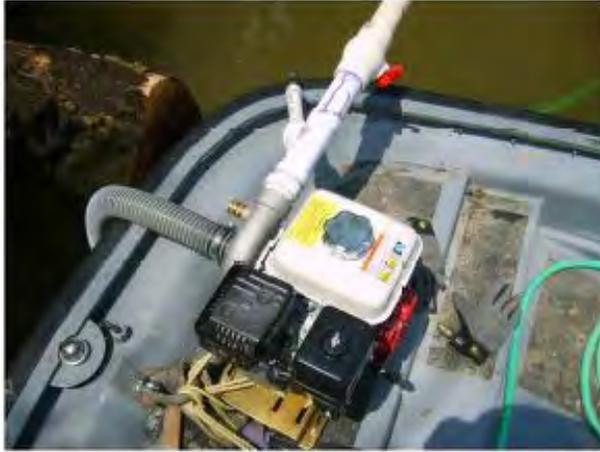
FIGURE 34. Hydro-probe pump (Pelletier et al. 2011:Fig 21).

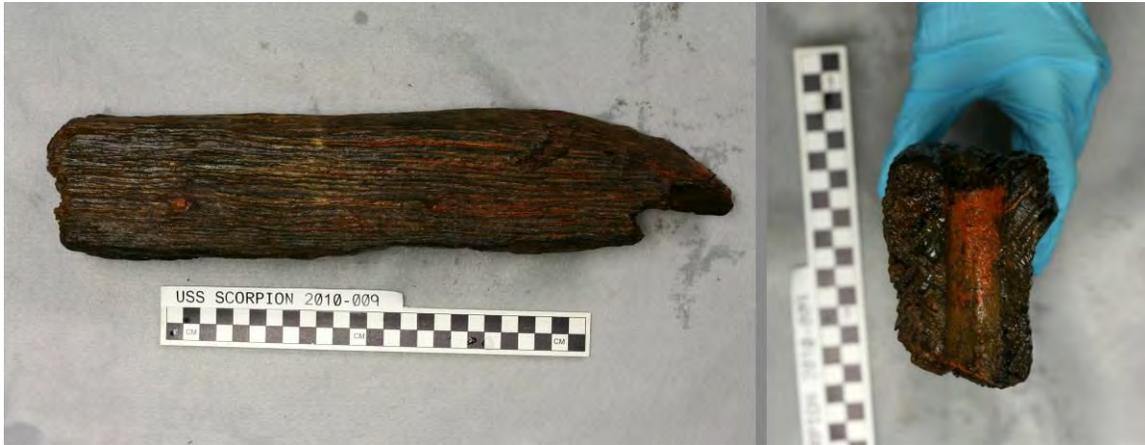
FIGURE 43. Face and anterior end of timber recovered from Test Unit #2. (Courtesy of Naval History and Heritage Command.)
