Keeping the Fleet Operational

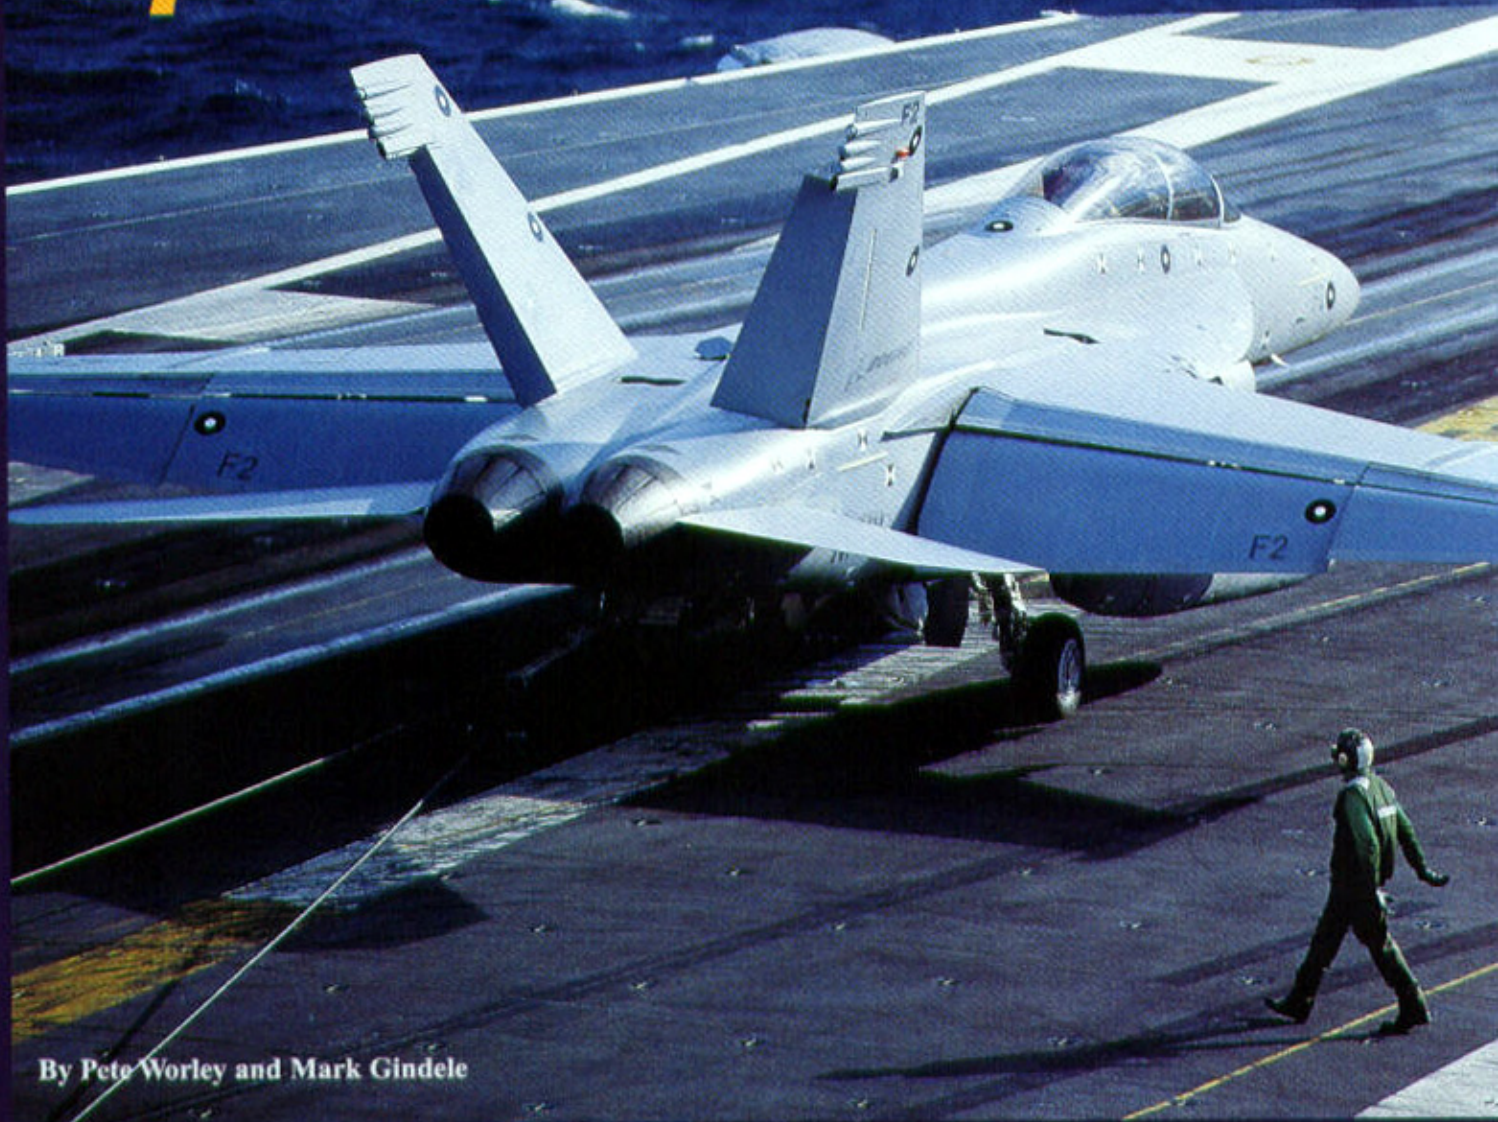
During sea trials aboard *Truman* (CVN 75), opposite, aviation boatswain's mates noticed a discrepancy involving the arresting cables, which led to the discovery of abnormal wear on the arresting gear pendant engines. Engineers from Naval Air Warfare Center Aircraft Division Lakehurst, N.J., diagnosed the problem and replaced a non-spec part on the retractable sheaves, above, allowing flight ops to continue normally.

Lakehurst dispatched personnel to investigate the problem. A team of engineers, mechanics and quality assurance representatives disassembled the pendant engine's retractable sheaves. After tests and further research, an engineer discovered that one of Lakehurst's design specifications had not been met by the manufacturer. The variance adversely impacted the shock absorber function needed during an arrestment, which caused excessive cable tension and wear as well as unusual wear patterns on the other equipment. Later tests aboard *Truman* showed that replacing the non-spec part eliminated the problem.
