Ms. Coble is the aviation issues specialist in the Naval Historical Center's Underwater Archaeology Branch.

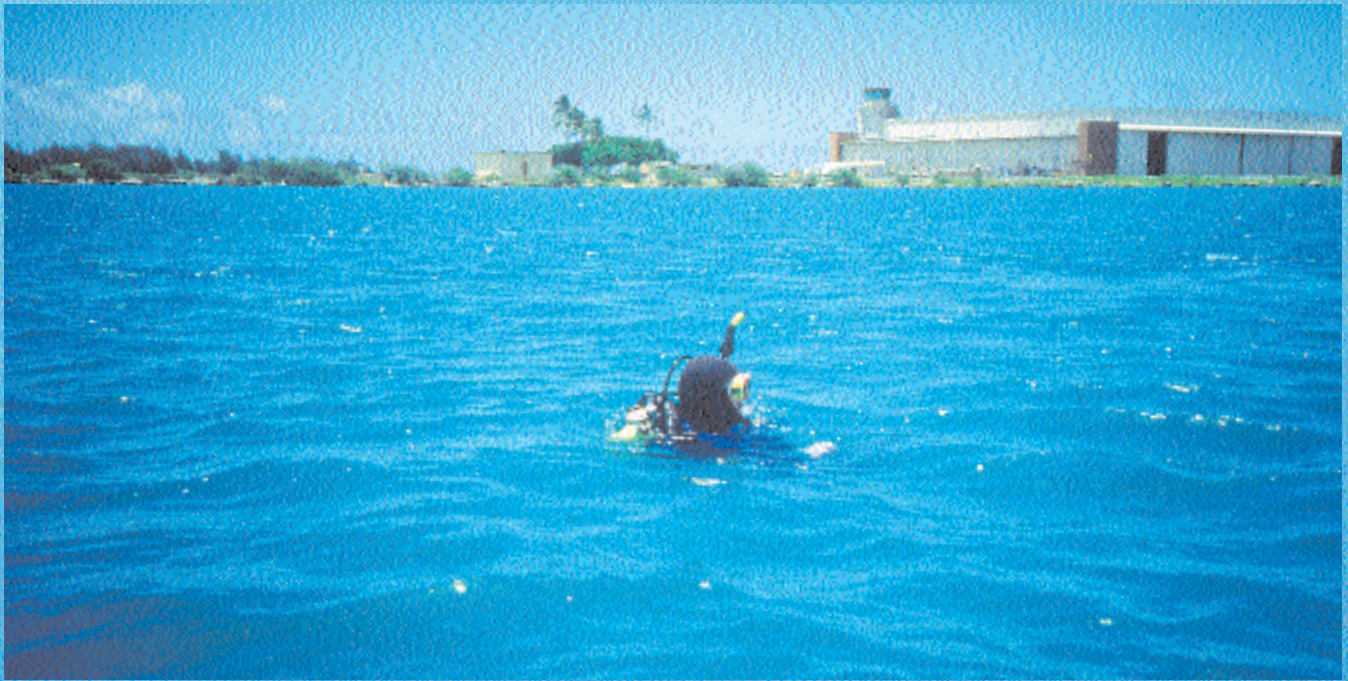
Above, an underwater archaeologist prepares to submerge to visually inspect a target of interest in Kaneohe Bay. Opposite, a student archaeologist takes measurements of the cockpit area of a PBV, being careful not to disturb tenant lobsters.
