H. L. Hunley
Recovery Operations

A Collaborative Project of:
Naval History and Heritage Command,
South Carolina Hunley Commission,
and
Friends of the Hunley

Principal Investigator:
Robert S. Neyland, Ph.D.
Department of the Navy

Naval History and Heritage Command
Washington, D.C.
2016

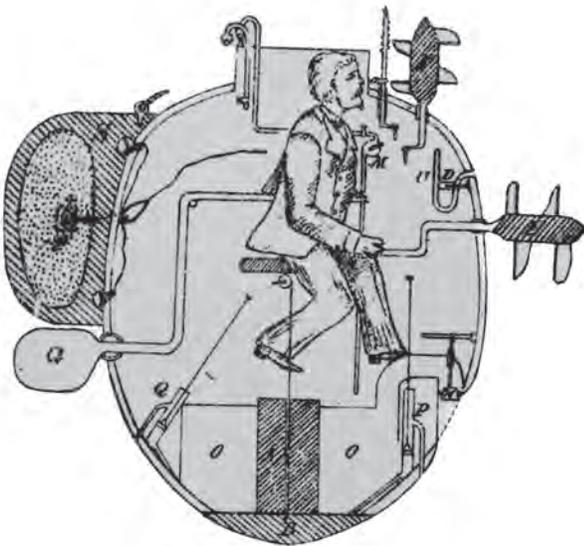
Figure 2.1. This widely published 1875 drawing of Bushnell's *Turtle* by Francis M. Barber is based only on written descriptions of the vessel, and likely contains many inaccuracies, particularly in the propellers, which were likely closer to standard screw propellers.

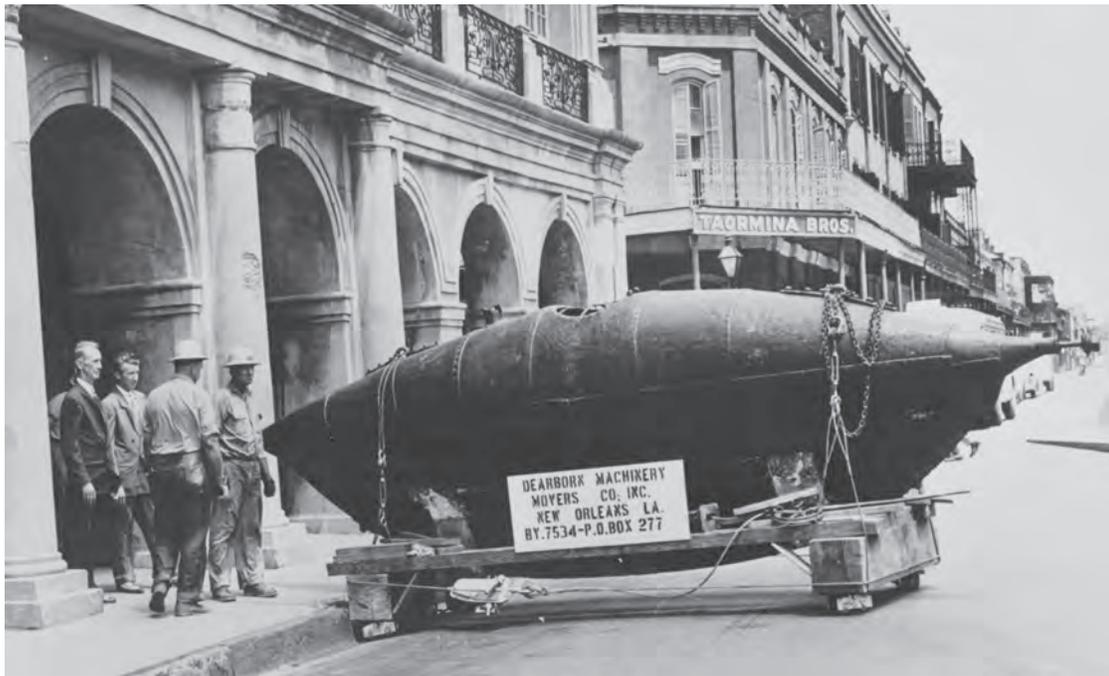
Figure 2.3. An unidentified submarine, once thought to be *Pioneer*, being moved to the Louisiana State Museum in New Orleans. The vessel is sometimes called *Bayou St. John Confederate Submarine* after the location where it was originally discovered. (Detail from NHHHC Photo Archives #NH 42860)

In 1878, a diver on the dredge boat *Valentine* discovered a small submersible in Bayou St. John that resembled Dorr's description (Kloeppel 1992:11). Although it is unclear who built the vessel, it was displayed at the Old Confederate Soldiers' Home in New Orleans and for many years was believed to be the earliest predecessor of *H. L. Hunley*. The vessel, which was 20 ft. (6.1 m) in length, 6 ft. (1.83 m) deep, and 3 ft. (0.91 m) wide, was eventually moved to the Louisiana State Museum in New Orleans (Figure 2.3).

While long confused with the vessel discovered at Bayou St. John (see Figure 2.3), the sketch provides clear evidence that *Pioneer* was a different boat altogether. Its ultimate fate is unknown. One possible explanation comes from the morning edition of the 15 February 1868 *New Orleans Picayune*. The newspaper posted an auction ad for:

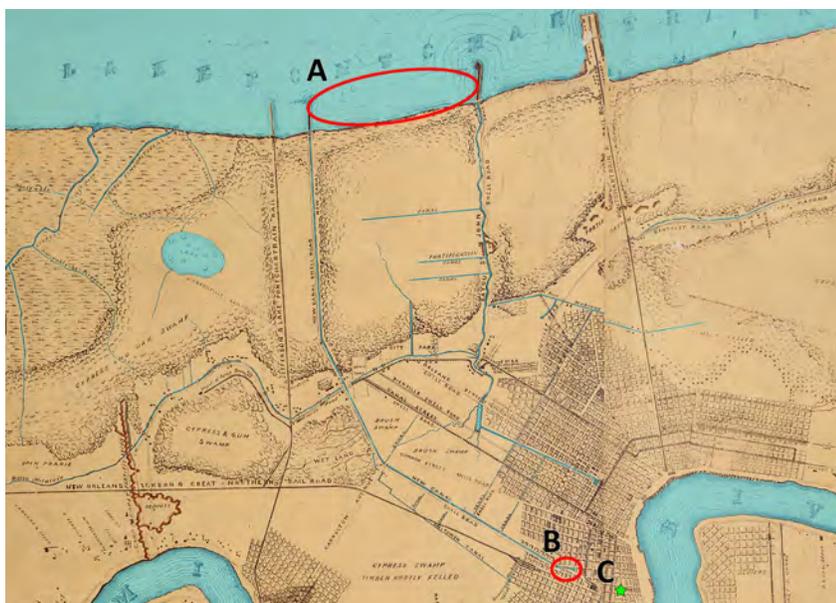
Figure 2.7. Map of New Orleans showing discovery locations of (a) the Louisiana State Museum vessel, and (b) *Pioneer*, as well as (c) the Leeds Foundry where *Pioneer* was built. (Annotated detail from Abbot 1863)

the New Canal connected Lake Pontchartrain to New Basin, which was also mentioned by Baird (1902:40) in reference to the boat he documented. An 1865 sketch by David M. Stauffer, then an ensign on USS *Alexandria*, depicts the same boat drawn by Colin and is labeled as coming "from the bottom of the New Basin, N.O." (Figure 2.6). McClintock claimed that the submarine crew practiced operational procedures and conducted simulated attacks in Lake Pontchartrain. The area near Claiborne Street, where the submarine was discovered, is only eight blocks from the New Basin. The New Basin, incidentally, is only eight blocks from where *Pioneer* was built at the Leeds Foundry (located at 923 Tchoupitoulas Street). It is the closest water access to Lake Pontchartrain from the foundry (Figure 2.7).

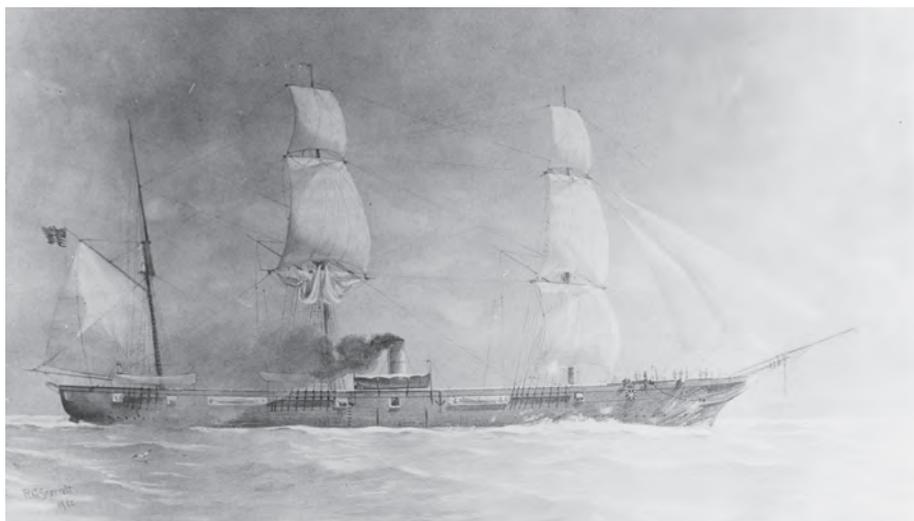
Figure 2.22. Wash drawing of the United States Sloop-of-War *Housatonic* by R. G. Skerrett (1908). (NHHC Photo Archives #NH 53573)

engagement. On that particular night, however, the crew of *Hunley* managed to avoid federal picket boats and propel their tiny craft within striking distance of the nearest blockader, USS *Housatonic* (Figure 2.22).

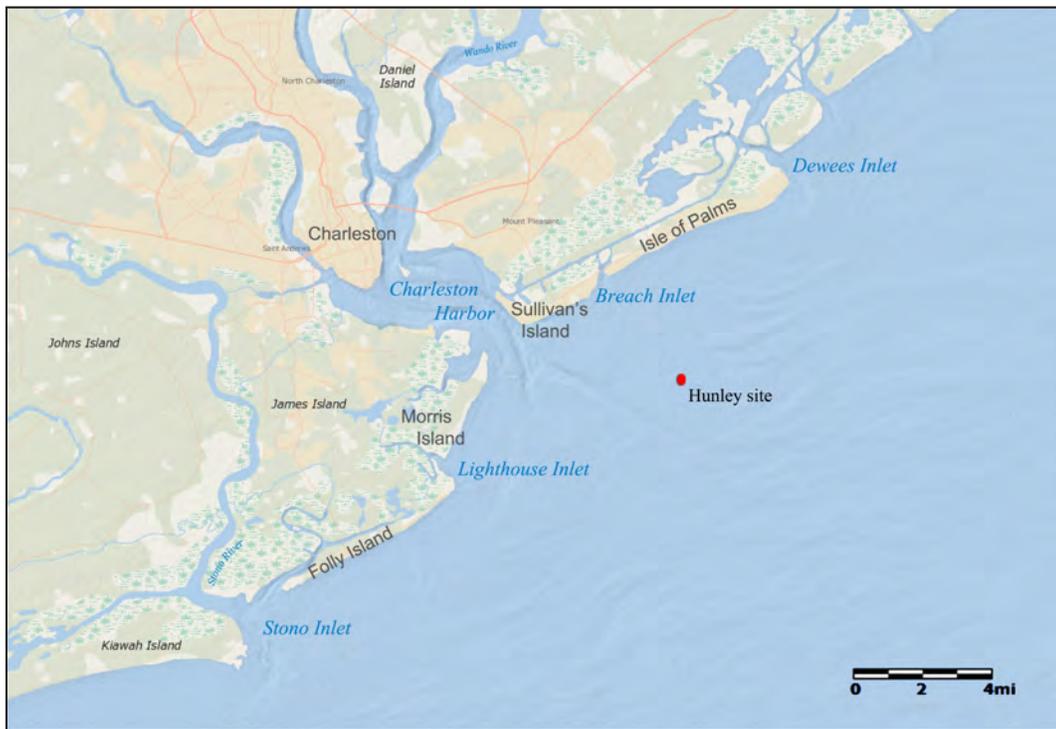
Figure 3.1. The *Hunley* site was located approximately 4 nautical miles (7.4 km) from the entrance to Charleston Harbor. Barrier islands are a significant feature of this part of the North American Atlantic coast. (Basemap from Esri et al., annotated by H. G. Brown, NHHC.)

The *Hunley* wreck site was discovered approximately 4 nautical miles (7.4 km) ESE of the entrance to Charleston Harbor at a depth of 8–10 m (26.25–32.81 ft.), depending on the tide, and buried beneath roughly 1 m (3.28 ft.) of sediment (Figure 3.1). The geology in the area is composed of a shallow, heterogeneous substrate resulting from a complex heritage. It was influenced by the availability and distribution of sediments within the marine system, long- and short-term sedimentary evolutions of the area, and the deposition and burial of the submarine itself. Building on an understanding of the site context for both *Hunley* and *Housatonic* provided by prior studies, a preliminary model of site formation was developed by considering the regional physiography, including the local barrier island systems, geological framework, and the impact of biological processes and human alterations to the environment.

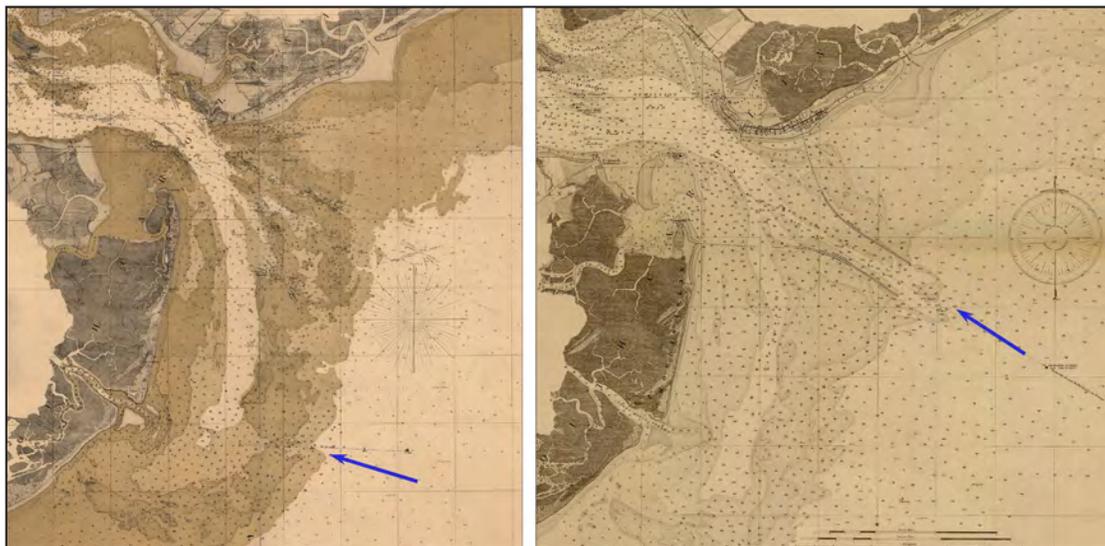
Figure 3.3. Charleston Bar in 1864 (left) and in 1899 (right). The primary route to access the main shipping channel is indicated with a blue arrow. (Details from USCS 1864 and USCGS 1899)

Prior to the 1880s, Charleston Harbor’s entrance was a difficult and circuitous path for ships to negotiate when entering or leaving port. At the time, the harbor’s large ebb-tidal shoals and delta extended approximately 3 km (1.86 mi.) offshore, at which point they were forced south due to predominant longshore currents. Thus the primary entrance to the harbor developed well south of Morris Island (Figure 3.3). To improve navigation into the harbor, a pair of stone jetties was constructed between 1877 and 1895 (Moore 1981:32–36).

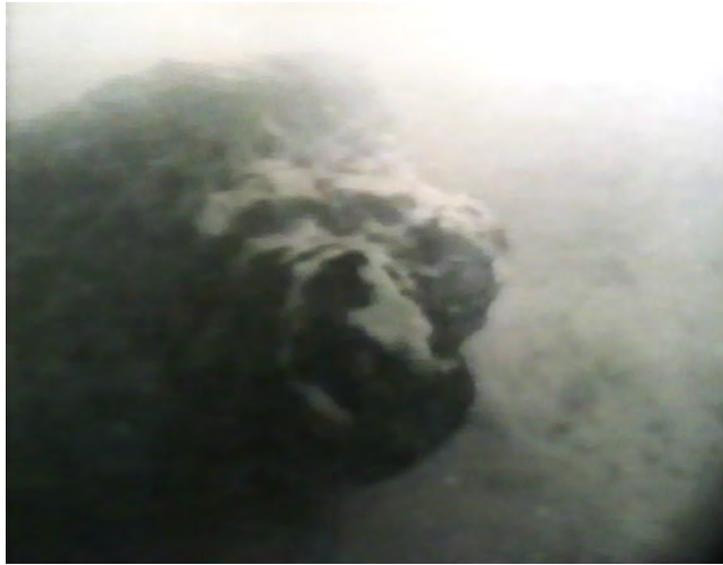
Figure 4.3. Screen capture from NUMA's 1995 video footage of the site. Distinguishing features such as the snorkel box helped build confidence that the vessel was indeed Hunley. (Courtesy of NUMA)

On 7 May 1995, Wilbanks, Hall, and Pecorelli returned to the site to document their discovery on videotape. Wilbanks had contacted Clive Cussler the previous evening, and Cussler requested that the find be substantiated on film. The team re-excavated the test unit and videotaped the forward hatch, snorkel box, and the port diving plane (Figure 4.3). The video evidence was presented two weeks later at a press conference held at the Charleston Museum.

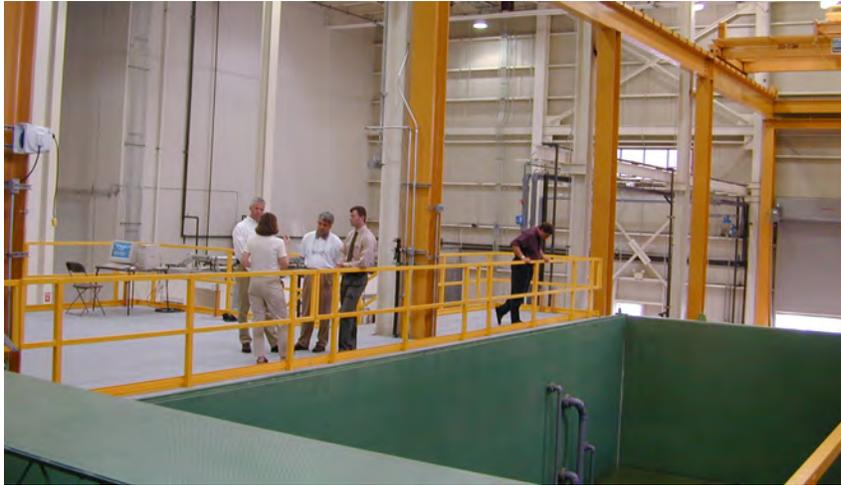
Figure 7.2. A view of the newly-constructed mezzanine looking down into the treatment tank. (Courtesy of FOTH)

Around the top rim of the chilled water tank, a 1,076 sq. ft. (100 m^2) mezzanine was constructed where the scientists could set up computer work stations and stage for the excavation (Figure 7.2). The mezzanine was

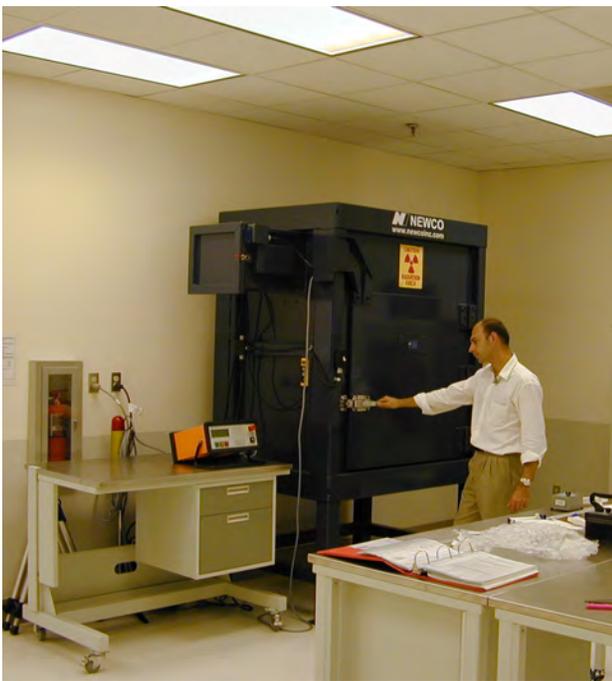
Figure 7.3. Senior conservator Paul Mardikian inspects the newly-installed digital x-ray unit in the dry laboratory. (Courtesy of FOTH)

and dirty to dry and clean. A roll-up door separated it from the wet lab. Upon entering the area was a cooler for storage of human remains and organic materials. The x-ray cabinet and digital radiograph system were also placed at this end of the lab to document the wet concretions and block lifts of sediment containing human remains, textiles, and artifacts without contaminating the rest of the lab with water or sediment (Figure 7.3). They could then be transferred directly to wet storage in the cooler or the warehouse. FOTH purchased a mobile 300keV x-ray tube that could be used in the cabinet or directly on the submarine. Fuji NDT Corporation donated the digital system, providing state-of-the-art x-ray capability to the project (Mardikian 2004:140).

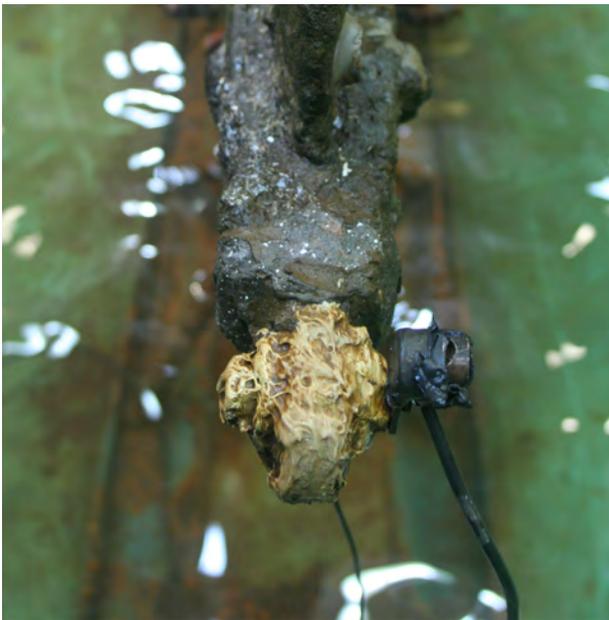
Figure 7.4. A negative cable for the impressed current system was attached to the bow where the spar was once mounted. A coating of epoxy protected the exposed metal. (Photo by H. G. Brown, NHHC)

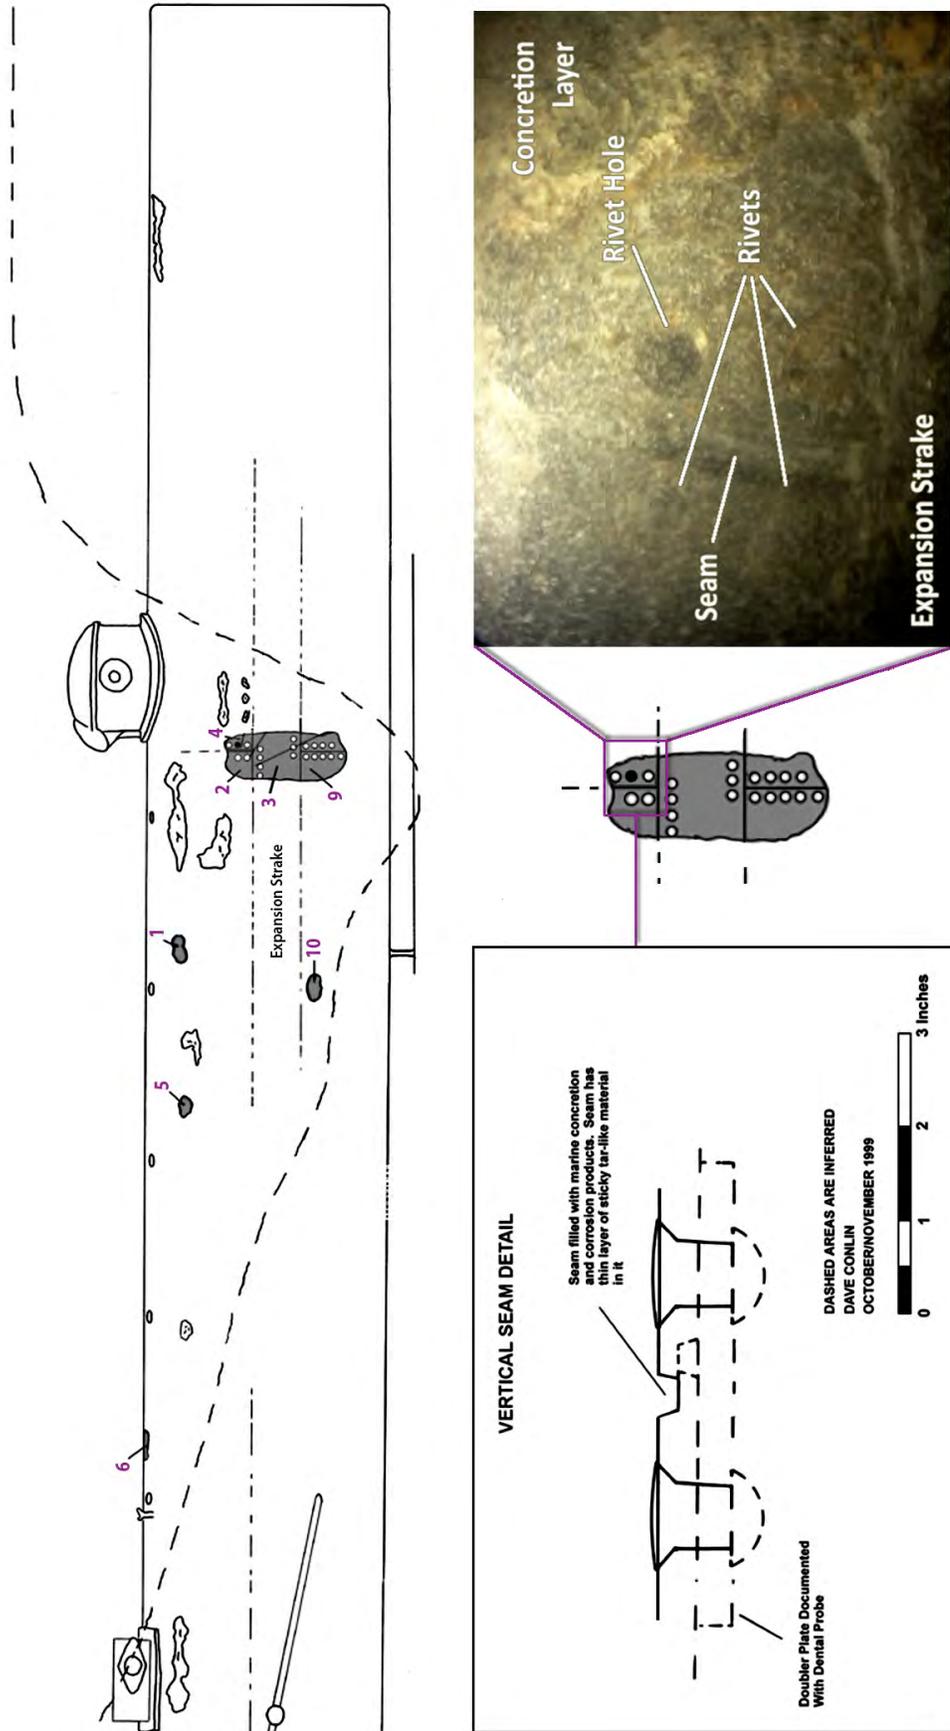
Figure 8.1. Portside view showing thickness testing locations 1–6 and 9–10 (Areas 7 and 8 were located on the starboard side). The area where a vertical plate seam intersects with the expansion strake (photo, lower right) provided a wealth of useful data for the finite element analysis. The missing rivet allowed for limited investigation of the interior seam structure (reconstruction, lower left). (Diagram and photo by David L. Conlin, NPS)

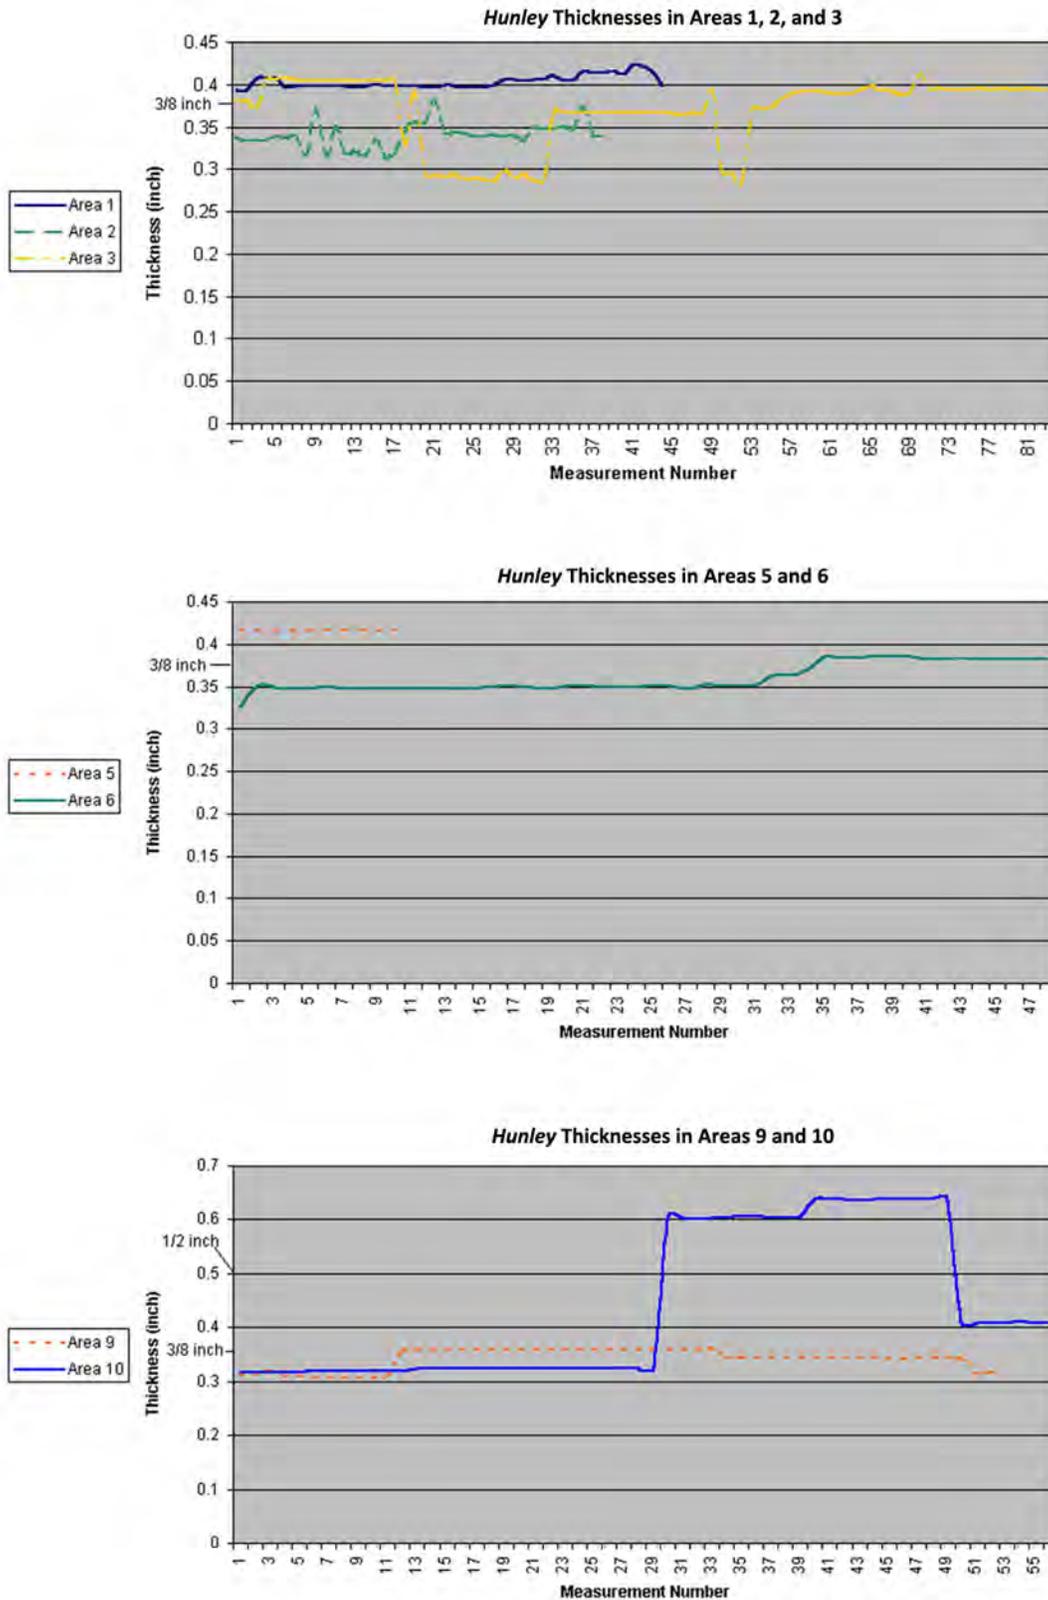
Figure 8.3. Graphs of the ultrasonic thickness readings from the port side of Hunley's hull. (Graphs by David L. Conlin, NPS)

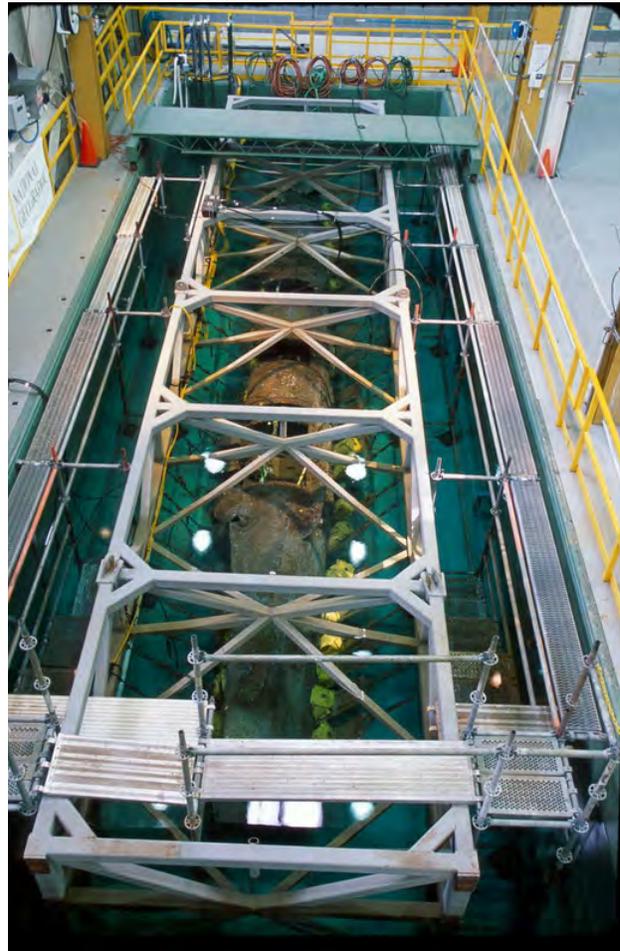
Figure 9.3. A view of the top of the frame in the chilled water tank. The wide openings provided by the vierendeel structure maximized diver access to the submarine during the recovery process. (Courtesy of FOTH)

The top chord plan utilized vierendeel panel openings, a structural style that eliminates cross bracing, to allow better access for the divers (Smith 2001) (Figure 9.3). Chevron braces along the sides were added to withstand lateral forces from currents, wind, and vessel motion, as well as horizontal forces from the gravity load of the submarine in the slings. The bracing design was so effective that the total displacement of

the bottom brace after the lift was 0.625 in. (1.59 cm) over 50 ft. (15.24 m) (Smith 2001). Ultimately, the frame could remain stable in a current of up to 2 knots or winds up to 100 mph (161 kph) and “withstand to 2 g vertically, 0.2 g longitudinally and 0.4 g laterally” (Smith

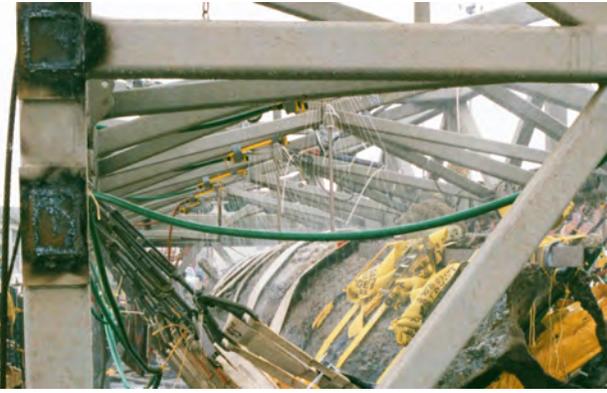
Figure 9.4. The soaker system designed to keep the hull wet during transport utilized ordinary sprinklers and pumped seawater. At left are the burn marks left from removing the bearing seats. (Photo by Rand Pixa, courtesy of FOTH)

To keep the submarine wet during transport to the laboratory, a soaker system was installed on the truss (Figure 9.4). While this system was relatively simple, consisting of ordinary lawn sprinklers installed along alternate cross braces, connected to hoses supplied with seawater, it was thorough and easy to install quickly. *Hunley* was out of water for a total of 9.5 hours, during which time it was never allowed to dry out.

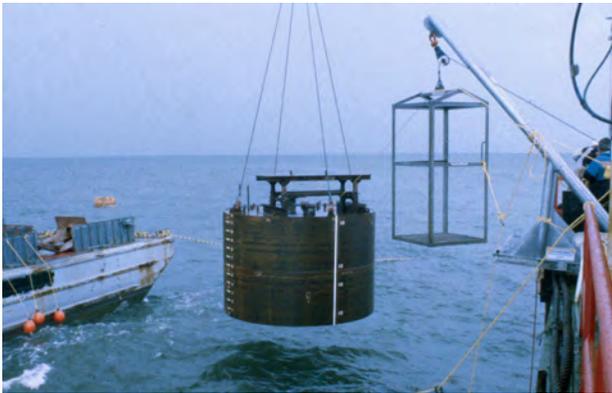
Figure 9.7. Fully rigged suction pile being lowered into the water. Depth markings can be seen down the side of the pile wall at left. (Courtesy of FOTH)

The suction piles were marked with depth indicators so they could be monitored by divers during the installation process. A dry land training exercise was performed with the recovery equipment so that potential problems could be anticipated and corrected. For installation, the caissons were rigged topside, then lowered by crane to the seabed and guided into place by divers (Figure 9.7). The seabed was prepared in advance, with an area approximately 20 ft. (6.1 m) in diameter and 5–6 ft. (1.52–1.83 m) deep excavated down from the mudline to receive the caissons, to ensure stability. The divers also monitored the evenness of pile caps and penetration rates during suction operations.

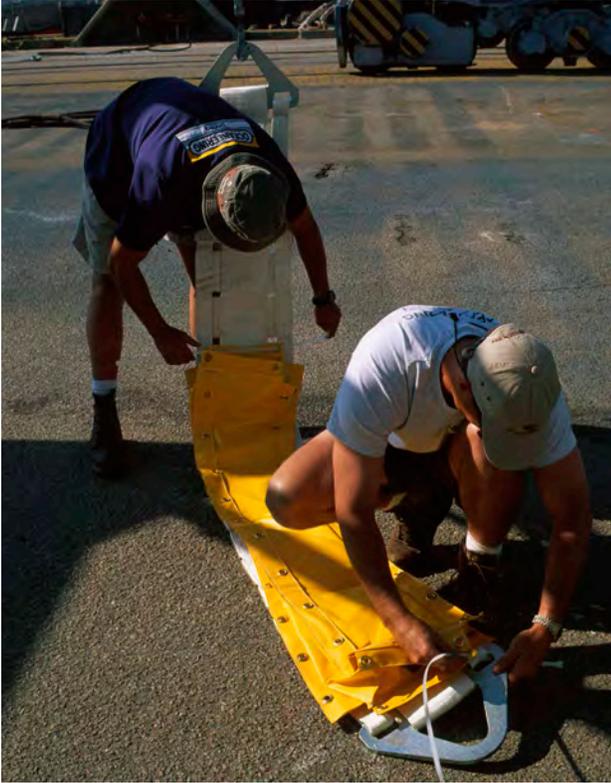
Figure 9.9. Members of the engineering team practice fastening a vinyl bag to a sling in land-based trials. (Courtesy of FOTH)

The tests proved the Froth-Pak product would work well in the conditions at the site. They then had to develop a delivery system to get the liquid foam in place against the hull before it began to harden, a window of only a few minutes. Vinyl bags were developed to contain the foam. They would cover the length of the side of the sling that would be in contact with the hull, and were attached to the slings with cable ties via grommets prior to filling (Figure 9.9).

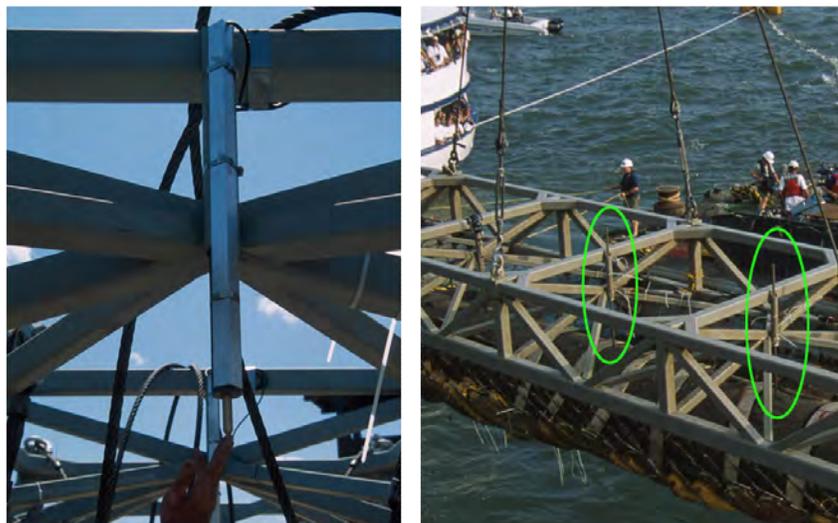
Figure 9.12. Linear variable displacement transducers (LVDTs), left, were planned for monitoring any longitudinal displacement of the hull. Two LVDTs were replaced with rods for manual monitoring (right). (Courtesy of FOTH)

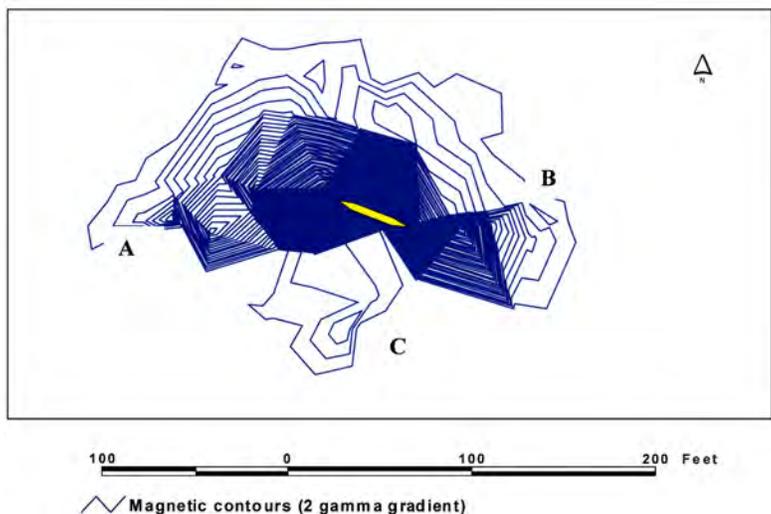
Figure 10.2. Magnetometer readings around the *Hunley* site. (Detail from Murphy 1998:60)

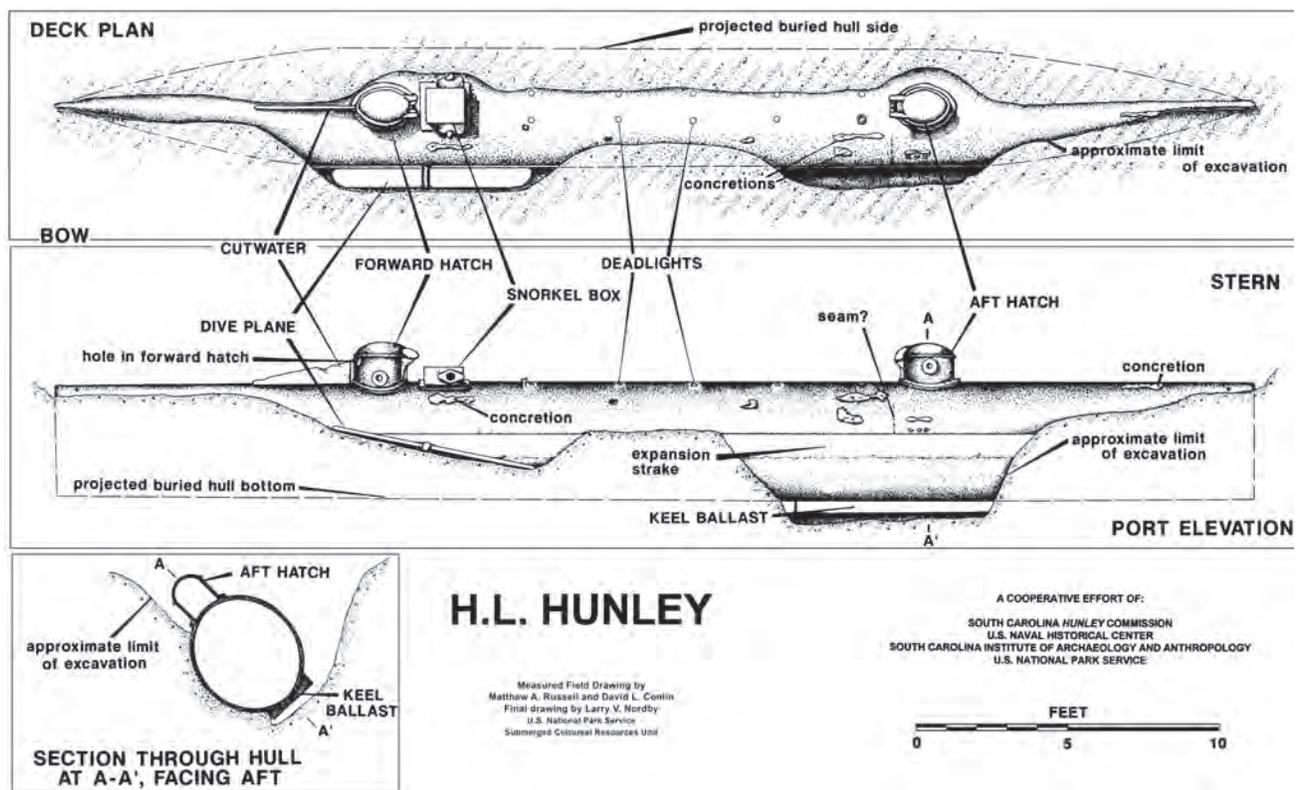
Figure 10.3. Site plan developed based on the 1996 investigation. (Murphy 1998:77)

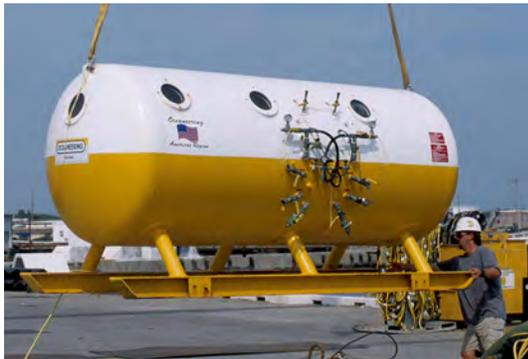
Figure 10.5. Hyperbaric chamber being readied for loading onto Marks Tide. (Courtesy of FOTH)

HAT divers followed the diving standards established by the American Academy of Underwater Sciences (AAUS) to ensure maximum protection of scientific divers from accidental injury and/or illness. The OII team adhered to the guidelines established by the Occupational Safety and Health Administration designed for to safeguard the U.S. commercial diving industry. In the event of a diving emergency, a double lock recompression chamber was on site at all times (Figure 10.5).

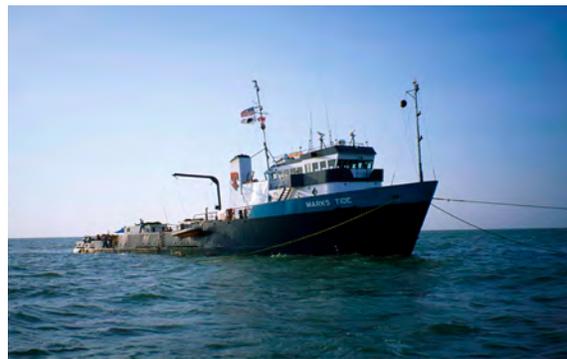
Figure 10.6. Marks Tide moored over the site. (Courtesy of FOTH)

During the first phase of excavation, dives were conducted from the 750 tn. (680 t) *Marks Tide*, a 180 ft. (54.86 m) supply ship owned by Tidewater Marine of

Amelia, Louisiana (Figure 10.6). It was moored over the *Hunley* site on a four-point mooring system and acted as the main base for diving support and dredging operations. This vessel allowed easy access to the water; divers could simply step off the deck into the water and return to the deck by climbing a ladder. Facilities included an air-conditioned trailer for the OII team, air compressors and dredge pumps for both dive teams, the

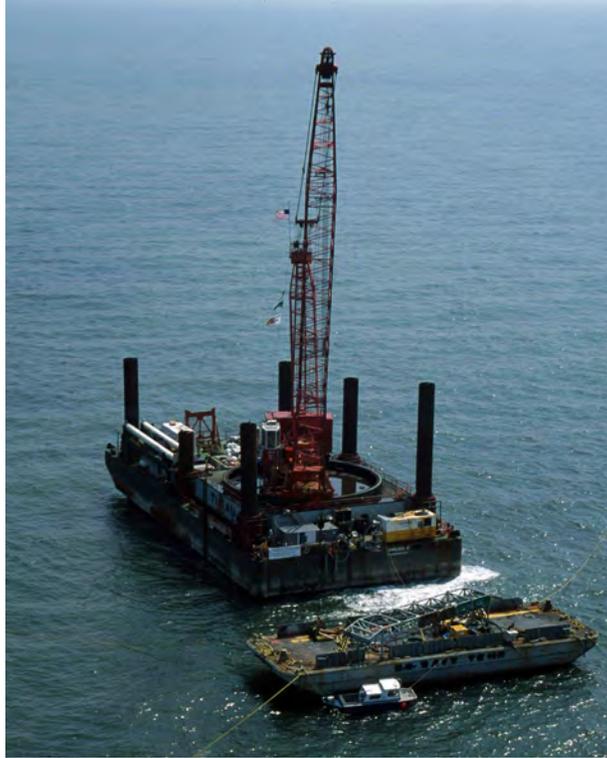
Figure 10.7. Karlissa-B in place over the site along with the supply barge, which housed the dredge pumps. The truss prior to installation is visible on the supply barge. Suction piles had already been placed on the sea floor. (Photo by Cramer Gallimore, courtesy of FOTH)

The second phase of excavation was therefore conducted from *Karlissa-B* (Figure 10.7), which was 170 × 80 ft. (51.82 × 24.38 m), and when jacked up above the water, had a deadweight capacity of 4,245 tn. (3,850 t). All portable equipment, including trailers, compressors, and pumps were relocated to this platform upon its arrival in July. With the deck of the vessel approximately 30 ft. (9.14 m) above the water, divers had to be lowered into and raised from the sea using a winch-operated lift platform, or stage. To keep the HAT and OII dredge pumps and water screens closer to the site they had to be placed on a separate supply barge.

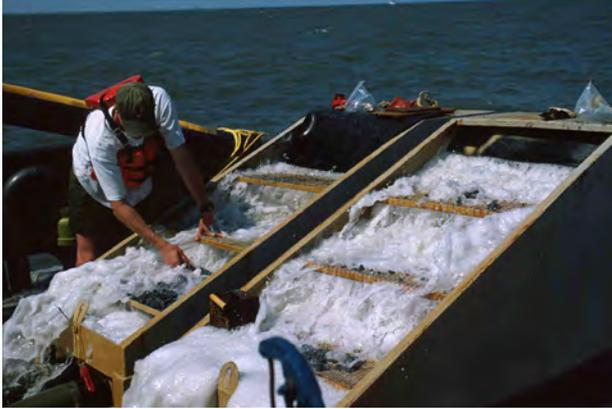
Figure 10.8. Sluice boxes designed by OII for screening dredge outflow had three tiers of increasingly smaller mesh. (Courtesy of FOTH)

OII used two custom-built 4 in. (10.16 cm) dredge systems to excavate. The dredge systems were powered by two jet water pumps joined together with a manifold to produce up to 1,000 GPM (3,785.4 LPM) of seawater at 200 p.s.i. (13.8 bar). Water from the high-pressure manifold was directed through two venturi devices called inductors, which use high-pressure water to create tremendous suction. The OII divers used two long 4 in. (10.16 cm) diameter rigid-walled hoses, connected to the suction end of the inductors, to excavate sand from the site. The output end of the inductors was connected to custom-built sluice boxes (Figure 10.8). Sand and water blasted into the top of the sluice box and then cascaded over three separate screens with graduated mesh diameters of 2.6 in. (6.6 cm), 1.7 in. (4.32 cm), and 1 in. (2.54 cm). One to two individuals monitored the screens for cultural materials at all times. Materials recovered were collected and placed in water in plastic bags and labeled with the corresponding dredge area. Non-cultural material was cleared from the screens and went into the bottom of the box, which drained overboard through two 6 in. (15.24 cm) rigid-walled hoses.

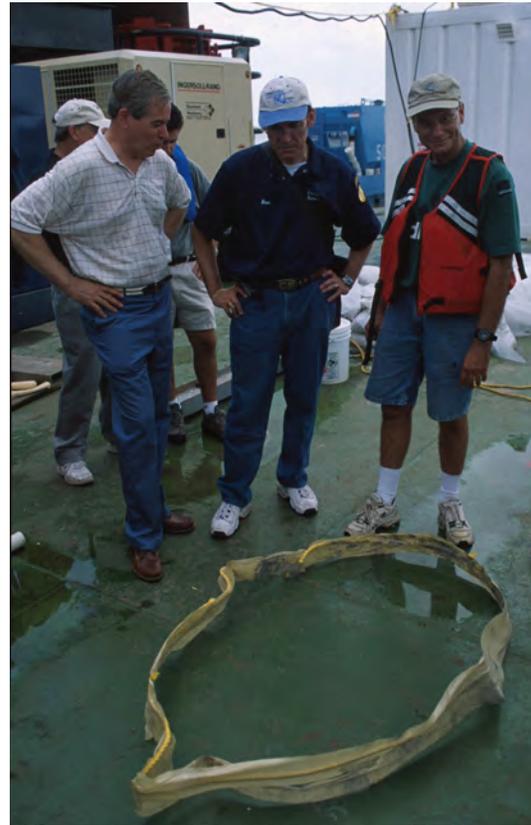
Figure 10.9. From left, Randy Burbage, Senator McConnell, and Robert Neyland examine fiberglass profile taken by divers. (Courtesy of FOTH)

To record the shape of the hull in situ, prior to each sling installation, archaeologists cast the exterior hull profile. The procedure consisted of encircling the hull with two layers of 4 in. (10.16 cm) wide resin-soaked fiberglass cloth from DuraPower Products Inc. (Pipe & Hose Repair Kit "Air" Activated Fiberglass Tape). After overlaying and tightening the two wraps with a piece of ⅝ in. (1.59 cm) three-strand polypropylene rope, another wrap was applied with a third piece of cloth. Once hardened, divers removed the fiberglass profile by making a single diagonal cut near the bottom of the submarine and lifting the profile off. Once on the surface, the profiles were reassembled and traced onto paper (Figure 10.9). Using a digitizing tablet, these tracings were entered into the computer drawing program AutoCAD.

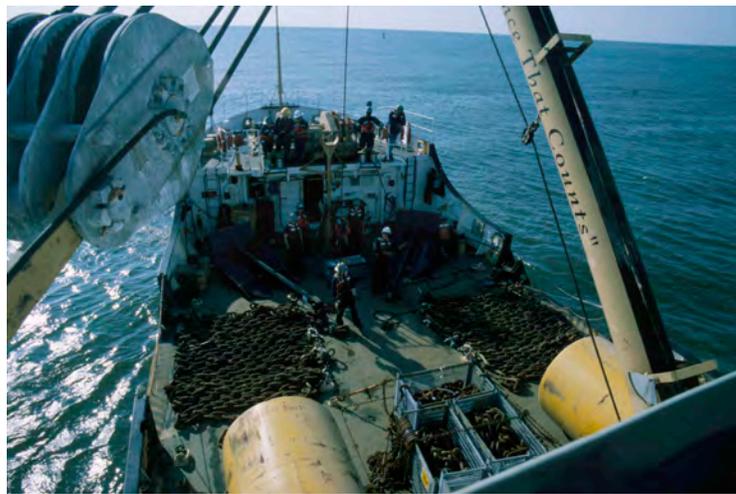
Figure 10.10. USCGC Madrona prepares to deploy the four mooring buoys used to secure Marks Tide safely without risk of damage to the site. (Courtesy of FOTH)

The first phase of operations involved delineating the site and establishing datum markers for mapping. Six yellow, 32 in. (81.28 cm) steel buoys were deployed from *Anita* to define the perimeter of a no-entry zone surrounding the *Hunley* recovery area. These buoys were marked with dusk-to-dawn yellow flashing lights and elevated aluminum radar reflectors. Four large mooring buoys were also put in place by the U.S. Coast Guard in preparation for the arrival of *Marks Tide* (Figure 10.10).

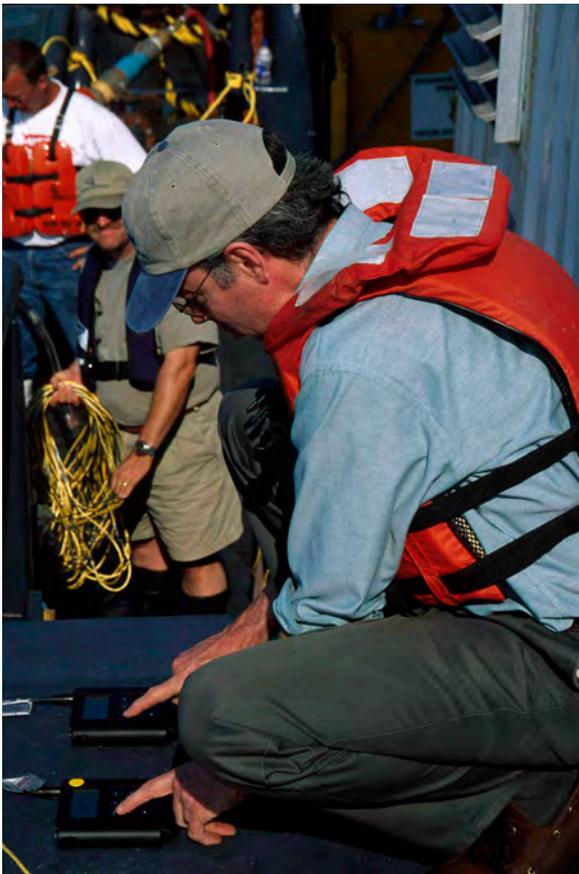
Figure 10.12. Steve West monitors instruments during corrosion potential studies conducted at the beginning of the excavation. (Courtesy of FOTH)

West performed the ORP measurements by modifying flat-surface, combination platinum probes (6.25 mm/0.25 in. diameter) to operate underwater. HAT divers cleared concretion from small areas of the hull surface using a hammer and chisel to reveal the iron plate surface; these areas were relatively smooth, but were not polished to remove corrosion and create a clean metallic surface as they had been for the ultrasonic thickness measurements. Two divers each placed one probe at different points on the hull surface, and West operated the pH/mV meter on the boat deck

and directed the team through voice communication, while other personnel handled the cables leading from the meter to the underwater probes (Figure 10.12). The divers first held Probe 1 at the bow and Probe 2 at the stern. After stable readings were attained, they reversed the positions of the probes, resulting in identical readings. They usually had to gently move the probe around on the hull surface until a stable reading was attained, indicating that contact between the probe and hull was not optimal, even though the flat-surface probes were of a small diameter. The dive team was successful in recording several readings. West determined from these readings that the corrosion potential at the bow of *Hunley* was -379 ± 2 mV vs normal hydrogen electrode (NHE), while that at the stern it was between -320 and -363 mV vs NHE.

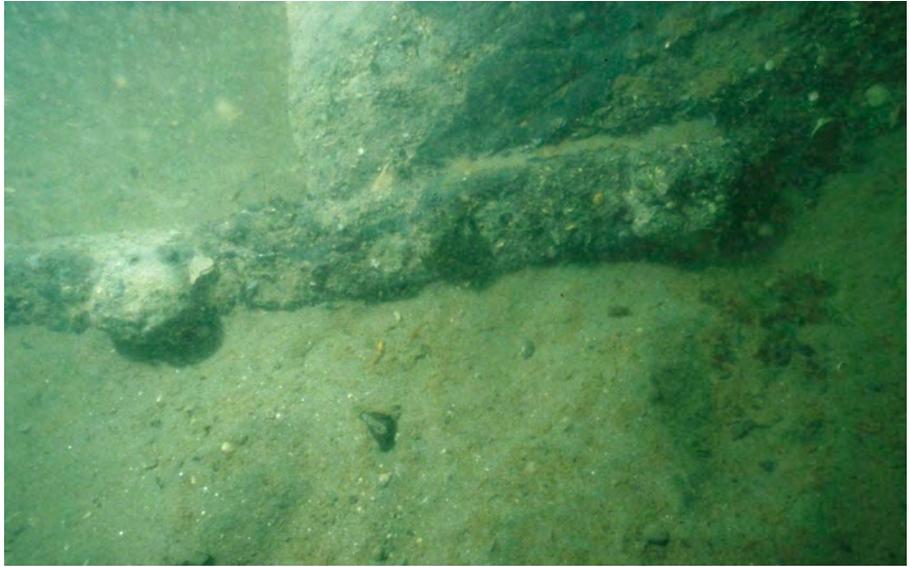
Figure 10.13. The torpedo spar in its original position attached to Hunley's bow. (Courtesy of FOTH)

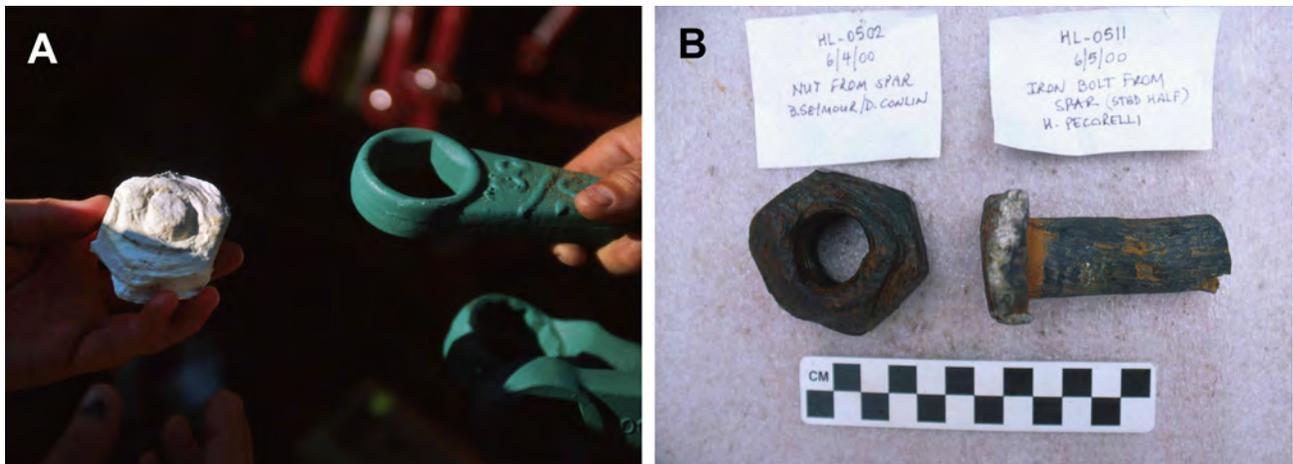
Figure 10.14. Mold of bolt (A) and recovered bolt (B) used to attach spar to main body of the hull. (Courtesy of FOTH)

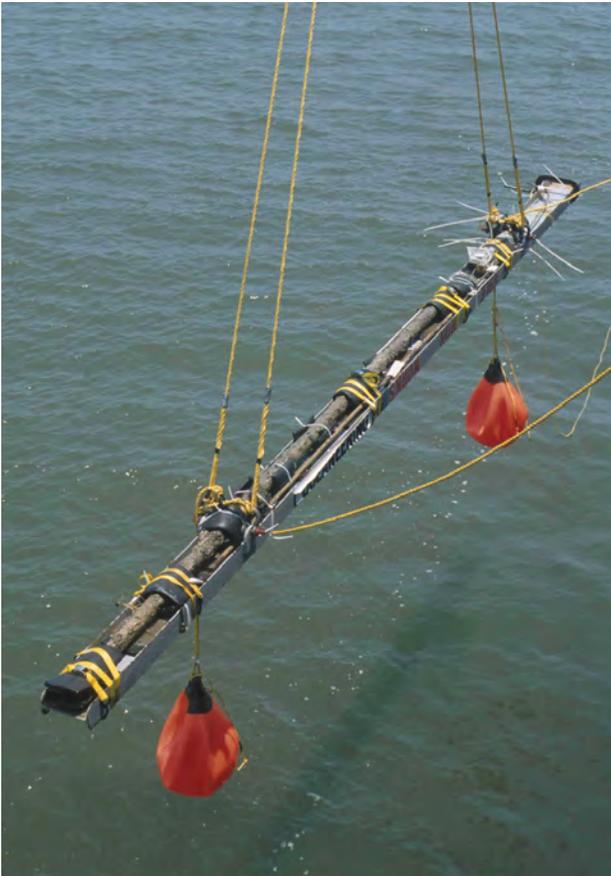
Figure 10.15. Hunley's torpedo spar was removed from the bow and raised separately to protect it from damage. (Courtesy of FOTH)

the seabed, where divers positioned it alongside the artifact to minimize the distance it had to be moved. The metal of the spar had completely corroded through in some places, revealing that, with the exception of the first few feet from the yoke, it was tubular rather than solid. The worst corrosion was found approximately 80 cm (31.50 in.) from the tip, where the connection was too tenuous to survive a change in position. Therefore the distal end was lifted separately. Both sections were placed in the cradle, which was then moved to the starboard corner of the excavation area and left on the sea bottom safely out of the way of ongoing dredging operations. Neoprene padding was secured to the spar with cable ties and plastic bags were placed over the hollow ends to help preserve them and to keep supporting mud in place. A long metal rod (HL-0463) that had also been discovered on the site was placed in the cradle as well, and the whole load was secured in place with ratchet straps. On 13 June, the spar was raised. A Charleston Harbor Pilot boat came alongside the *Marks Tide* and the first major component of the submarine was lowered onto the deck and safely transported to the WLCC (Figure 10.15).

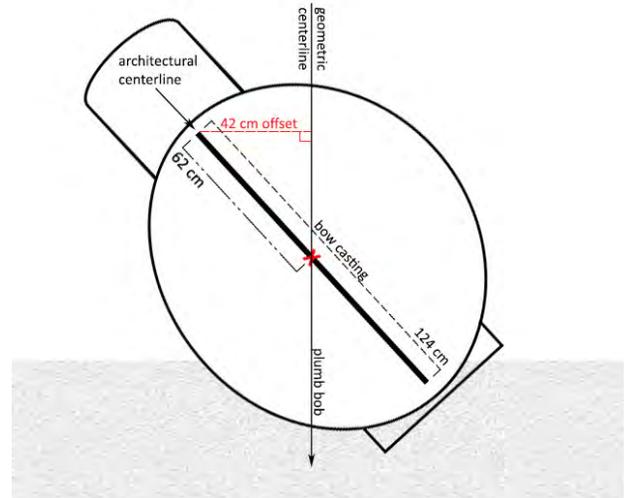
Figure 10.16. Measurements taken to determine the geometric centerline of the hull as it lay on the seabed. (Diagram by H. G. Brown, NHHC)

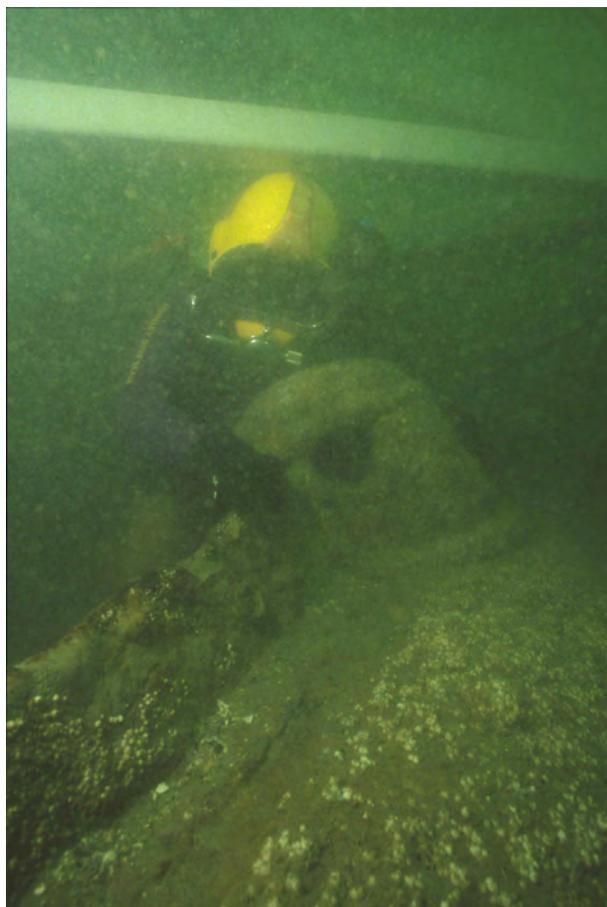
Figure 10.18. Diver working around the forward conning tower with truss beams directly overhead. (Courtesy of FOTH).
