H. L. Hunley
Recovery Operations

A Collaborative Project of:
Naval History and Heritage Command,
South Carolina Hunley Commission,
and
Friends of the Hunley

Principal Investigator:
Robert S. Neyland, Ph.D.
Department of the Navy

Naval History and Heritage Command
Washington, D.C.
2016

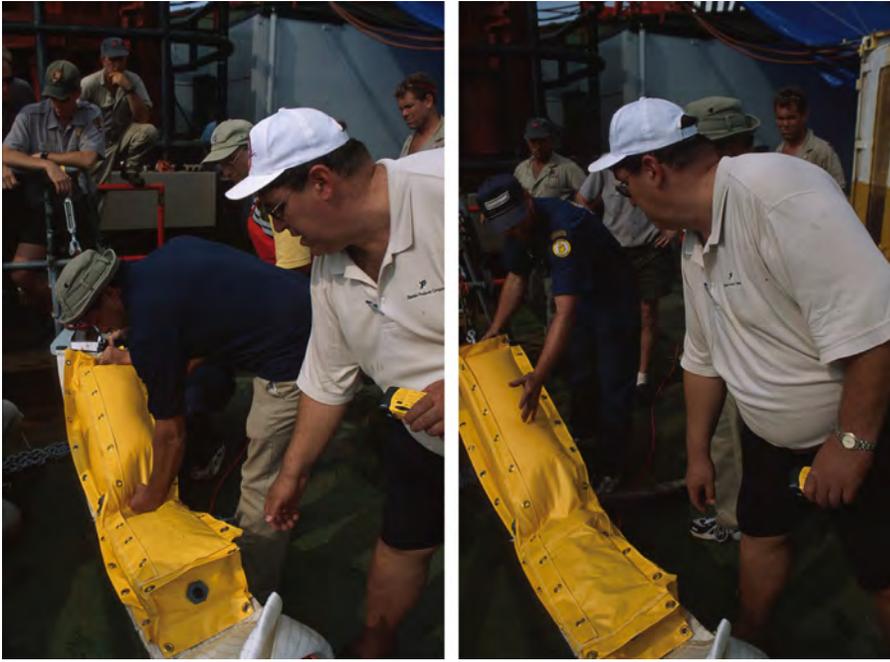
Figure 10.19. Bill Youmans, Michael Gatto Jr., and Mark van Emmerick demonstrate the foam setting up around an object. (Courtesy of FOTH)

Following the profile casting, OII divers placed the slings for that section beneath the submarine and secured them loosely to the turnbuckles on the truss. Next, vinyl bags cable-tied to the inner surface of the lifting slings were injected with expandable foam, which, when filled, fit the submarine's lower exterior contour perfectly (see Chapter 9). Bill Youmans of Flexible Products and Michael Gatto Jr. of NCS Supply were on board the *Karlissa-B* during the initial foaming process to ensure all went smoothly (Figure 10.19). The foam set up in approximately two minutes. Once the foam was in place, the OII team then began tensioning the lifting sling. An OII engineer monitored the computer load-cell display from *Karlissa-B* and directed OII divers as they tightened the turnbuckles in accordance with the load distribution plan devised by Perry Smith.

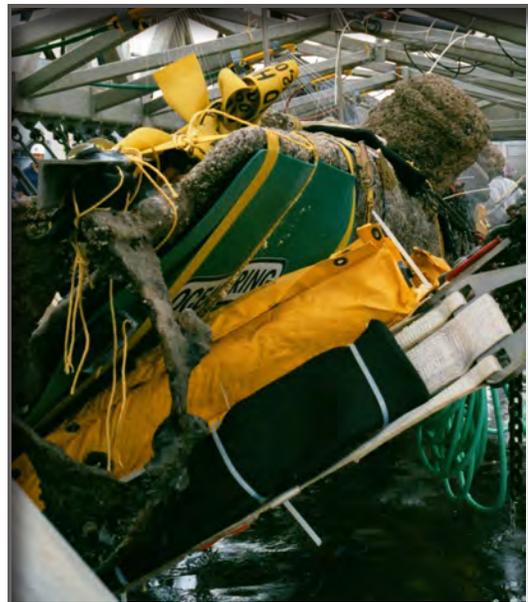
Figure 10.20. A patch was placed over the starboard stern hole to ensure no loss of interior contents. (Photo by Rand Pixa, courtesy of FOTH)

spanned several sling stations and required patching before the slings could be set. It was covered with a large neoprene pad, which was held in place by four 6 in. (15.24 cm) wide ratchet straps. A strongback of angle iron was placed along the port side near the top to hold the ratchets away from the hull surface. The strongback extended aft beyond the stern to provide additional protection and rigging support to the propeller shroud (Figure 10.20). When the patch was complete, the slings were filled and tightened in place. The two smaller holes were patched after the slings were in place, the bow hole with neoprene and the conning tower with filled with expandable polyurethane foam. The slinging process was completed on 4 August. A total of 32 slings supported the submarine.

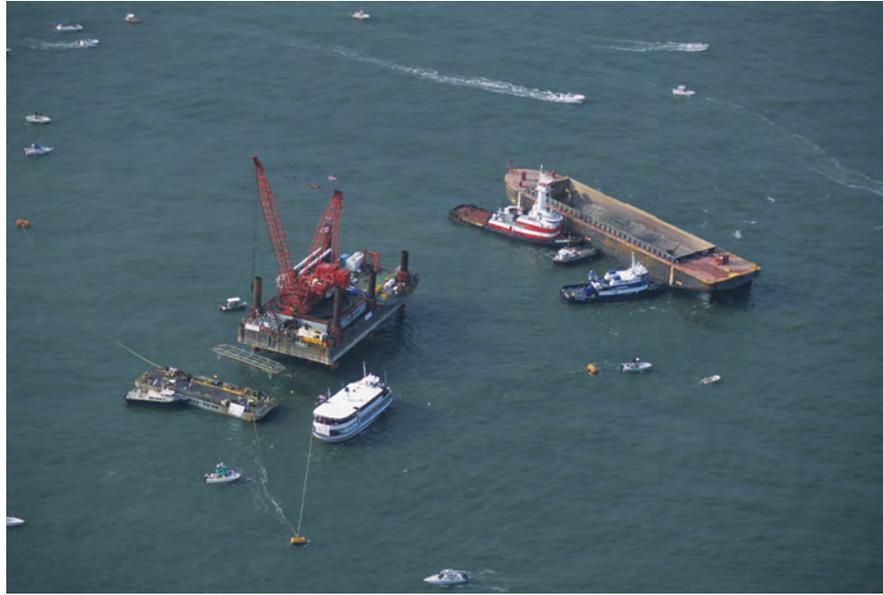
Figure 10.21. Aerial view of the raising of Hunley, showing disposition of vessels around *Karlissa-B*. (Photo by Cramer Gallimore, courtesy of FOTH)

The large hopper barge from Great Lakes Dredging was towed to site and held in position by the two tugs (Figure 10.21). However, it also became apparent that the 102 ft. (31.01 m) long *Spirit of Charleston*, which was stationed very close to the recovery barge, would act as a breakwater as well. The interagency security team, including the 87 ft. (26.52 m) USGC cutter *Yellowfin*, established a perimeter around the site. The security zone proved necessary as the number of private boats, including kayaks and jet skis, was estimated at 600 vessels.

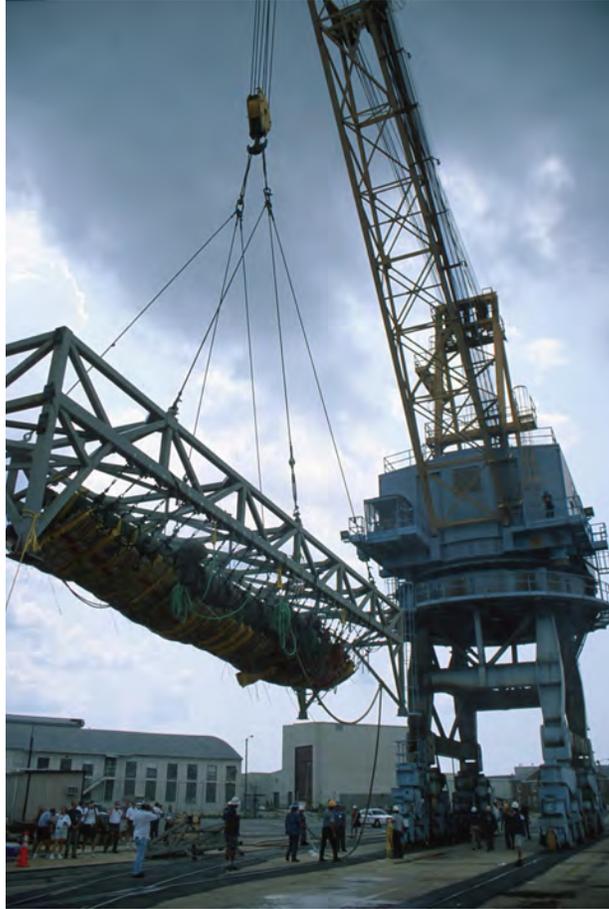
Figure 10.24. H. L. Hunley on its final leg of the journey, carried by rail-based portal crane to the WLCC. (Courtesy of FOTH)

set to work removing the bearing seats from the truss with a cutting torch in preparation for its placement into the tank. With the truss prepared, it was lifted by one of the shipyard portal cranes and carried to the WLCC, where it was transferred to an overhead crane inside the conservation building (Figure 10.24). The truss was then lifted, carefully positioned over the tank, and slowly lowered inside. The submarine was safely in the tank by 6:15 P.M. and Mardikian immediately began filling it with water. From recovery to placement in the tank, transport had lasted a total of 10 hours. Once inside the tank, the rigging was removed from the truss and the tank filling sequence was initiated. Conservators ensured hull was kept wet during the four hour procedure. Over the next 24 hours the tank water was chilled from 20° C (68° F) to 10° C (50° F). The only period the submarine had not been kept wet was during the transfer from the pier to the laboratory tank.

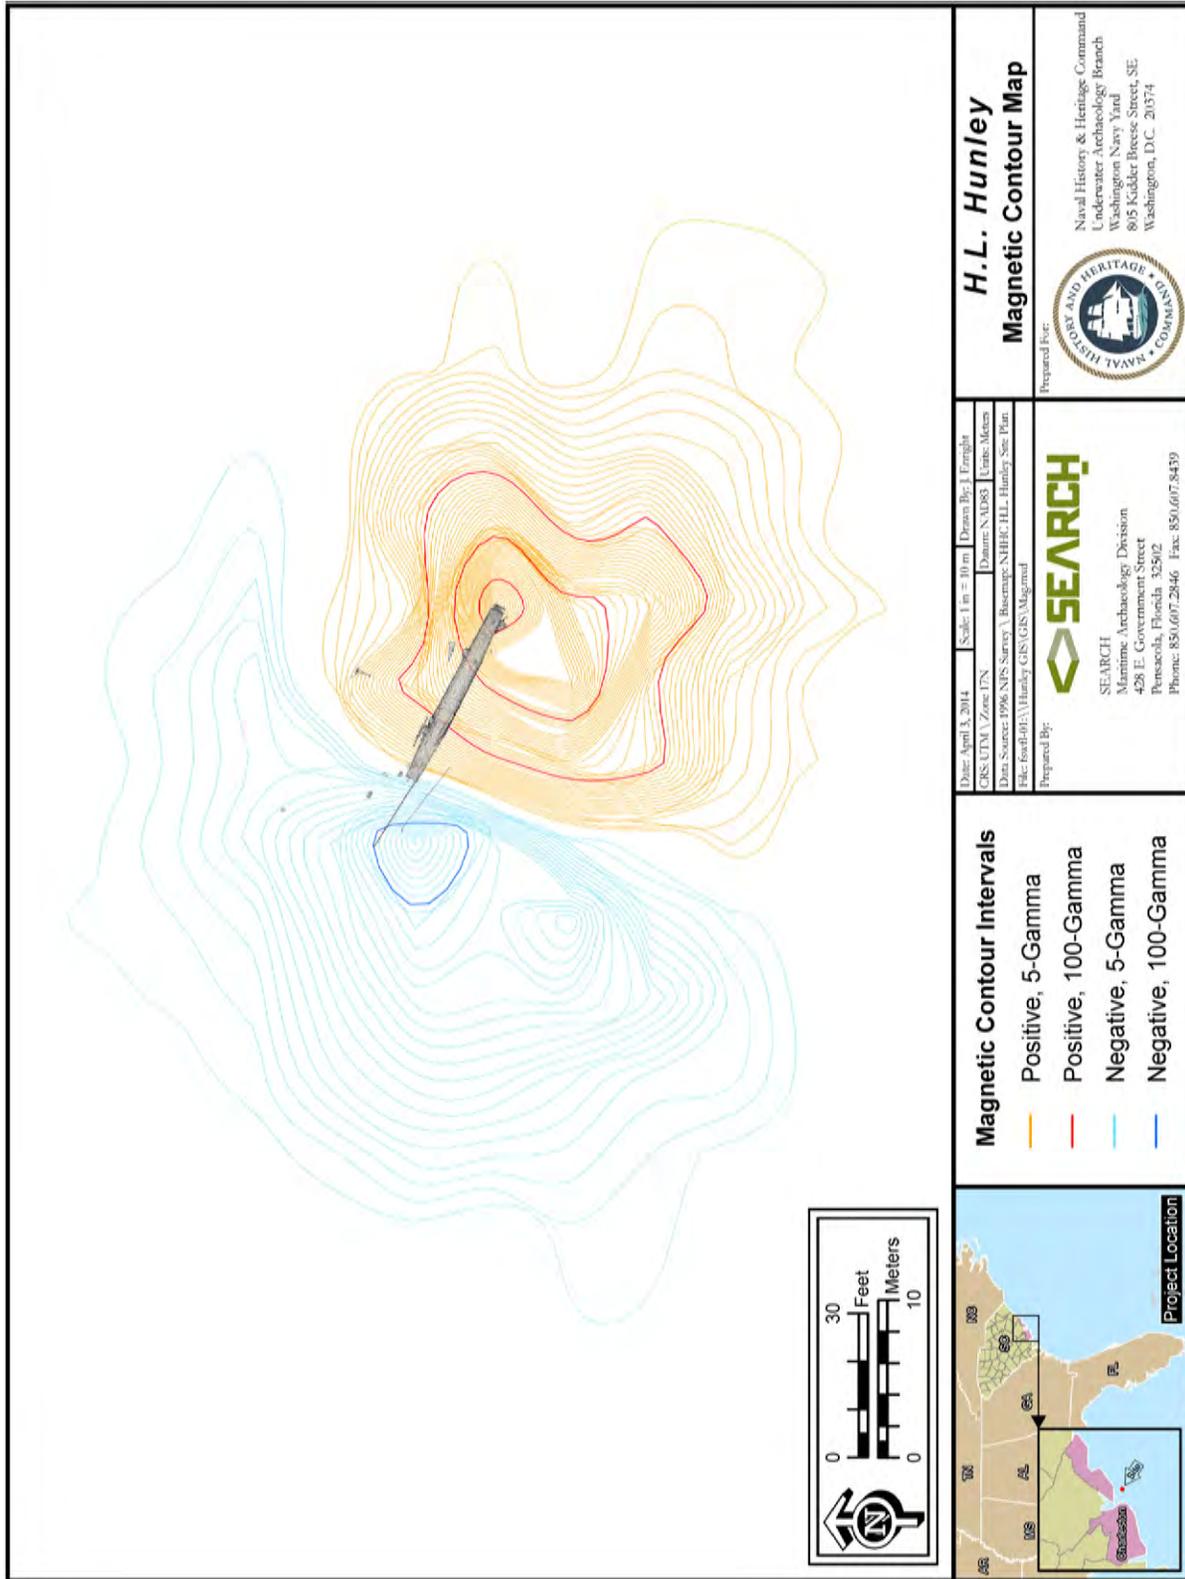
Figure 11.2. Magnetometer data from 1996 overlain on the post-recovery site plan. Deeply buried material, such as the grapnel anchor and cutwater, did not show distinctive signatures in the shadow of the readings from the hull.

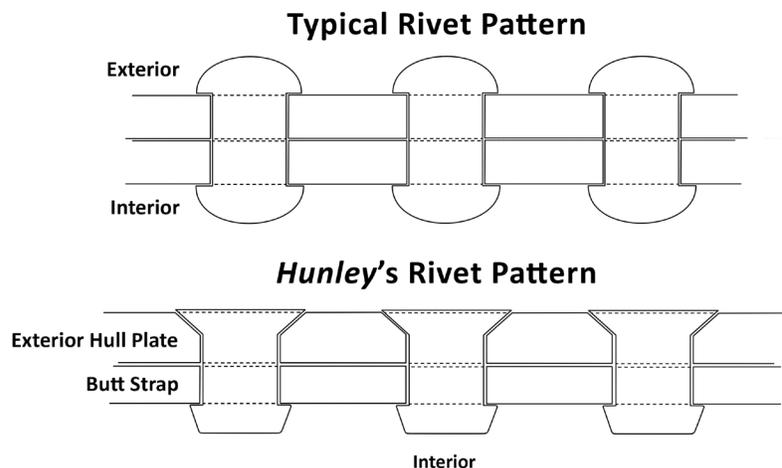
Figure 12.3. Diagram of the riveting style used on *Hunley* compared to the more standard industrial riveting method common at the time.

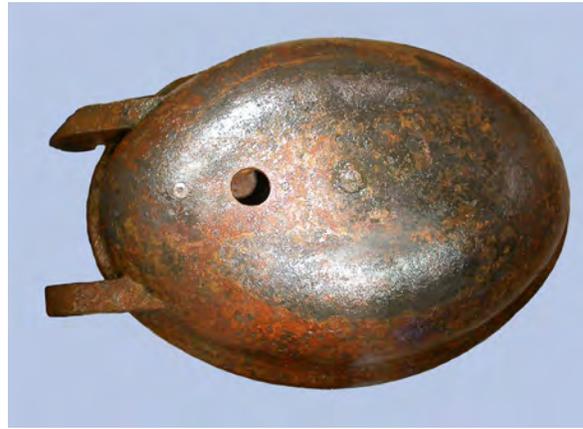
Figure 12.5. Top of aft hatch cover after deconcretion. The glass from the deadlight was removed and conserved separately. (Photo by Johanna Rivera, courtesy of FOTH).

The hatch covers are shallowly dome-shaped and fit inside the hatch coaming, sealing closed over a rounded lip. Both hatches open toward the center of the submarine’s crew compartment. The aft hatch cover is 56.7 cm (22.32 in.) in length, 38.5 cm (15.16 in.) wide, and ranges from 12 to 15 cm (4.72–5.91 in.) high. *Hunley*’s builders placed a single glass deadlight in each hatch cover, along the centerline, but closer to the hinged side, centered approximately 18 cm (7.09 in.) from the hinged edge (Figure 12.5). Two hinge arms, part of the casting, extend from the cover, approximately 16 cm (6.30 in.) apart, and align with two hinge arms cast into the coaming. The hatches were secured from the inside, with no external latch or handle.

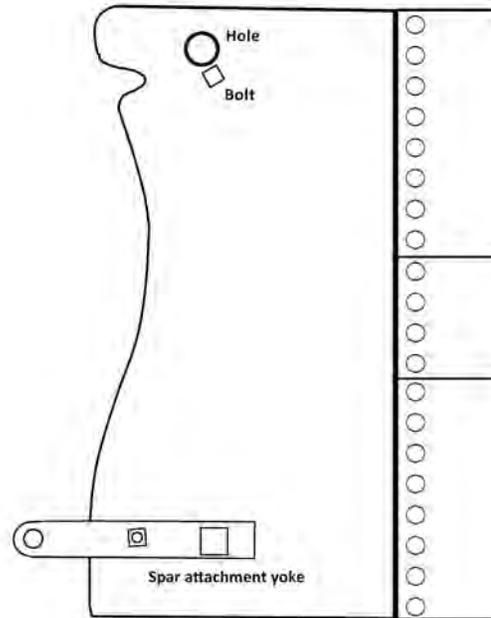
Figure 12.6. Portside view of the bow casting, showing deterioration of leading edge (rivet spacing approximate). (Diagram by Mari Hagemeyer, NHHC).

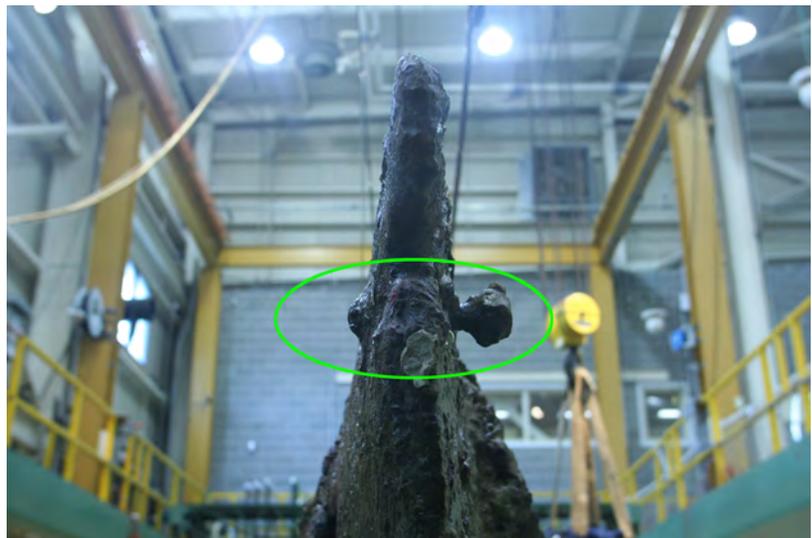
Figure 12.7. A substantial bolt laterally penetrates the bow casting. (Photo by H. G. Brown, NHHC).

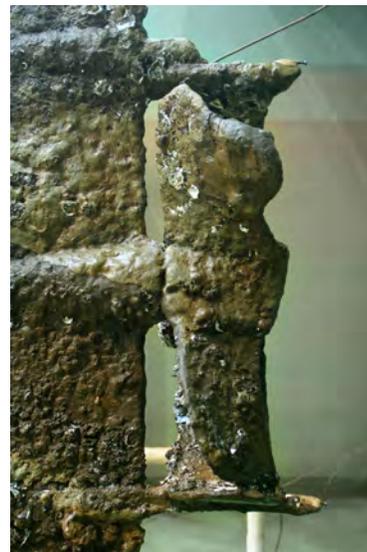
Figure 12.11. Propeller as exposed by loss of the port side of the shroud. The brackets holding the shroud also provided mounting points for the rudder. (Photo by H. G. Brown, NHHC)

Seven of the submarine's eight-man crew turned an iron crankshaft attached to a roughly 69 cm (27.165 in.) diameter, three-bladed cast-iron propeller. The blades had a maximum width of approximately 19 cm (7.48 in.) and a thickness of 2–3 cm (0.79–1.18 in.). An iron shroud originally surrounded the propeller, of which only just over half survives, primarily on the starboard side. It measures approximately 20 cm (7.87 in.) wide and 1.5 cm (0.59 in.) thick, with a diameter of approximately 76.6 cm (30.16 in.). The shroud was mounted to the stern casting with a pair of Y-shaped yokes similar to, but smaller than, the one used to secure the spar to the bow casting. The dimensions of the arms, as estimated through the heavy layer of concretion, are 20 cm (7.87 in.) long and 5 cm wide (1.97 in.). The yoke arms meet aft of the stern casting and extend into a flat, horizontally-oriented iron bar or bracket, approximately 6 cm (2.36 in.) wide and 2 cm thick (0.79 in.), to which the shroud was fastened. The end of each shroud bracket continued beyond the after edge of the shroud to provide a means for mounting the rudder (Figure 12.11). Only the lower mounting point appears to have survived, though this will be clearer once the conserva-

tion phase is completed. The surviving portion of the upper bracket extends 27.5 cm (10.83 in.) beyond the after edge of the stern casting, while the lower bracket extends 30 cm (11.81 in.).

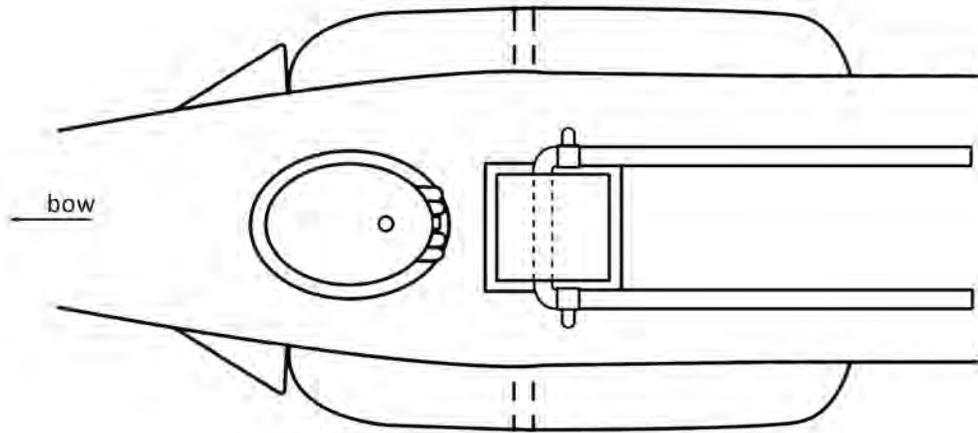
Figure 12.13. Idealized plan view showing position of diving planes and their protective skegs, in addition to the forward conning tower and snorkel box. (Diagram by Mari Hagemeyer, NHHC).

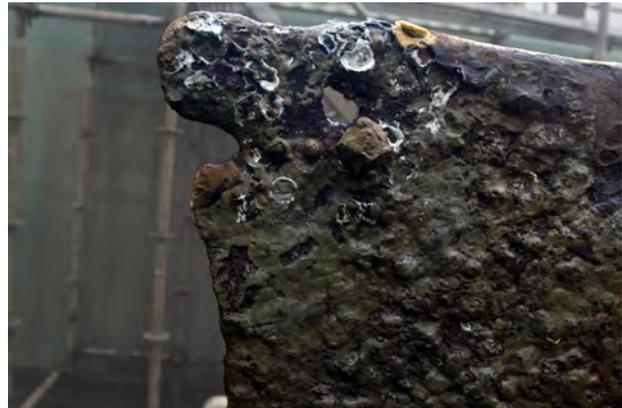
Figure 12.16. Horse oyster shells can be seen at the top of the port side of the bow casting, but the area below has been worn smooth by hydrodynamic forces. (Photo by H. G. Brown, NHHC).

Large areas of the hull were also covered with marine growth, the most distinctive being the white remains of colonies of star coral (*Astrangia danae*) and the horse oyster (*Ostrea equestris*) (Murphy 1998:150–51). The upper areas preserved more evidence of colonies growing on the hull itself, while the lower areas, in the region of the Pleistocene mud layer, were covered in a thick shell/mud conglomerate. A few areas were relatively smooth with minimal shell coverage, such as portions of the bow casting (Figure 12.16). This apparent lack of colonization may be the result of high energy water flow during the period prior to the vessel's burial (see Chapter 13).

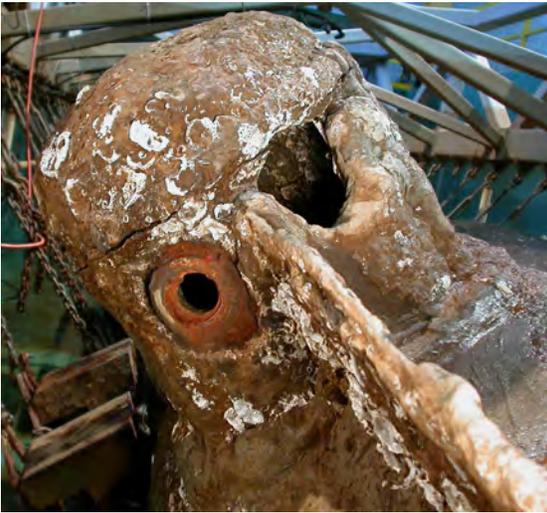
Figure 12.17. Hole in the forward conning tower encompassing the total loss of the port viewport (Courtesy of FOTH).

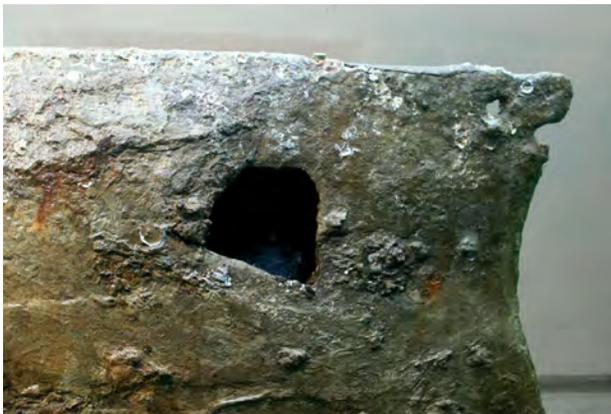
Figure 12.18. Hole in bow, along boundary between wrought- and cast-iron components. Deterioration of the leading edge of the casting is also visible at right. (Photo by H. G. Brown, NHHC).

The other two holes are located along the starboard side, one near the bow, one near the stern, both in the vicinity of the boundary between the cast-iron ends and the wrought-iron plates. These appear to have developed after the submarine had settled into its final position, as a result of a complex interaction of erosion and corrosion processes (see Chapter 13). The bow hole

is trapezoidal in shape, measuring 27.4 cm (10.79 in.) at its widest point and 26.6 cm (10.47 in.) high (Figure 12.18). It begins 26.5 cm (10.43 in.) from the top of the hull, and 57.7 cm (22.72 in.) aft of the surviving edge of the bow casting.

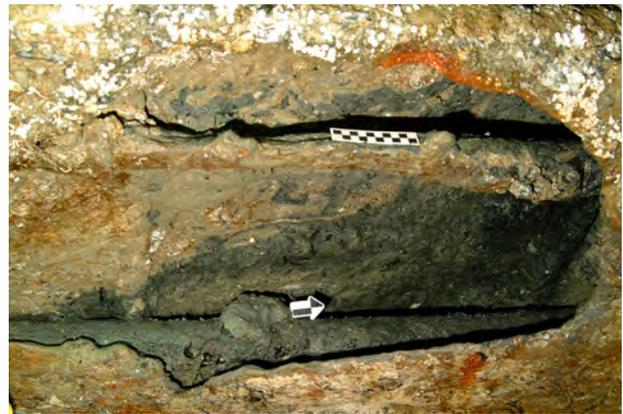
Figure 12.19. The largest hole was at the stern near the top, crossing the boundary between the wrought- and cast-iron components, causing the loss of several rivets and exposing the steering rod. (Courtesy of FOTH)

The stern hole is somewhat ovoid in shape, beginning 3 cm (1.18 in.) down from the top of the vessel and 32 cm (12.60 in.) forward of the after edge of the stern casting (Figure 12.19). It measures approximately 90 cm (35.43 in.) at its widest point with a maximum vertical expanse of 50 cm (19.69 in.). It crosses the boundary between the stern casting and the aftermost starboard top quarter plate. The steering rod can be seen through the upper third of the opening, running horizontally along the vessel's centerline.

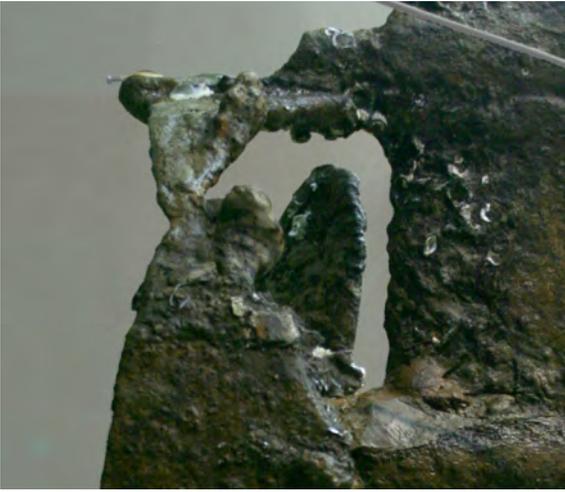
Figure 12.20. Damage to the top starboard quarter of the propeller shroud. (Photo by H. G. Brown, NHHHC).

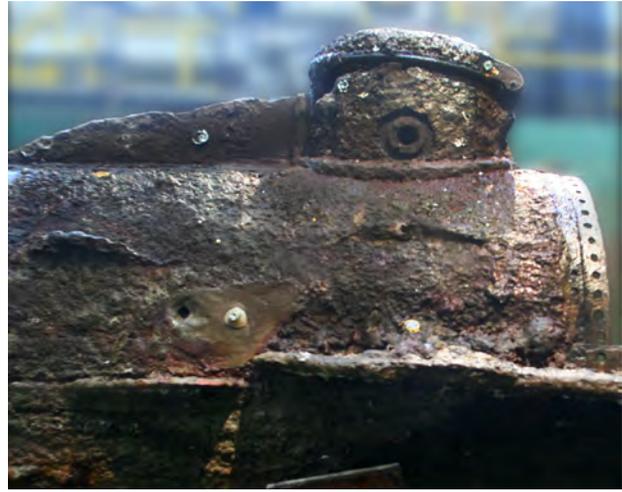
Figure 12.21. The port side diving plane is in a slightly raised position. (Photo by H. G. Brown, NHHHC).

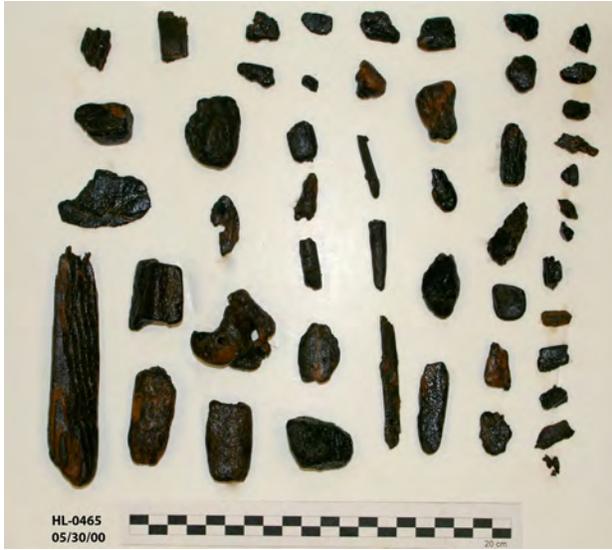
Figure 12.22. Sample of a wood lot collected from dredge outflow during the excavation. This material did not prove diagnostic. (Photo by H. G. Brown, NHHHC).

The wood fragments consisted of a combination of naturally occurring branches and sticks, along with heavily weathered or eroded fragments that appear to have been part of man-made objects (Figure 12.22). Of this material, none could be linked directly to the submarine. Harbor outflow may account for much of the material. Several larger wooden pieces were found closer to the submarine, including a barrel cant (HL-0587), which represent material culture, but could not be tied directly to the submarine.

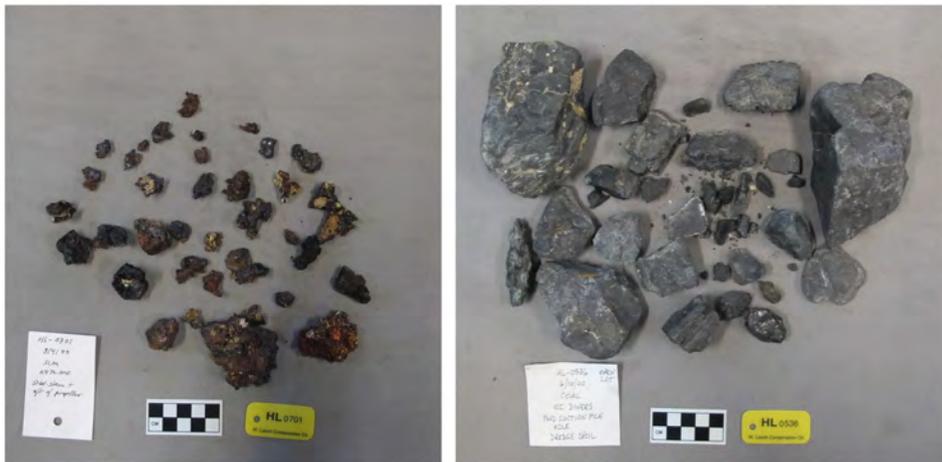
Figure 12.23. Typical collection of slag (left) and coal (right) collected from sediment surrounding Hunley. (Photos by H. G. Brown, NHHHC)

Coal and coal slag were found in abundance around the site (Figure 12.23). This material was collected from the dredge outflow, weighed and counted. While it did not originate from *Hunley* itself, some may have been transported from the nearby *Housatonic* wreck. The material varied greatly in size, and, in the case of slag,

density. The distribution of this material was plotted and compared to other environmental data to help reconstruct the post-depositional processes affecting the site (see Chapter 13). The most noticeable clusters of coal and slag were found under the propeller and immediately to starboard, at the very bow down around the spar, and along the starboard forward quarter, particularly below the hole in hull. Some was even found inside the hull, carried in with the rest of the sediment as the interior gradually filled.

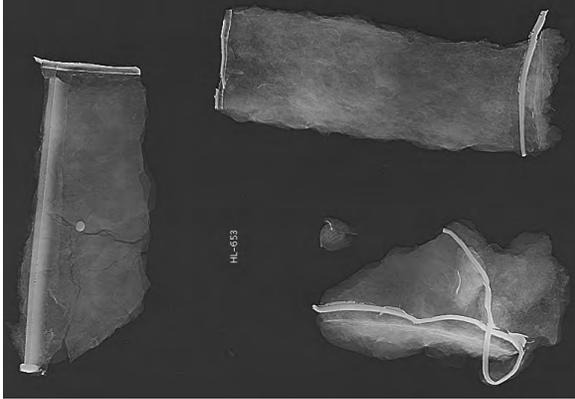
Figure 12.24. A radiograph of HL-0653, showing diagnostic seams that confirm identification as a tinned iron can. (Courtesy of FOTH).

At least sixteen lots of iron fragments can be confirmed as cans, primarily due to shape and the presence of lead solder, a common component of cans until the late 20th century (Table 12.2).¹ Seven of these were found through radiography to be complete or nearly complete: HL-0427, HL-0653, HL-0654, HL-0700,

HL-3288, HL-3667, and HL-3678 (Figure 12.24). Fifteen additional lots consisting of small fragments and no lead have also been classified as cans based on their shape and texture, but no diagnostic features remain. While this material is not directly related to *Hunley*, as with the coal and slag, an examination of the distribution of the cans has contributed to a reconstruction of the post-depositional processes at the site (see Chapter 13).

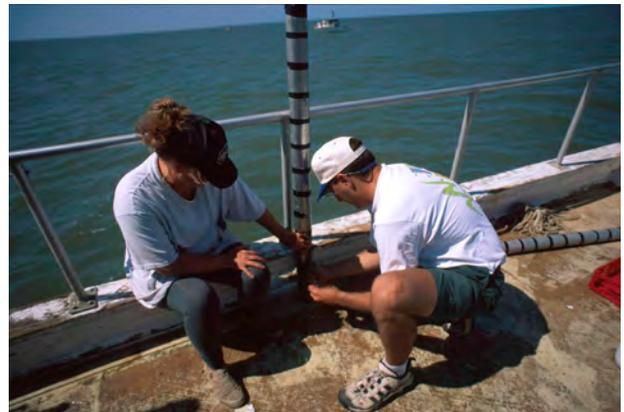
Figure 13.2. Drs. Pam Morris and Scott Harris prepare cores for sampling. (Courtesy of FOTH)

Each pound core was collected by the following method: project staff utilizing surface-supplied or scuba diving equipment used weighted slide hammers to drive standard 3 in. (7.6 cm) aluminum irrigation pipes into the seafloor. Water-extraction holes drilled at equal intervals along each aluminum pipe were covered with Teflon tape to reduce sample contamination; black plastic tape was placed over these holes to increase the overall strength of the device during the coring process (Figure 13.2). A core catcher was installed at the base of each tube to hold sediment in place while the tube was removed from the seafloor and lifted through the water column to the deck of the research vessel.

Rivets were drilled to release the core catcher, and sediment was extruded onto a plastic gutter for sample collection. Samples were taken from the base of the core first; subsequent material was obtained from each successive overlying sediment layer. The distance from the base of the core to the sediment-water interface was calculated as follows: the total core length was established as the bottom depth and the “zero” depth marker coincided with the seafloor. Water samples were collected from each pound core with a sterile syringe and placed in sterile Nalgene containers. Bacteriological samples are extremely sensitive to outside contamination; consequently, these specimens were collected from each core prior to the textural analysis sampling process. This ensured that no additional contamination of sediment by oxygen and/or bacteria occurred while each core was being sampled in the field.

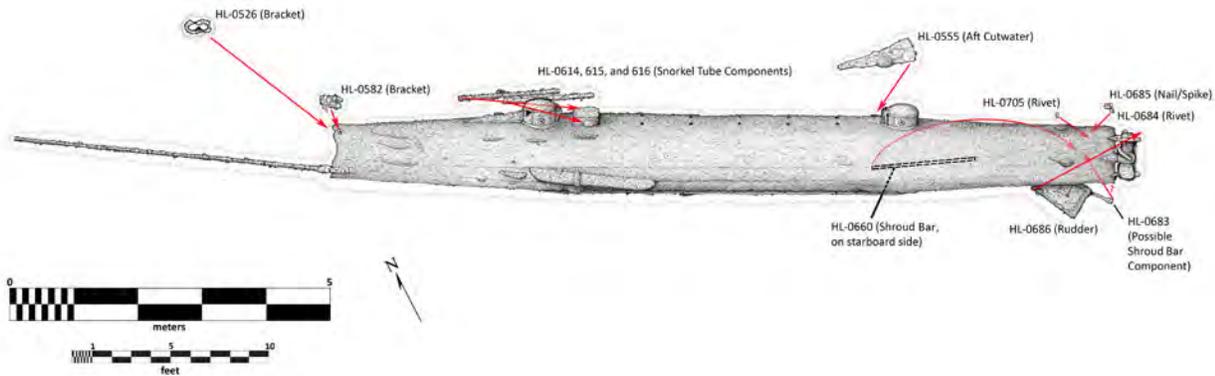
Figure 13.11. Site plan showing locations of the disarticulated components, with red arrows indicating their point of origin. Due to the steep cant of the wreck, the shroud attachment bar (HL-0660) appears to be beneath the hull in this view. (Site plan by James W. Hunter III, annotated by H. G. Brown, NHHC)

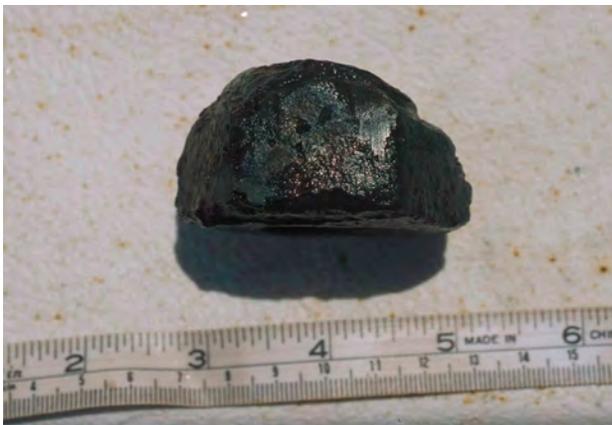
Figure 13.12. Erosion is evident on the outer surface of the nut that connected the spar to the hull at the base of the bow casting on the port side. (Courtesy of FOTH)

The hull itself showed significant areas of metal loss that are directly tied to the flow of water and suspended sediment around it. The leading edge of the bow casting, formerly a straight vertical edge, was worn into a scallop shape. Even the nut holding the spar on to the bow was heavily worn (Figure 13.12), attesting to the strong flow along the port side of the bow. The skag in front of the port diving plane was also somewhat eroded, and it is possible the diving plane itself was pushed upward out of horizontal alignment from the currents flowing

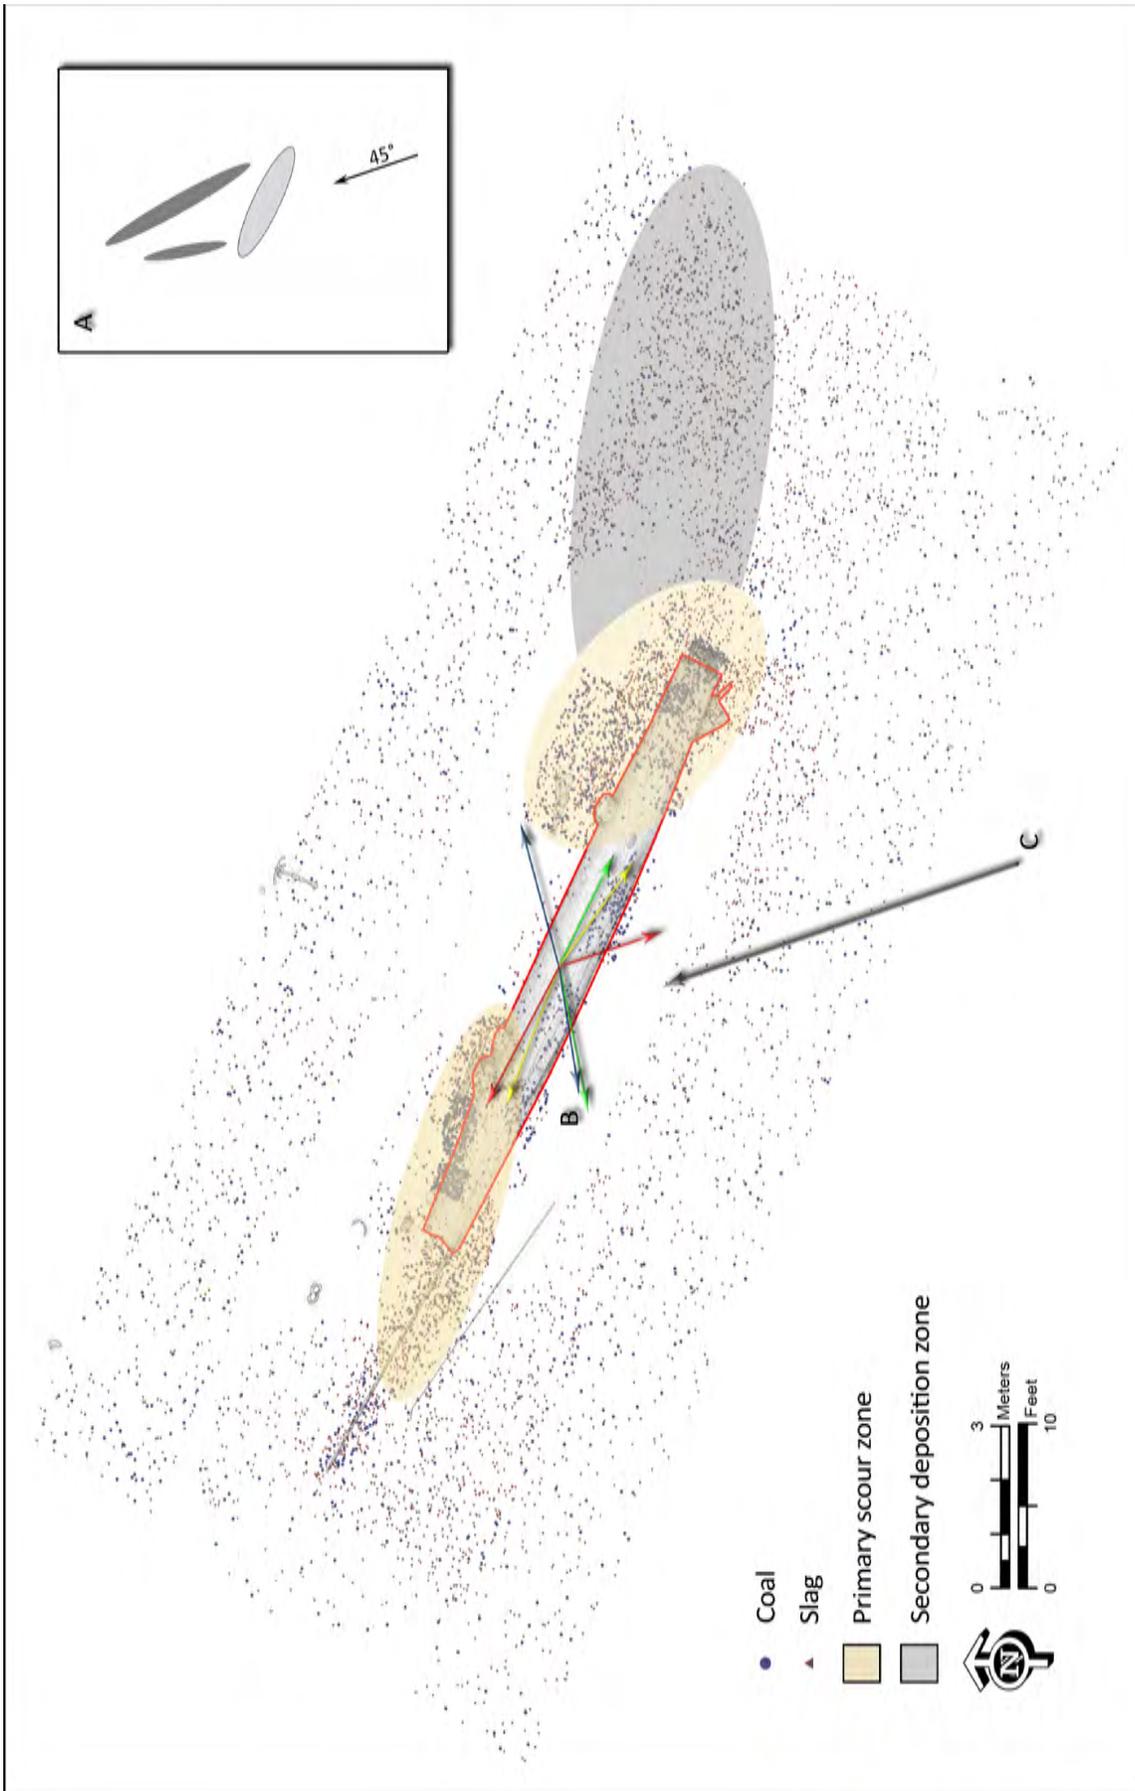
Figure 13.16. Idealized projections demonstrating asymmetrical, convergent scour pattern similar to those identified at the Hunley site are based on an angle of incidence of approximately 45° (A). Comparing 1856 current data from a nearby station (B) shows no vectors that correspond to the projected angle of incidence (C) required to generate the documented scour areas, suggesting storms coming up from the south may have been a significant factor in the formation of the site. (Coal and slag distribution map provided by J. Enright, SEARCH Maritime Archaeology Division, annotated by H. G. Brown, NHHHC)

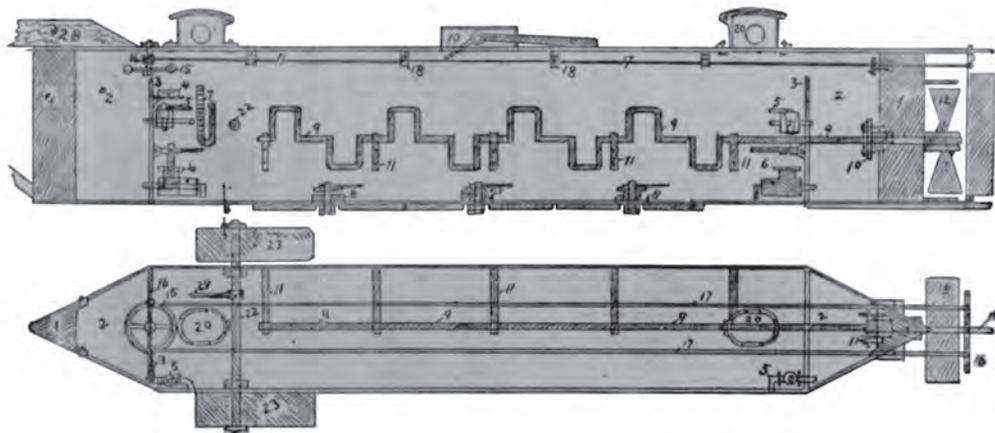
Figure 14.1. Published drawings of H. L. Hunley based on sketches by William Alexander (ORN 1.15:338)

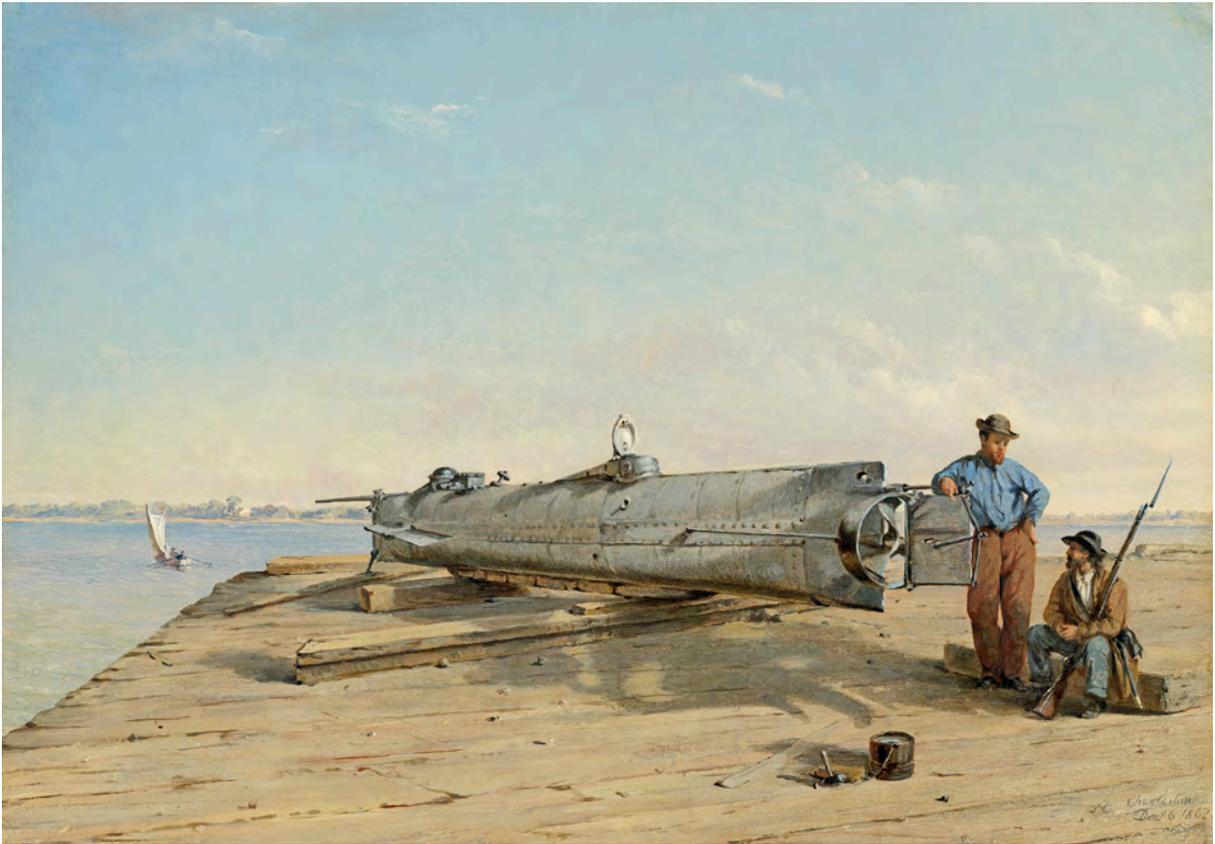
Figure 14.2. Oil painting by Conrad Wise Chapman depicting H. L. Hunley in Charleston. (Courtesy of The Museum of the Confederacy, Richmond, Virginia)

The most valuable image documenting the exterior of *Hunley* is the painting by Conrad Wise Chapman, a Confederate soldier and artist who painted a series of scenes based on sketches he made during his army service (Figure 14.2). It has proven remarkably accurate when compared to features documented archaeologically and may prove the best source for identifying possible features lost during or after the sinking. In addition, a study for the painting, dated 2 December 1863, survives and shows details, particularly in the steering system, that are not as clear in the oil (see Figure 14.10). Many later depictions, including the watercolor wash by R. G. Skerrett published as a frontispiece in the *Official Records of the Union and Confederate Navies* (ORN 1.15), were adapted from Chapman's work, but significant inaccuracies were introduced in each iteration (Figure 14.3).

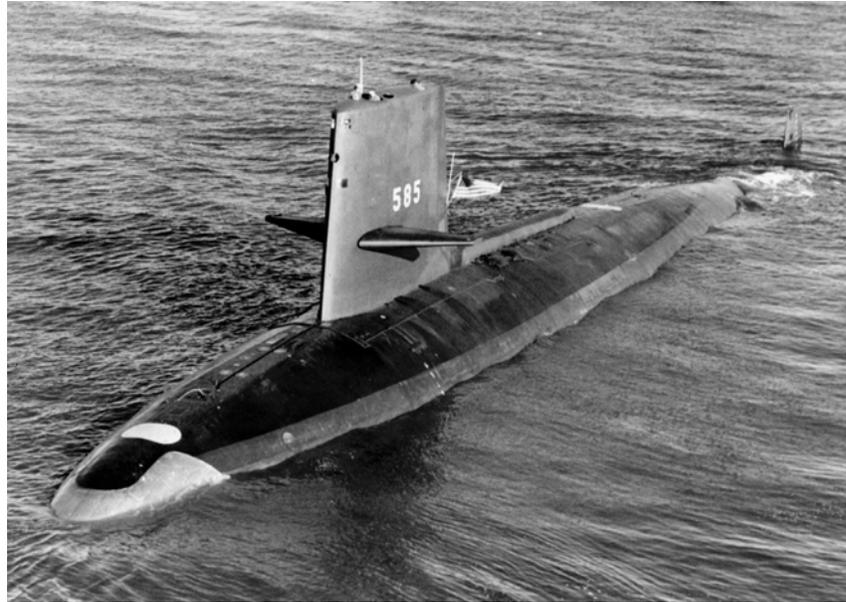
Figure 14.6. USS *Skipjack* (SSN-585) utilized a parabolic bow and gradually tapering body that is hydrodynamically ideal but costly to produce. (NHHC Photo Archives)

and Rydill 1994:105–6, Joubert 2004:17–18) (Figure 14.6). Since such a form calls for a constantly varying diameter, even modern builders frequently adopt a parallel midbody form to save construction costs and time (Burcher and Rydill 1994:106).

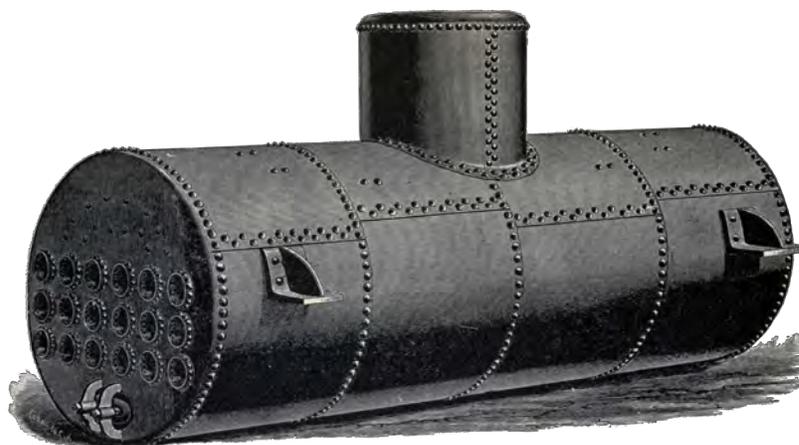
Figure 14.8. This flue boiler from Hutton (1897:443) provides an example of the number and position of rivets penetrating a typical boiler plate, making reuse challenging.

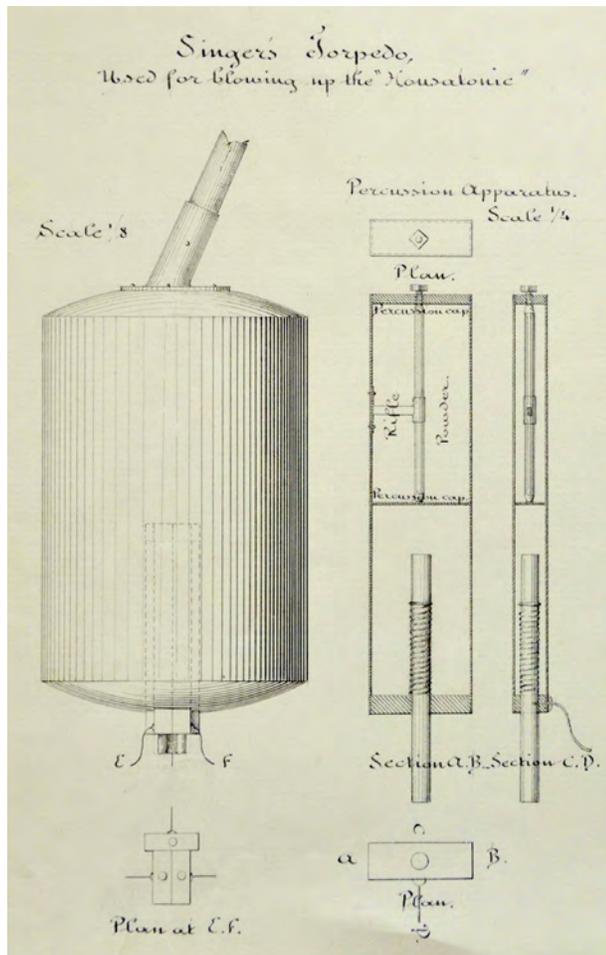
Figure 14.14. Sketch of Singer torpedo adapted for use on a spar. Note letters E and F near the trigger are not annotated. (Courtesy of NARA, RG 94, Quincy Adams Gallimore papers)

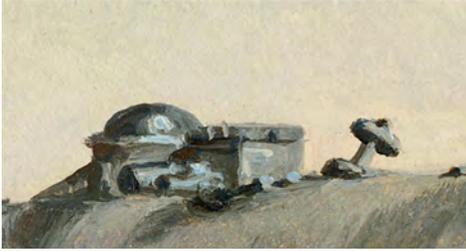
Figure 14.15. Detail from Chapman's painting of Hunley showing a reel positioned aft of the snorkel box. (Detail from *H. L. Hunley* by Conrad Wise Chapman, courtesy of The Museum of the Confederacy, Richmond, Virginia)

Another component depicted in Chapman's painting was the aforementioned reel described by Mazyck as being rigged with a steel cable (Figure 14.15). In Chapman's original sketch, there is only a straight rod in the same position, which may have been the mounting point for a separate spool. No reel or rod was attached to the submarine when discovered, nor was one located in the surrounding sediment. Once the hull has been fully deconcreted, it may be possible to tell whether the reel was lost after the sinking or if it had been removed, for some reason, prior to leaving port.

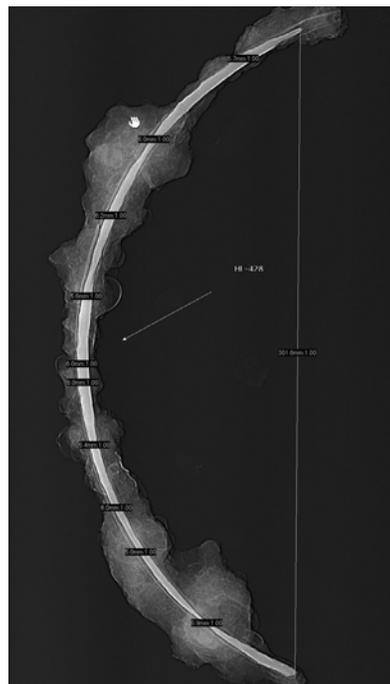
Figure 15.1. Radiograph of HL-0428, the largest fragment of a heavily concreted curved iron rod. (Courtesy of FOTH)

A cluster of concretions were recovered, primarily starboard of the bow, that preserved the original iron, in part, or the hollow mold of a cylindrical rod or wire with a diameter of ca. 0.5–0.6 cm (0.2–0.24 in.). One piece (HL-0432) was consistent in size and composition, but was found near the stern; however it showed a fresh break, suggesting it had been dislodged from its original position. The pieces curve gradually and likely originally formed a ring or hoop. Based on the largest preserved segment (HL-0428), the diameter was approximately 32 cm (12.60 in.) (Figure 15.1). The combined segments form a preserved circumference of roughly 82 cm (32.28 in.), or 81% of the projected total circumference.

The material was found just above the level of the bow, prompting the consideration that it was related to the spar rigging system. However, one would expect braided cable there, rather than solid iron. In addition, the thickness of the metal is too robust for wire, suggesting the piece acted as a stationary strengthening component. It seems unlikely that a solid iron hoop was employed anywhere on the exterior of the submarine. The metal is similar in gauge to a bucket handle, or bail, but those are semicircular, and the surviving pieces form almost an entire ring. Bails for canning jars involve a more complete circle around the neck, but generally are on a smaller scale than represented here. While its original use may never be learned, it is most likely that the object is intrusive to the site.

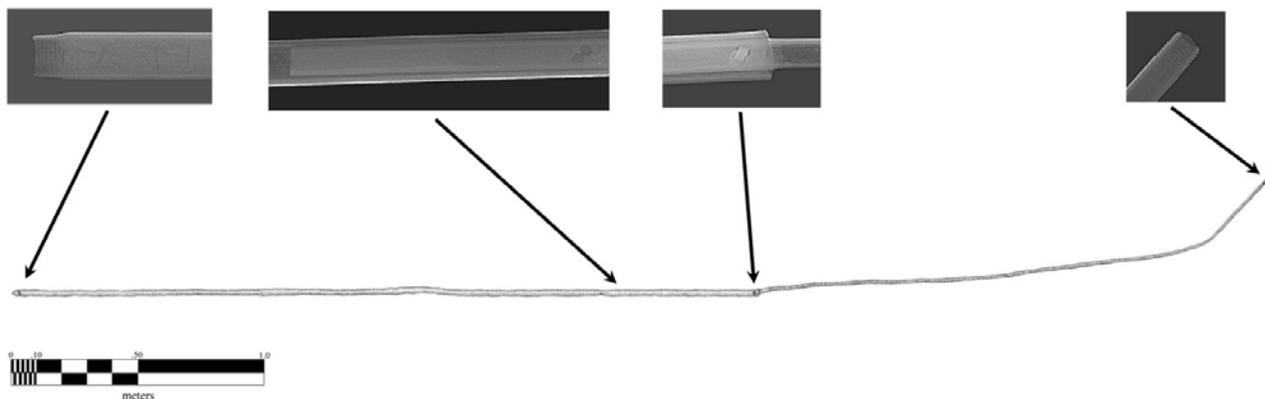
Figure 15.2. Galvanized steel rod found near the submarine's bow. Radiographic images show structural points of interest. (Illustration by James W. Hunter III)

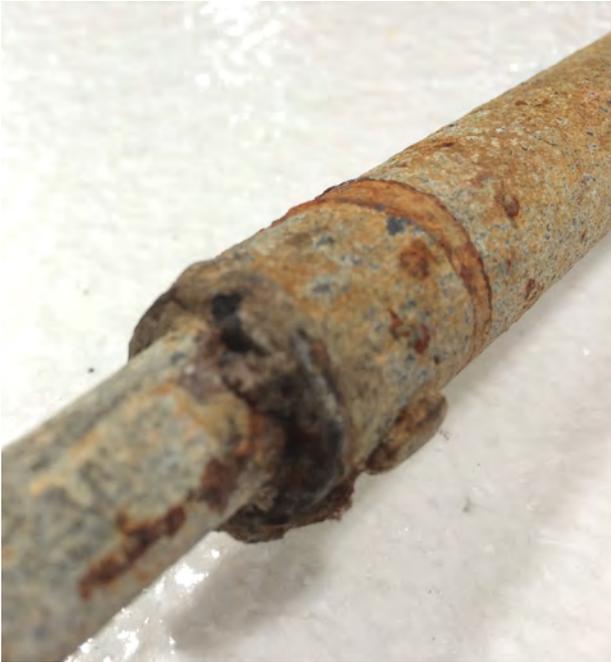
Figure 15.3. Photograph of the joint shows a band of rust indicating the position of a possible clamp or bracket. (Photo by Michael Scafuri, courtesy of FOTH)

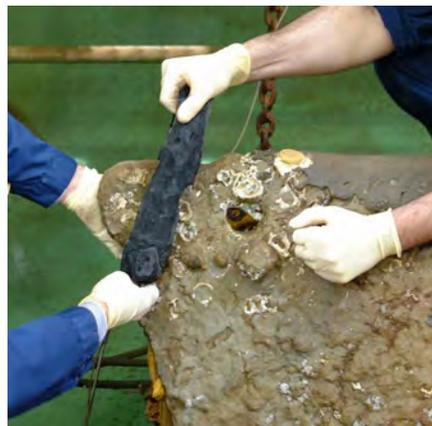
Figure 15.4. Project staff hold bracket HL-0526 against its hypothesized position on the submarine's bow casting. Note the square-headed fastener or nut for bracket HL-0582 immediately beneath the hole in the bow casting. (Detail of photograph by Susanne Grieve, courtesy of FOTH.)

The flat nature of the metal points to its use as a bracket rather than a shackle, which would have had rounded edges to allow rigging lines to pass smoothly through it. Project archaeologists hypothesize that this piece of hardware, in conjunction with another, similar piece (HL-0582, below), probably held *Hunley's* wooden boom in place along the upper surface of the bow. A semicircular depression located along the forward upper extremity of the bow is most likely the remnants of a hole through which the bracket's iron pin was inserted and affixed to the submarine's hull (Figure 15.4). The bracket is closed, with no breaks or distortions, indicating the piece remained in place on the hull until erosion of the bow casting compromised the integrity of the hole through which it was attached (Figure 15.5).
