H. L. Hunley
Recovery Operations

A Collaborative Project of:
Naval History and Heritage Command,
South Carolina Hunley Commission,
and
Friends of the Hunley

Principal Investigator:
Robert S. Neyland, Ph.D.
Department of the Navy

Naval History and Heritage Command
Washington, D.C.
2016

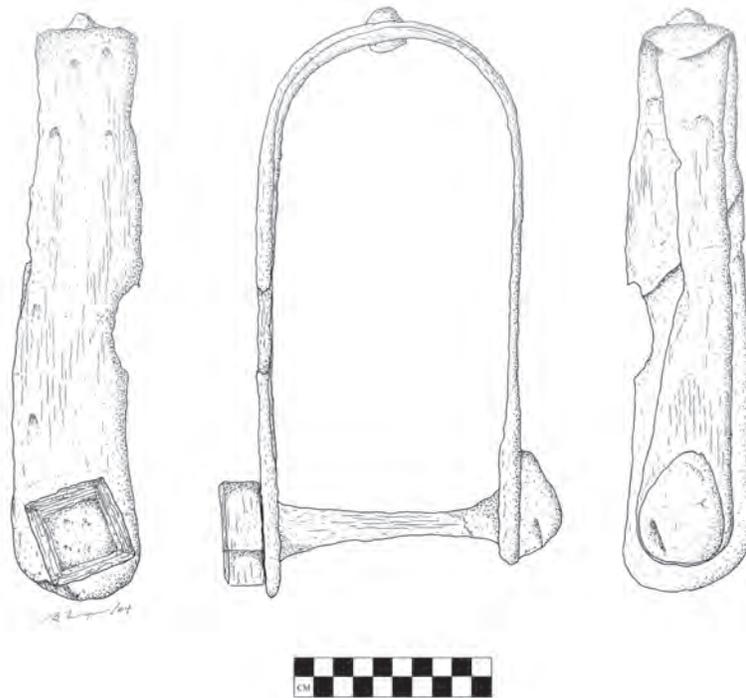
Figure 15.5. Forward spar assembly bracket (HL-0526). (Illustration by Bruce Thompson.)

The flat nature of the metal points to its use as a bracket rather than a shackle, which would have had rounded edges to allow rigging lines to pass smoothly through it. Project archaeologists hypothesize that this piece of hardware, in conjunction with another, similar piece (HL-0582, below), probably held *Hunley's* wooden boom in place along the upper surface of the bow. A semicircular depression located along the forward upper extremity of the bow is most likely the remnants of a hole through which the bracket's iron pin was inserted and affixed to the submarine's hull (Figure 15.4). The bracket is closed, with no breaks or distortions, indicating the piece remained in place on the hull until erosion of the bow casting compromised the integrity of the hole through which it was attached (Figure 15.5).

Two fasteners bind the straps together and complete the bracket. The largest is a wrought-iron pin that has an overall length of 17.1 cm (6.73 in.) and a maximum preserved of 3.1 cm (1.22 in.). The head of the pin appears square in profile, exhibits a maximum

width of 4.6 cm (1.81 in.) and a maximum preserved thickness of 2.0 cm (0.79 in.). Conversely, the pin may be round-headed and have a threaded end to which a square-shaped nut is affixed. Ferruginous concretions and mineralized deposits obscure the point at which the pin, square-headed head or nut, and bracket strap meet; consequently, an accurate assessment of the pin's construction is presently impossible. A small 2.3 cm (0.91 in.) long round-headed rivet holds both straps together at the apex of the bracket. The rivet has a maximum preserved diameter of 2.0 cm (0.79 in.) and appears to have been peened on both ends to hold it in place. According to Bruce Thompson (pers. comm.), the bracket's construction attributes suggest that it was assembled by one of the following two scenarios:

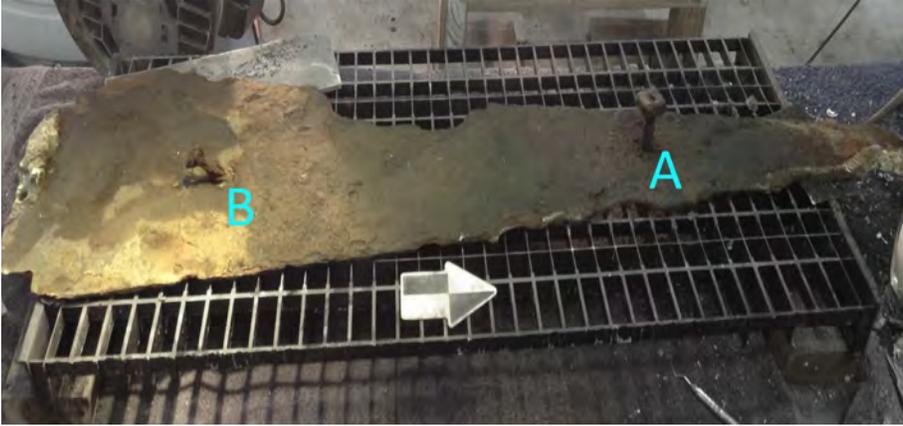
Figure 15.6. Starboard side of aft cutwater (HL-0555). Bolts A and B likely functioned as rigging points. (Photograph by Paul Mardikian, courtesy of FOTH)

A flat triangular shaped piece of heavily concreted wrought iron was identified as the submarine's aft cutwater, a piece that was originally mounted along the centerline of the hull, attached to the leading edge of the aft conning tower to prevent fouling (Figure 15.6). The artifact was discovered forward of the aft hatch, 100 cm (39.37 in.) below the top of the hull on the starboard side. The piece became dislodged from the hull following *Hunley's* loss and was discovered during the excavation.

At its longest point, the piece measures 108 cm (42.52 in.), it is 26 cm (10.24 in.) high where it abutted the conning tower. The surviving length of the hypotenuse is 106 cm (41.73 in.), but there is some metal loss along this edge, particularly at the end that was in contact with the conning tower, and there is a semi-

circular area of loss about halfway down its length. The average thickness of the metal plate is 0.80 cm (0.315 in.). The bottom corner of the cutwater was cut away to fit over the seam where the conning tower attached to the hull plate. A bolt or rivet hole survives approximately halfway down the back edge to assist in the mounting of the piece to the hatch coaming.

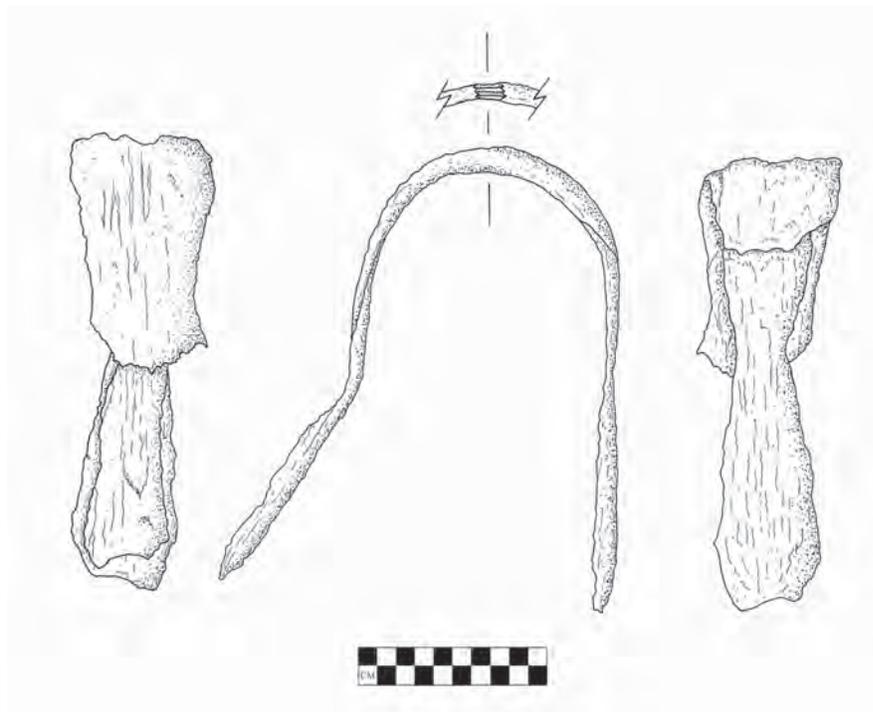
Figure 15.7. Aft spar assembly bracket (HL-0582). (Illustration by Bruce Thompson.)

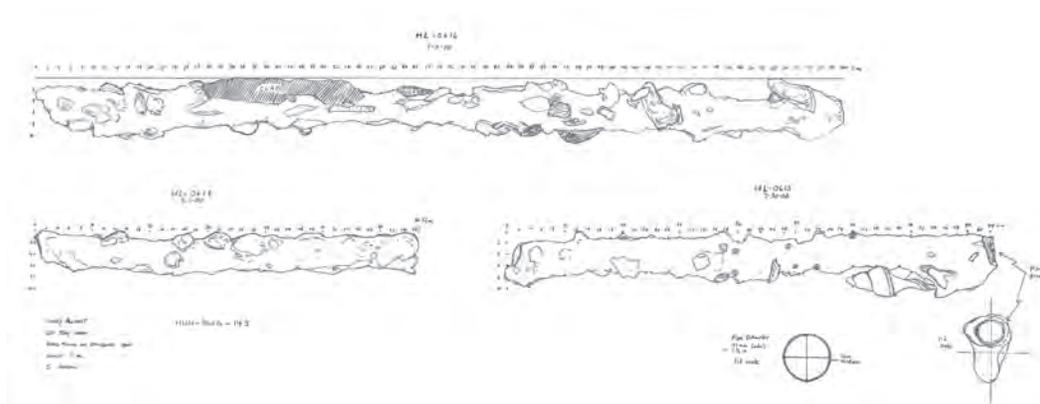
Figure 15.8. Field drawing of snorkel tubes showing their heavily concreted state. (Illustration by Shea McLean, courtesy of FOTH.)

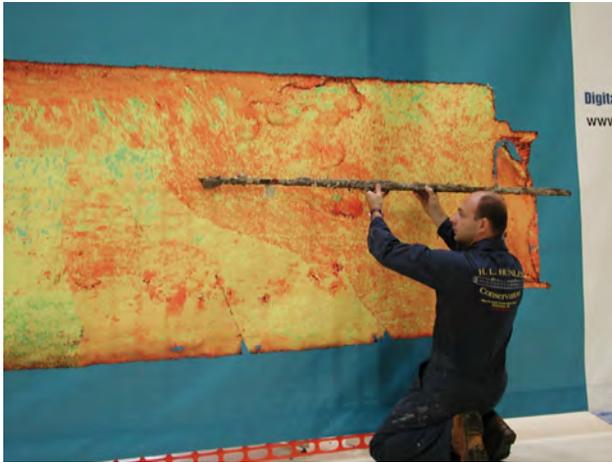
Figure 15.9. Paul Mardikian holds starboard shroud attachment bar (HL-0660) in corresponding port position on a full-scale print of the submarine. (Photo by Philippe de Vivies, courtesy of FOTH)

HL-0660 — Shroud Attachment Bar

A long, thin metallic concretion was found roughly parallel to the starboard side, connected to the hull at one end, just forward of the aft stern hole, near the top edge of the expansion strake. The detached end terminated 14 cm (5.51 in.) forward of the aft conning tower. Due to the fragility of the connection point, the piece was detached from the hull prior to lift. The concretion was removed to expose a long, flat iron bar or strap, measuring 1.78 m (5.84 ft.) in length, 3.0 to 3.6 cm (1.8–1.42 in.) in width, and 1.49 cm (0.59 in.) thick (Figure 15.9). The edges of the artifact show signs of deterioration.

The object was identified as the starboard shroud attachment bar, originally running from the propeller shroud to the expansion strake near the seam of the second and third quarter plates from the stern. Labeled as “Shroud Guard” in the sketch from McClintock’s (1872) meeting with the British Admiralty, the piece was apparently designed to prevent fouling of the propeller and damage to the shroud. It may also have provided some lateral stability to the shroud, which was mounted to the stern at the top and bottom.

At some point after sinking, the piece was detached from the shroud and bent forward nearly 180°, deforming the metal at the point of attachment to the hull plating. Given its final position, it seems unlikely that this could have occurred after the submarine’s tilting to starboard. The surviving length is too short to reach the propeller shroud and no adjoining piece was found adjacent to its final position, suggesting that a

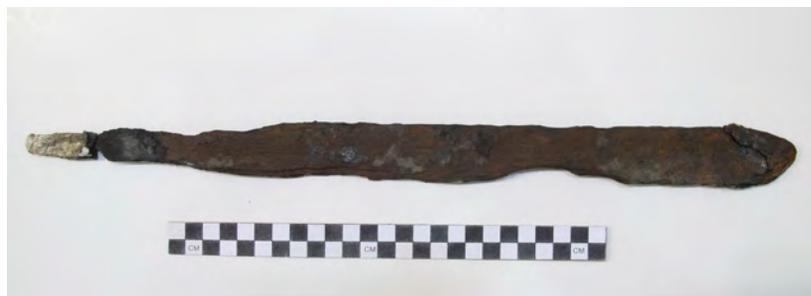
Figure 15.10. Cast of a wrought-iron bar (HL-0683) found near the rudder. (Photo by Virginie Ternisien, courtesy of FOTH)

A heavy concretion was found at the starboard side of the submarine, near the aft stern hole. The concretion was removed to reveal a section of flat, wrought-iron bar, most of which was preserved metal (Figure 15.10). One end contained a void from which a polyurethane cast was made. The artifact measures 46 cm (18.11 in.) in length, with a maximum thickness 0.6 cm (0.24 in.). The width tapers from 3.5 cm (1.38 in.) at its widest point to 2.2 cm (0.87 in.) at the cast end. The wider end tapers sharply to a rounded point, though whether this was its initial shape or a result of post-depositional processes is difficult to determine. No fastener holes or other attachment points were found.

Conservator Paul Mardikian (2014 pers. comm.) noted that the x-rays did not show the usual distinct demarcation of the original surface of the object and that the concretion layer closely conformed to the areas of damage and metal loss. He suggested that the object might have suffered some damage after it had begun to concrete, and subsequently a new concretion layer formed over resulting areas of fresh metal exposure. The end recovered through casting shows evidence of elongation, possibly reflecting a deformation related to its disarticulation from the submarine.

The piece is consistent in width with the starboard shroud attachment bar (HL-0660), although it is 0.89 cm (0.35 in.) thinner, so it does not appear to be the missing adjoining piece of that component. The piece may be related to the rudder steering assembly, but it is less than 1 cm (0.39 in.) narrower than the various wrought-iron pieces concreted to the rudder (HL-0686). While its original position on the submarine cannot be determined, its material and shape is consistent with elements from *Hunley* and likely was associated with the steering assembly.

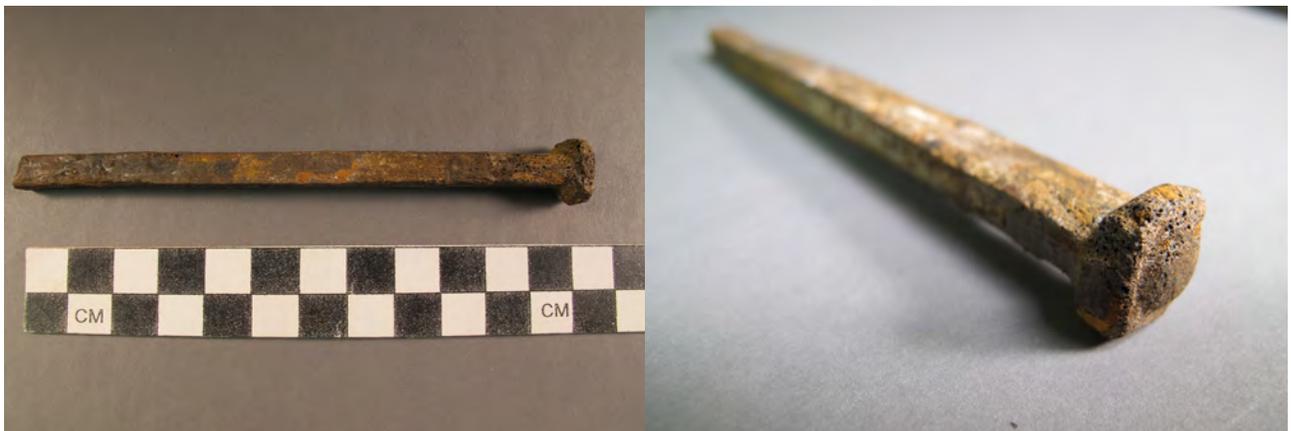
Figure 15.12. Cast of a dome-headed spike or nail (HL-0685) found in a concretion near *Hunley's* stern. (Photos by Paul Mardikian, courtesy of FOTH)

A small ferrous concretion was found 80 cm below and 30 cm to starboard of the top of the stern. Its overall size was 14.0 × 9.0 × 6.5 cm (5.51 × 3.54 × 2.56 in.). Based on x-ray imaging, it was determined that no original metal survived and a polyurethane cast was

made of the void (Figure 15.12). The preserved shape proved to be a rectangular shafted spike with a square head with a raised dome in the center. The surviving length of the shaft is 12.5 cm (4.92 in.), although it appears the tip was broken off. The square head is approximately 1.4 × 1.4 cm (0.55 × 0.55 in.). The rectangular shaft is consistent with late 18th to late 19th century production. This type of spike is ideal for use in wood; however since no other hardware from the rudder has yet been found, its use as part of the rudder assembly was considered. This was ultimately ruled out, as the moving joints would require cylindrical hardware. The spike is more likely intrusive, possibly from the wooden-structured *Housatonic*.

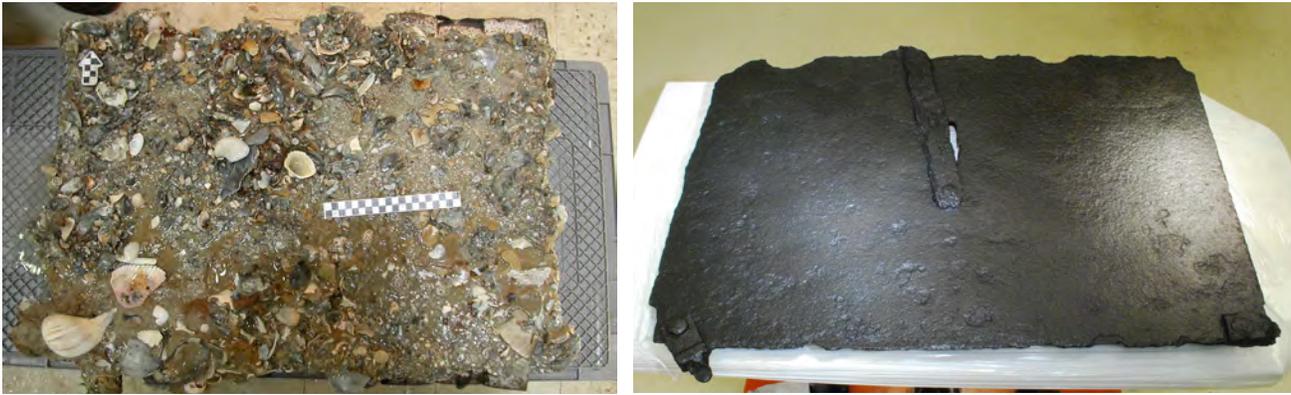
Figure 15.13. Port side of rudder (HL-0686) before conservation (left) and after conservation (right). (Photos by M. Scott Harris (left) and Johanna Rivera (right), courtesy of FOTH)

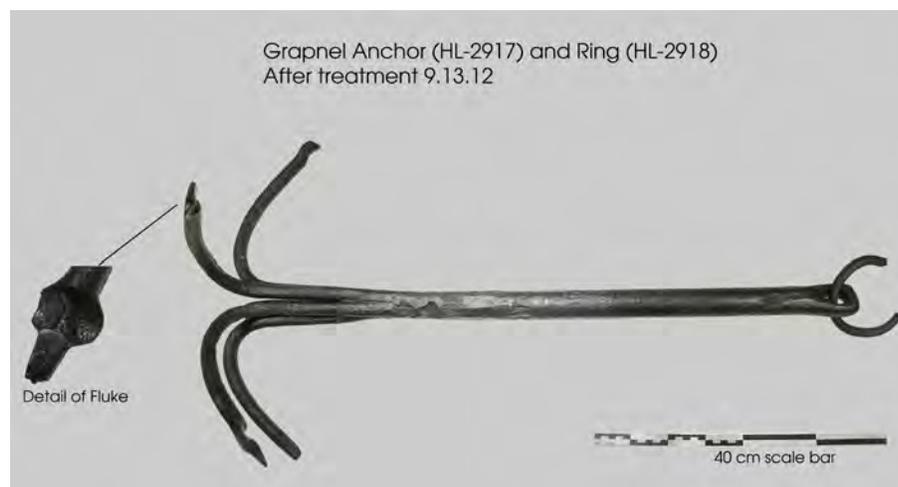
Figure 15.15. Five-tined grapnel anchor (HL-2917) and ring (HL-2918) after conservation treatment (Photo by Chris Watters, courtesy of FOTH).

During the magnetometer survey that was conducted in 2001, a year after *Hunley* was recovered, the sensor detected a deeply buried magnetic anomaly at the edge of the original excavation boundary to starboard of *Hunley*. Upon investigation, this anomaly was found to be a concretion containing a wrought-iron grapnel (HL-2917) (Figure 15.15). It was embedded in the Pleistocene mud at the same level as the keel. Three of the five arms had been caught in the Pleistocene mud, one of which was distended by at least

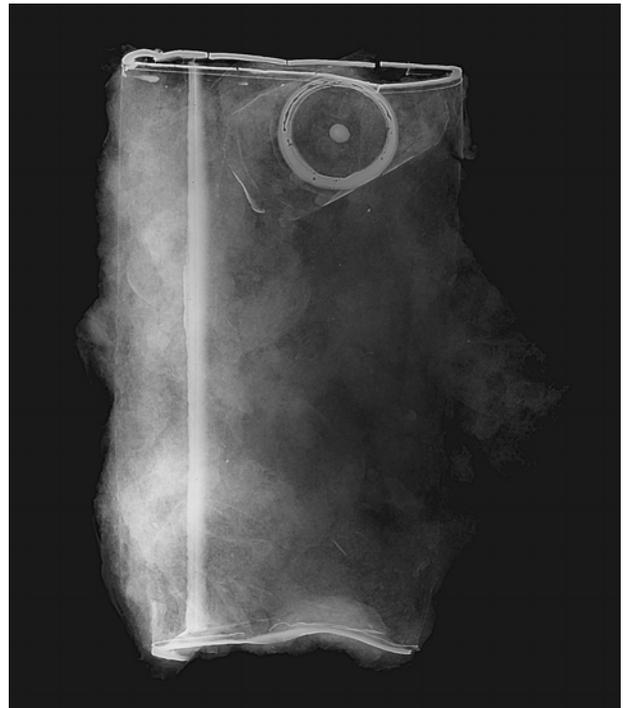
Figure 15.17. A radiograph of the heavily concreted HL-3667 shows a preserved vented cap typical of late 19th century manufacture. (Courtesy of FOTH)

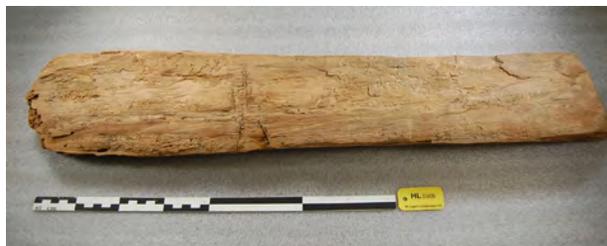
Figure 15.21. Wooden plank (HL-0505) found close to starboard bow. (Photo by Michael Scafuri, Courtesy of FOTH)

A thick wooden plank was found adjacent to the starboard bow, 42 cm (16.54 in.) below the top, and extending 27 cm (10.63 in.) forward of the bow casting (Figure 15.21). It has a maximum length of 67.3 cm (26.50 in.), maximum width of 12.2 cm (4.80 in.), and maximum thickness of 5.8 cm (2.28 in.). One end is cut at roughly a 35° angle and retains visible cut marks (Figure 15.22). The opposite end is heavily deteriorated, with no original surface surviving. Two parallel scoring marks are present across one face approximately

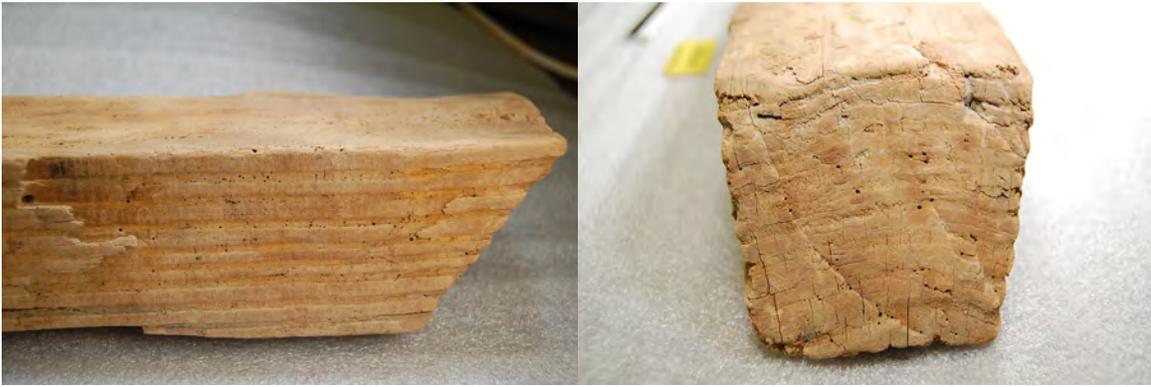
Figure 15.22. Side view showing angled cut (left) and cross section (right) of HL-0505. (Photos by Johanna Rivera, courtesy of FOTH)

One long, thin piece (HL-0505) was found adjacent to the starboard side of the bow. Roughly trapezoidal in cross section, the piece is 68 cm (26.77 in.) long, 10 cm (3.94 in.) wide and 6 cm (2.36 in.) high (see Figure 15.22). One end is well preserved with a clear diagonal cut, while the other is heavily worn by teredo damage. Two cut marks run perpendicular to the grain along the wider side, approximately 27 cm (10.63 in.) from the cut end. The possibility that this was part of the spar boom

27 cm (10.63 in.) from the eroded end. The marks are 3.15–3.9 cm (1.24–1.54 in.) apart. Another, shallower set of scoring marks are found on the opposite face, roughly the same distance from the end and the same distance apart.

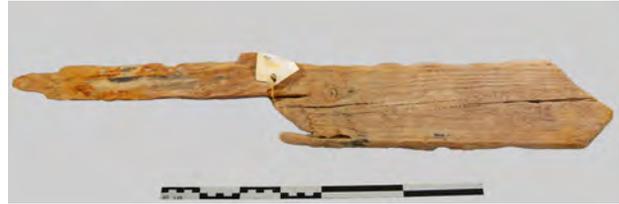
Figure 15.25. Worn wooden plank with pointed end (HL-0594). (Photo by Johanna Rivera, courtesy of FOTH)

A broken and worn wooden plank (Figure 15.25) was found 77 cm (30.32 in.) aft of and 92 cm (36.22 in.) below the top of the bow, to starboard. The piece measures 65 cm (25.59 in.) in length, 15 cm (5.91 in.) in width and is 1.5 cm (0.59 in.) thick. One end was cut into an asymmetrical V shape, most likely by a saw based on the parallel tool marks. The edges appear beveled, although this follows the grain and may therefore represent natural deterioration. The sawn point measures 6 cm (2.36 in.) and 5 cm (1.97 in.) along each face. The opposite end measures only 2.4 cm (0.95 in.) in width, due to the loss of a longitudinal section of wood along a split in the grain beginning 37 cm (14.57 in.) from the sawn end. Several other splits along the grain are present. No fastener marks were found.

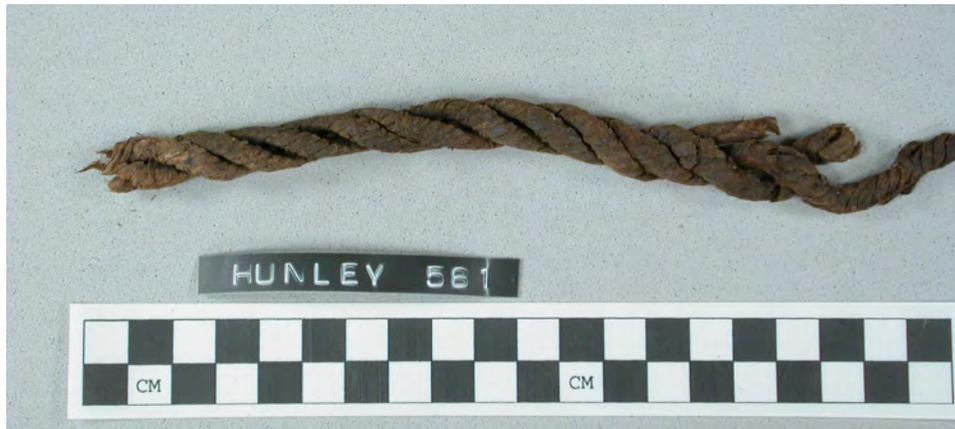
Figure 15.26. Fragment of Z-twist rope (HL-0581). (Courtesy of FOTH)

A piece of natural fiber rope was found 60 cm (23.62 in.) below and 43 cm (16.93 in.) aft of the top of the bow, approximately 18 cm (7.09 in.) to starboard, parallel to the hull. When recovered, the segment was 7.5 cm (2.95 in.) long and 1.3 cm (0.51 in.) in diameter (Figure 15.26). This results in a circumference, while saturated, of 4.08 cm (1.6 in.). The end closest to the bow was frayed, while the after end appeared broken off and most likely was once connected to one of the

fragments recovered in a separate lot (HL-0585). There was no visible evidence of tar or other preservative. The fragment appears to be made up of yarns Z-twisted into strands, three of which were laid together to form a plain rope in an S-twist; three of these were further closed together to form a cable with a Z-twist. Based on terminology outlined by Sanders (2009:6–9), the rope appears to be a left-laid cablet, or cable-laid rope of “less than 9 inches (229 mm) in circumference.” Cable-laid rope was reputed to have greater resistance to chafing and “were relatively impervious to water, being known as ‘water-laid’” (Sanders 2009:8).

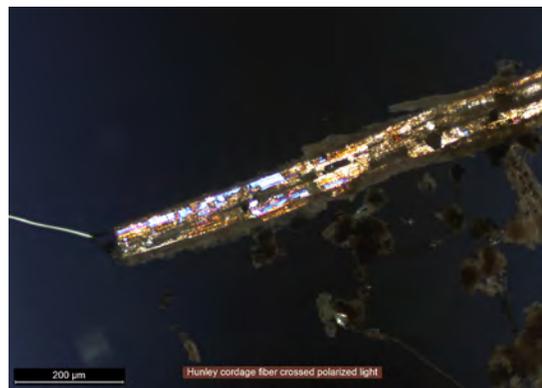
Figure 15.27. Sample of rope fiber (HL-0585) examined under cross polarized light. (Image by Susan Heald, National Museum of the American Indian)

A sample was examined by Susan Heald, textile conservator with the National Museum of the American Indian using a Nikon Eclipse polarizing microscope. Since the rope had been conserved with silicone oil prior to examination, the light was unable to penetrate the fibers well (Figure 15.27). Nevertheless, it was evident that the fibers were not inconsistent with hemp, although several other bast fibers, such as jute and flax, demonstrate similar patterns. Abaca, however, as a leaf fiber, and cotton, as a seed fiber, can be ruled out.

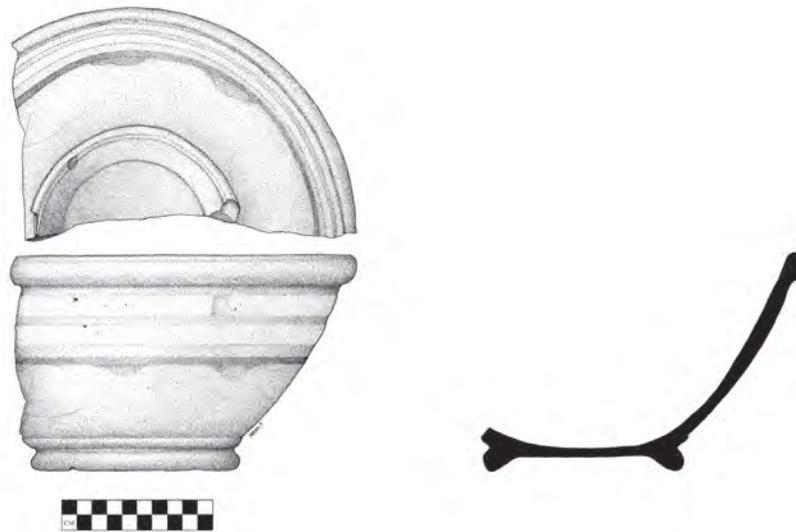
Figure 15.28. Slip-banded American yellow ware bowl fragment (HL-0448). (Illustration by James W. Hunter III, courtesy of FOTH)

A large ceramic sherd was recovered from the starboard OII perimeter trench, roughly in line with the bow of the submarine. The piece makes up approximately one-third of a slip-banded American yellow ware bowl (Figure 15.28). It retains many of the vessel’s important diagnostic attributes, including significant portions of the rim and base, as well as a number of decorative elements. The sherd measures 14.3 cm (5.62 in.) (linear distance) from the bottom of the foot ring to the top of the rim, and has a maximum preserved

The sherd has a dark, yellowish-brown body with numerous inclusions of various sizes and types. Except where broken, the specimen is completely covered in clear (presumably alkaline) glaze. Three annular bands—two composed of white slip and one of dark brown slip—are located between the lower edge of the rim and the approximate middle of the sherd (Figure 15.29). Both white bands are 1.4 cm (0.55 in.) wide; the brown band is 0.4 cm (0.16 in.) wide. All three bands exhibit areas where the slip was accidentally disrupted or disturbed during the manufacturing process. Although the vessel was likely wheel-thrown, no rill marks are evident on either the interior or exterior surface of the sherd.

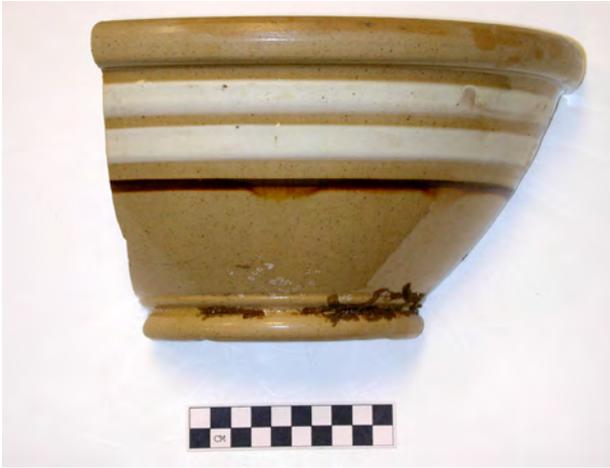
Figure 15.29. Annular decorative bands on the outer surface of HL-0448 show some manufacturing flaws. (Courtesy of FOTH)

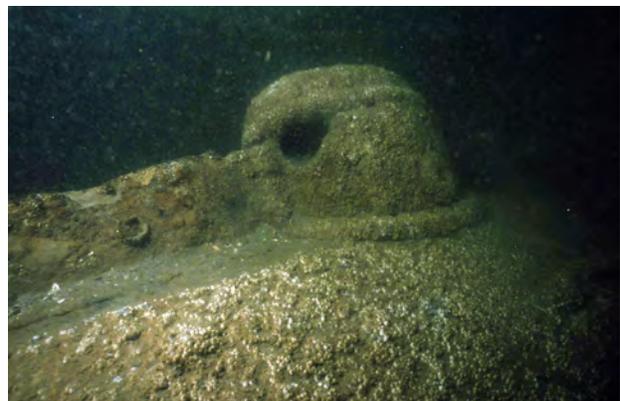
Figure 16.3. What caused the hole in Hunley's conning tower, and when, remain critical questions in reconstructing the sinking event. (Photo by Brett Seymour, courtesy of FOTH)

The clearest sign of damage to the hull was the loss of the port viewport in the forward conning tower (Figure 16.3). Presuming it did occur prior to the sinking, either as a result of small arms fire or shrapnel, it is problematic because the conning tower was above the surface of the water and Dixon would have had time to block the hole to prevent water from flooding the submarine. However, weather and sea state could also have been a contributing factor. With the wind building from the northwest at the time of the attack and immediately afterwards, and the tide setting to the northeast, seas would have been building with waves that could have thus been lapping over the conning towers. The damage to the forward conning tower alone should not have been sufficient to sink the submarine, provided it stayed above the surface. The hole could have been plugged with a garment or rag to prevent water from
