GRAMPAW PETTIBONE

Pass the Word

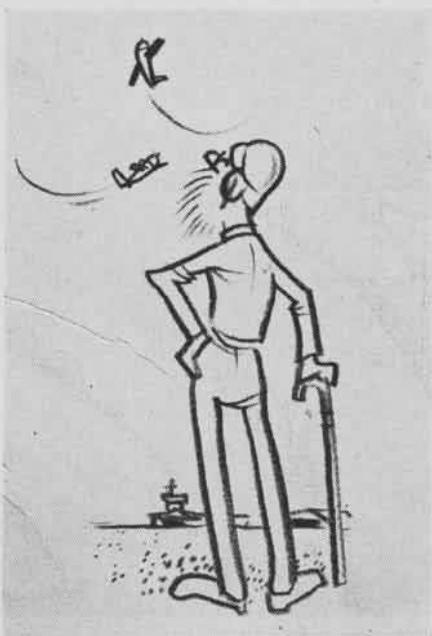
A considerable number of reports are being received of tail-wheel caster lock damage caused by towing or taxiing planes with the tail-wheel locked.

It should be easy to clean up such a simple problem. First, be sure everybody understands what happens when the tail-wheel is locked. Then suggest kindly (followed up with the big stick) that everyone put forth the effort necessary to insure it is unlocked each time before tow-

ing or taxiing. Maintenance and overhaul officers can help by raising a stink in the squadron concerned every time this is not done.

In some cases, entire squadrons need indoctrination on this point, as indicated by the fact that tail-wheel caster lock damage, reported as having occurred in this manner, is listed as material failure, when very evidently it is 100 percent personnel failure.
