# GRAMPAW PETTIBONE

## Wanted: An Opening

## Prematurely Gray

## In a Hurry?

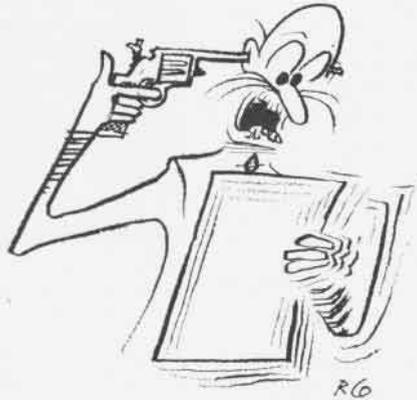
He flew west for half an hour, looking without any success for a break in the overcast, then turned around and

flew back to Dallas. By this time he had been airborne for about three hours. He couldn't tell for sure, as he had no watch and hence had to estimate the time.

With his fuel supply low and the weather very bad, he decided that he would have to jump. Not wishing to bail out over a populated area he flew north until both gas tanks were empty and then went over the side.

"On all cross country flights where weather conditions are marginal and the possibility of encountering instrument conditions exists, the aircraft and pilot must meet instrument flight requirements."
