Gramps from Yesteryear

Close Shave

Suddenly!

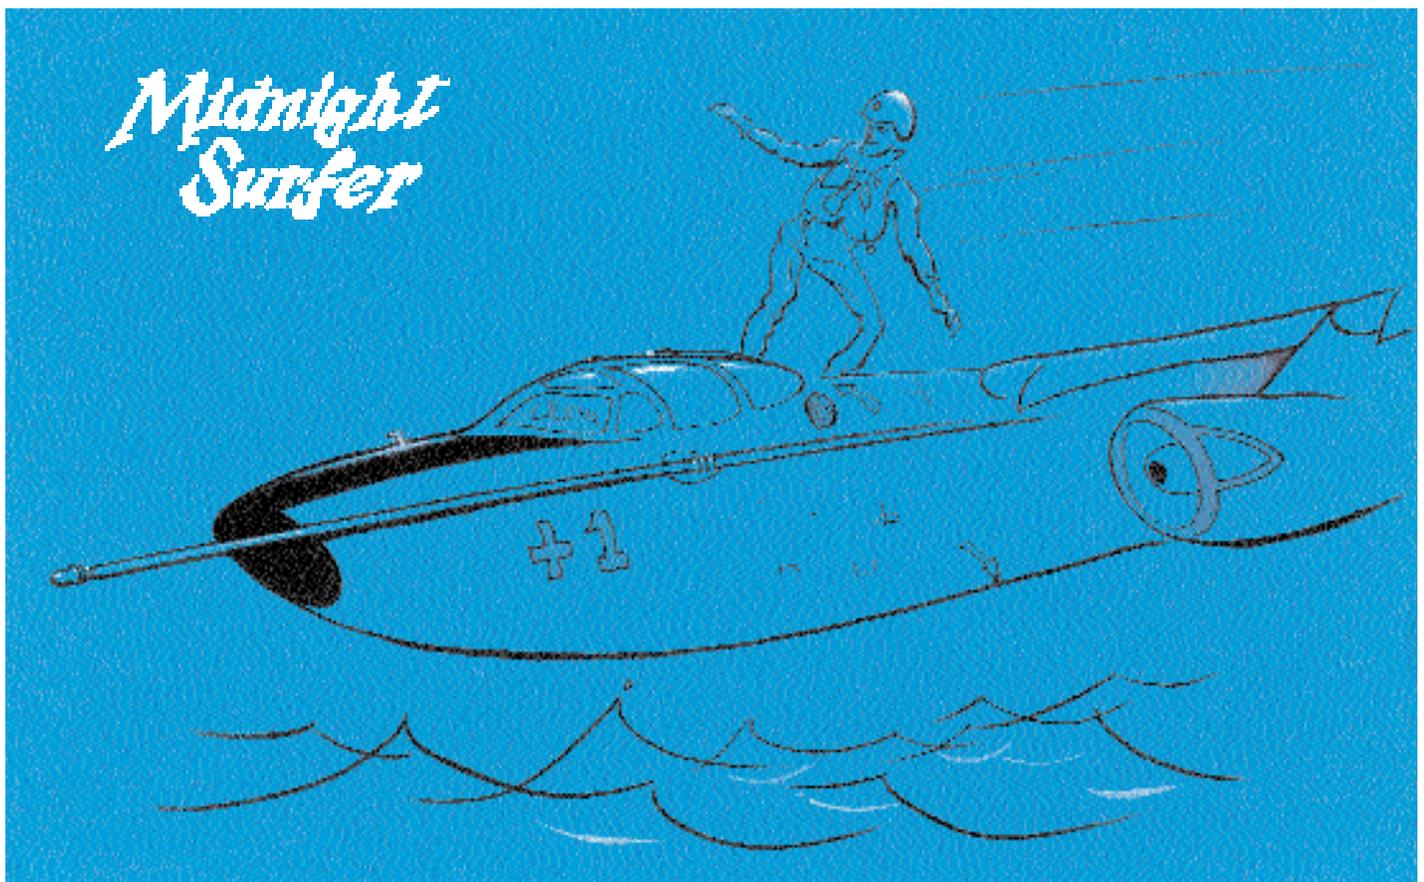
An A3D returning from a night training hop crossed the ramp of an attack carrier with the meatball right on the money. The hook picked up the number two wire after the touchdown and the arrestment seemed normal. Suddenly, the wire broke, and the big plane lurched forward with full power on—but SLOW! As the Skywarrior cleared the flight deck, the pilot cleaned up his landing gear and concentrated on holding his attitude and airspeed. All three men aboard held their breath as they watched the altimeter unwind.

The A3D shuddered as it spanked the water. The pilot gently eased the yoke toward him as the fuselage lightly slid through the dark water. After a few seconds, the aircraft broke free of the sea and climbed swiftly.

Vectored by the carrier, the bomber flew to a nearby island airfield and landed safely. Inspection of the A3D revealed that the underside of the fuselage aft of the bomb bay door and the port engine nacelle had been dragged through the water. The landing signal officer logged the narrow squeak as an arrested landing, a bolter and a water touch and go.

How close can you get to wet feet? This pilot is a cool one, but if he has many more like this, I'll have to check the competition before I unlimber one of my tall tales at any happy hour where the air wing is represented.

Just goes to prove you ain't got an accident till she smashes to a stop, so keep flyin' it. You may luck out. This crew did.
