GRAMP AW PETTIBONE

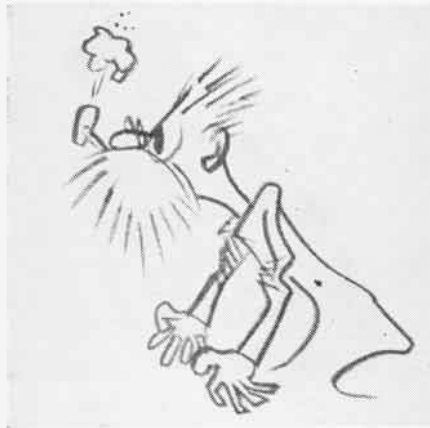
The collision referred to was the severance of four high tension cables midway between suspension points located on the ridges on opposite sides of the Chattahoochee River. The cables were approximately 60 feet above the river and some 200 feet below the adjacent ridges.

Pilot: "I immediately climbed to 2500 feet and checked the plane for damage. The flight characteristics were unchanged except that the plane shuddered under 100 knots. The landing light on the port wing was knocked out and the starboard wing had a cut about two feet long from the leading edge to the trailing edge at about the center of the wing. I thought that I was north of the field and a little west so I took a heading of 150 degrees. The beam was still incomprehensible."

I guess by now you realize that you flew right smack into a thunderstorm and that once you were in it you did just about everything wrong.

2. The next rule that you forgot was: "Don't turn around once you get well into a thunderstorm." Had you remembered this you would have broken out in the clear in a matter of four or five minutes of rugged straight and level flight.

when you realized that you were lost and went down to 60 feet above the terrain in heavy rain to look for sign posts.

My advice to you is **STAY ON THE GROUND UNTIL YOU LEARN A FEW OF THE BASIC PRINCIPLES OF INTELLIGENT FLIGHT PLANNING.**
