GRAMPAW PETTIBONE

20 Knots Over Mach

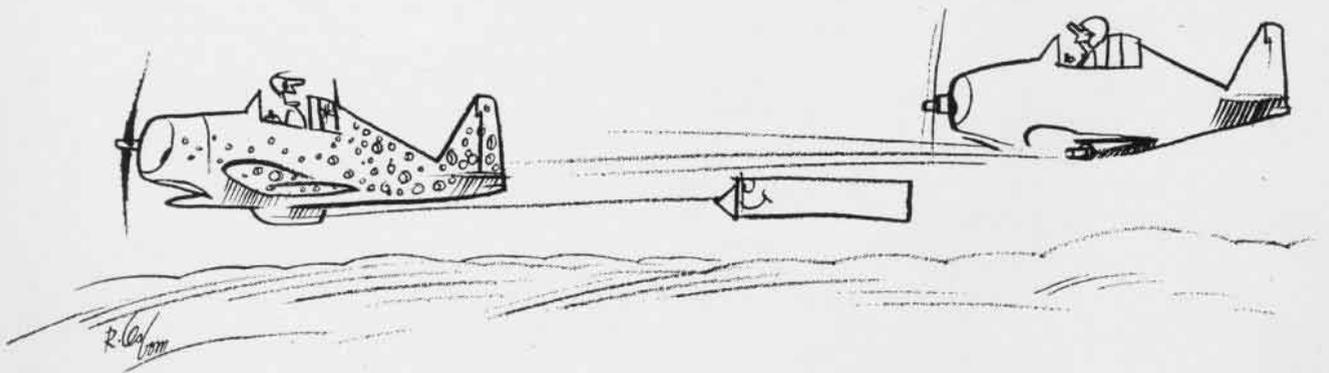
The pilot had been towing a 25A aerial target banner which was trailing approximately 900 feet behind the plane. During the gunnery flight, several course changes were necessary in order to remain clear of the gunnery flights. All of the pilots in this particular flight were sure that they were not in a position to hit the tow plane during their firing runs, and it is possible that the bullets came from a plane in one of the other gunnery flights. In any event, the path of the bullets through the wing indicates that they were fired from a position about 10 degrees off the stern and in a rather flat attitude.
